LOG # LF 101
TARGET # C2039
COORD: LAT _____
LONG _____

PRESSURE
DECK WEB
ROADMAP

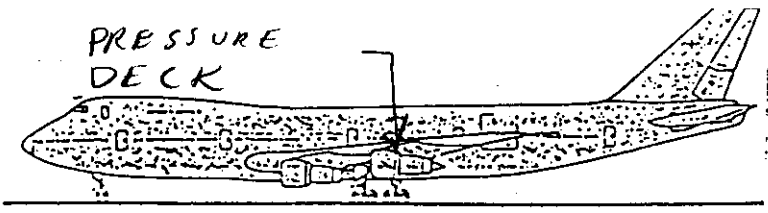
SEGMENT OF HORIZONTAL DEBRIS FIELD GREEN
PRESSURE DECK FROM LBL 80 TO LBL 104
AND STA 1250 - 1263, FLOOR BEAM CHORDS
ARE FRACTURED AT LOWER CHORD.

PART IS NOT SOOTED
