LOG # LF 106
 TARGET # C 026
 COORD: LAT _____
 LONG _____

PRESSURE
DECK WEB
ROADMAP

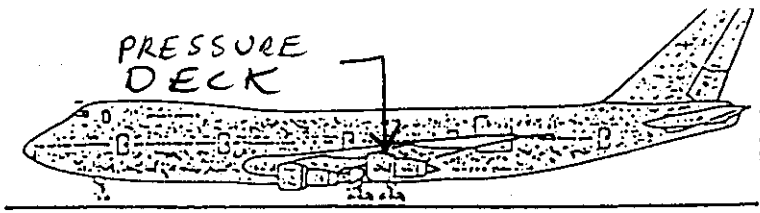
HORIZONTAL PRESSURE DECK DEBRIS FIELD GREEN
 SEGMENT FROM STA 1312 - STA 1294
 AND FROM LBL 59 to LBL 84.
 LBL 75.92 FLOOR BEAM CHORD IS ATTACHED
 AND FRACTURED AT VERTICAL FLANGE RADIIUS
 BETWEEN STA 1312 AND 1303. THE WEB=
 FRACTURED ON REMAINING SEGMENT OF CHORD

PART IS HEAVILY SOOTED

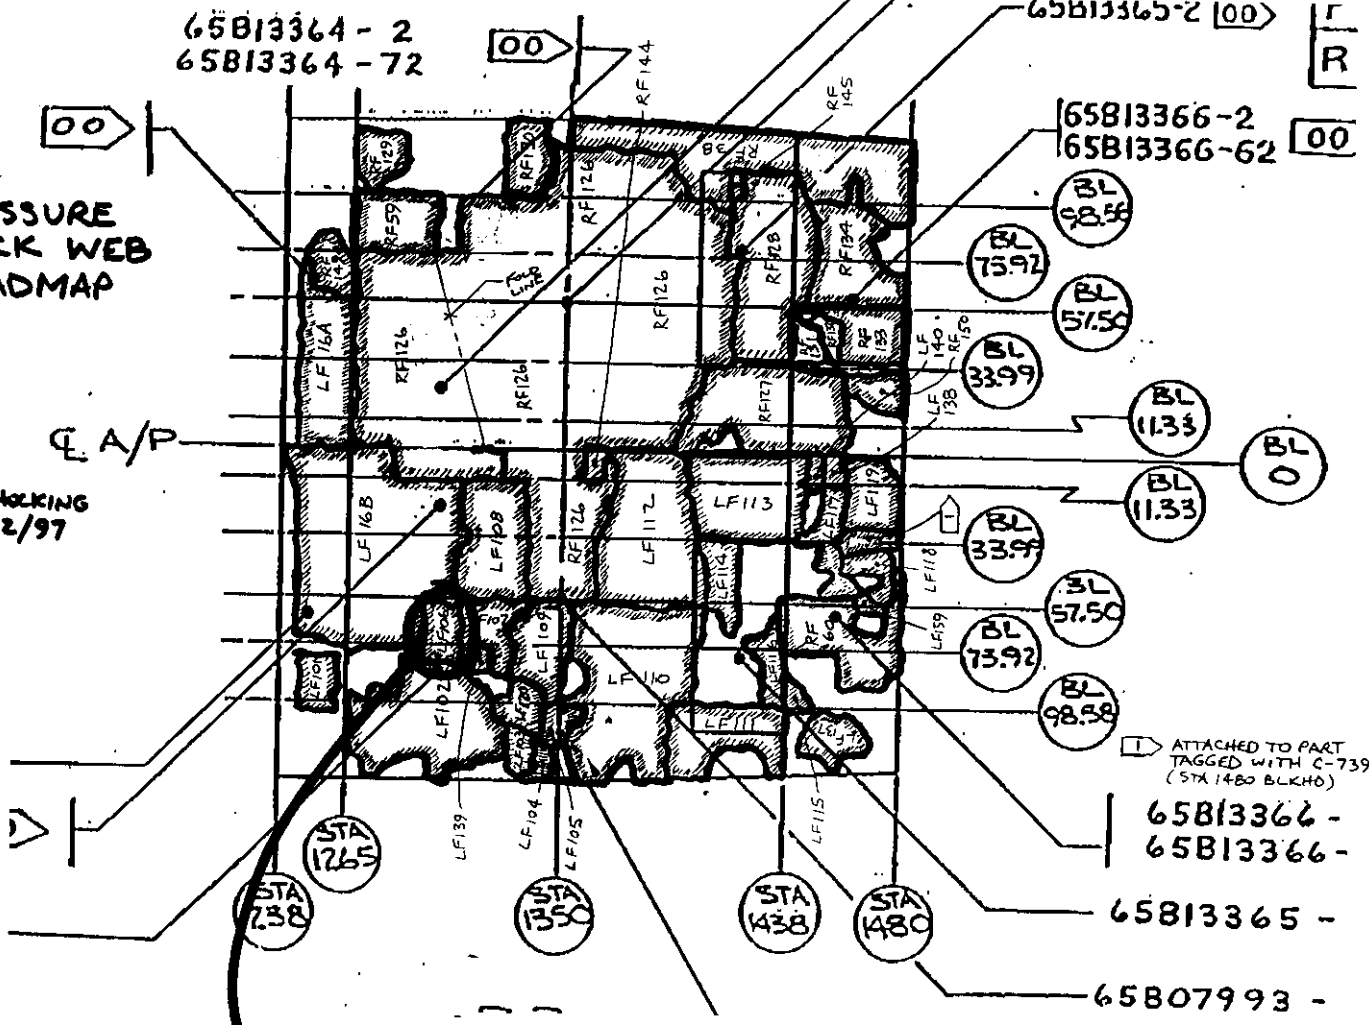
LOG#
LF106

ATTACHED TO PART
TAGGED WITH C-739
(STA 1480 BLKHO)
