LOG # 505 BSAI 10-1-96
LF 30

DEBRIS FIELD 13

LF30A LF30R & L

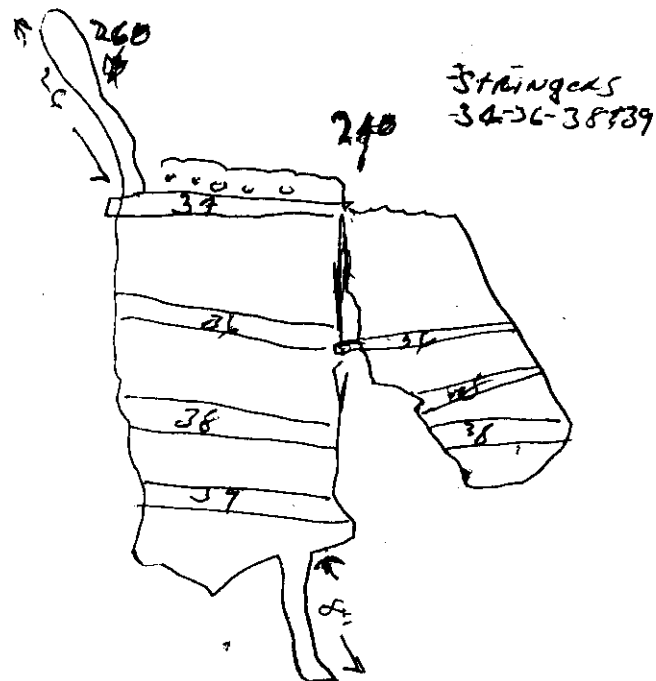
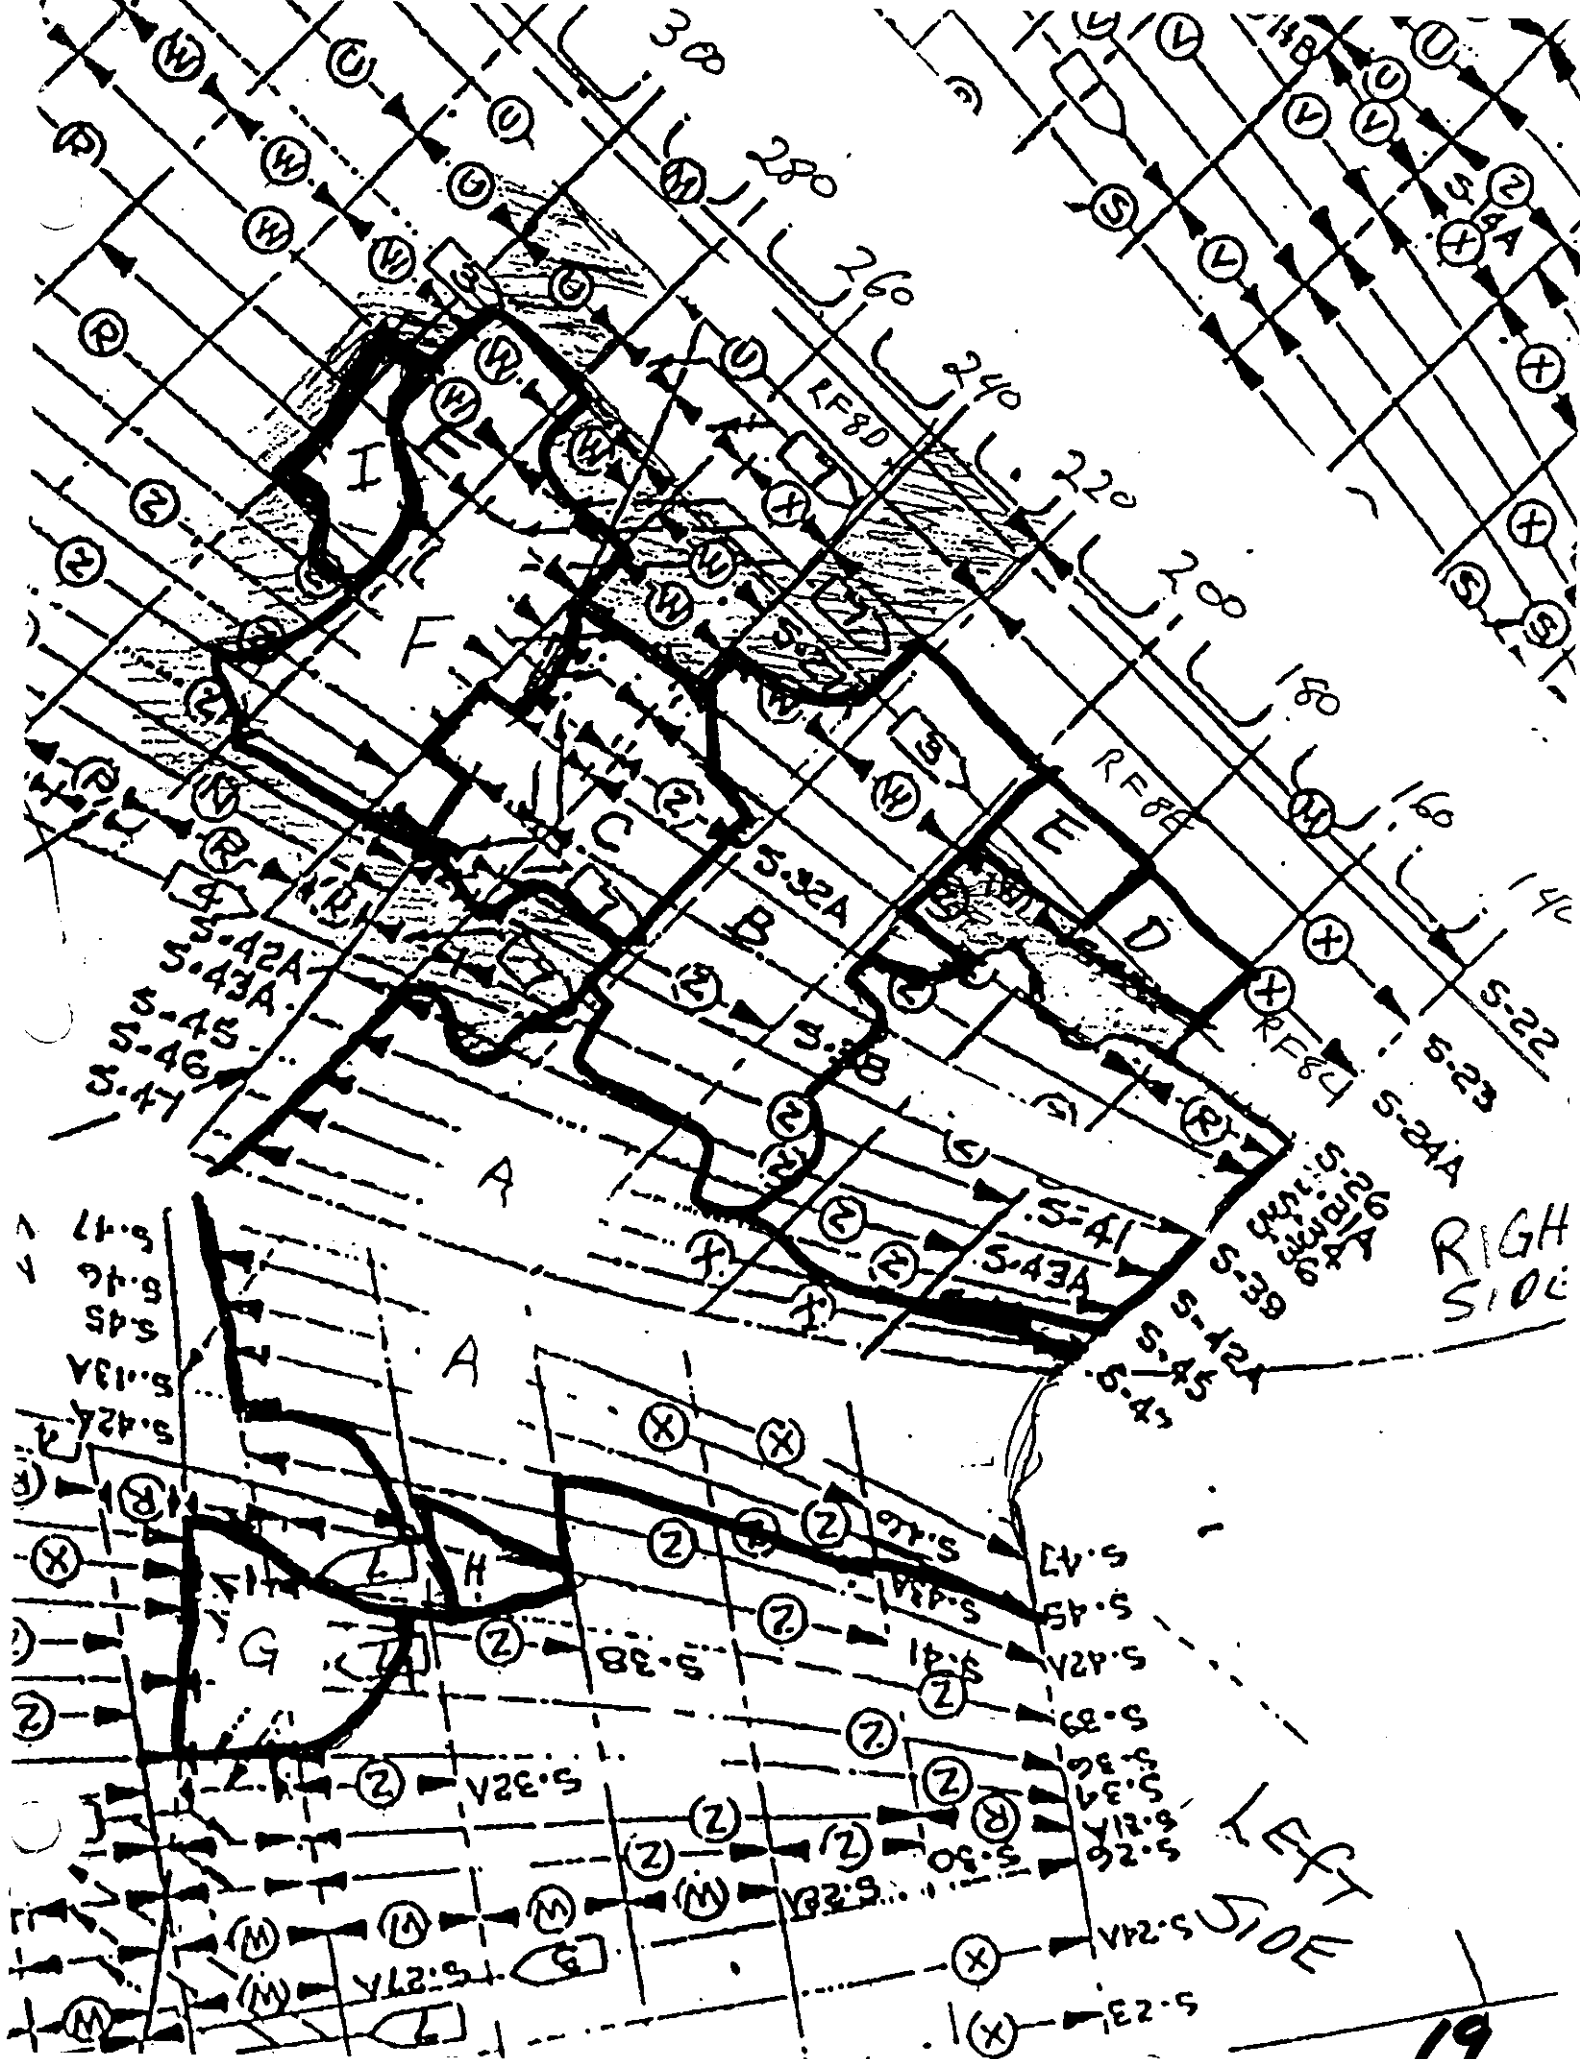
LF30 I (R)

PIECE MEASURES 24" x 20"

Station 300 MISSING FRAME

STRINGER 30 MISSING

STRINGER 34 FLATTED 3"

PIECE CURLED OUTWARD & JAGGED EDGES
