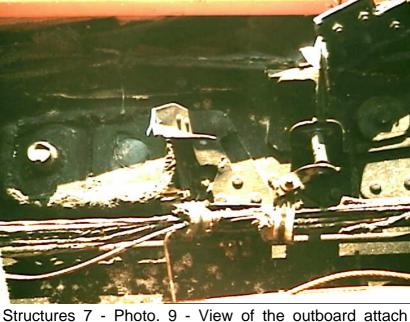
fitting upper fasteners for the outboard flap hinge. Note the tension fracture of the inboard bolt (on the left).
