LOG # RF172

TAG # C2505  
~~TARGET~~

DEBRIS FIELD GREEN  
FBI Lot  
P-24-96-7

STA 1600 R/H Frame Segment

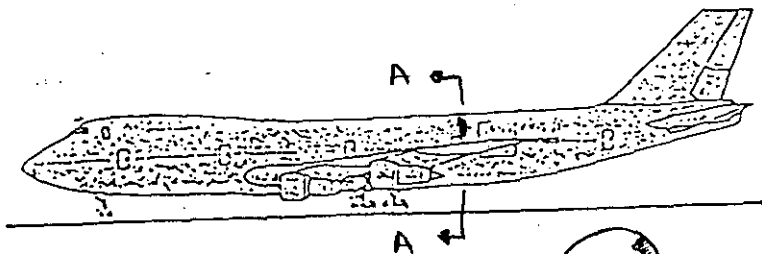
Sec AA  
Looking Fwd

A section of Sta 1600 frame from  
7" above Str 16 R to 5" below Str 20 R.

The stringer clips are attached to the frame.

The shear tie between Str 16 R and 17 R is  
attached to the frame. The center third of the  
shear tie, skin flange, remains with the shear tie;  
the rivet tails common to the skin pulled through.

The frame is twisted 90° from end to end.

The outer flange is missing above str 16 R, as is  
the fwd extension of the Str 16 clip.

The outer flange is missing below Str 20, as is the  
portion of the str 20 clip common to the stringer.

The frame inner flange is cracked, continuing  
into the web, btwn Str 16 and 17 and  
btwn Str 17 and 18.

The frame web is cracked from the outer str 20,  
up to the mid point at Str 19.

Possible light soot in places.
