LOG # RF 19 RTS
A-B
9-30-96

DEBRIS FIELD #3 (near)
Red

RHS fuselage crown skin fwd of STA 940.

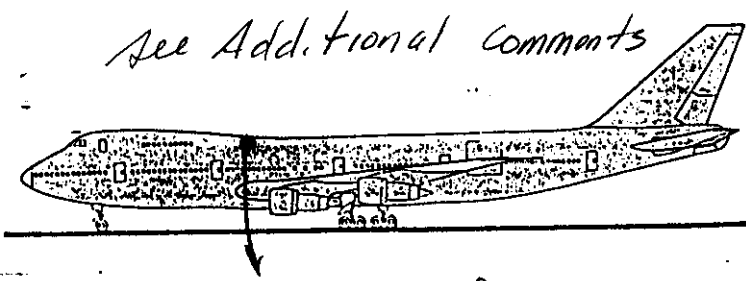
Ⓐ Red Tag A166 $40^{\circ}38'33.7''$
 $72^{\circ}38'42.2''$

Ⓑ Red Tag A268

No frames or stringer remain attached. Part Ⓐ is curled

outbd as shown.

Part Ⓑ fits up with part Ⓐ.

There is no evidence of smoke or fire damage. All failure lines are static failure.

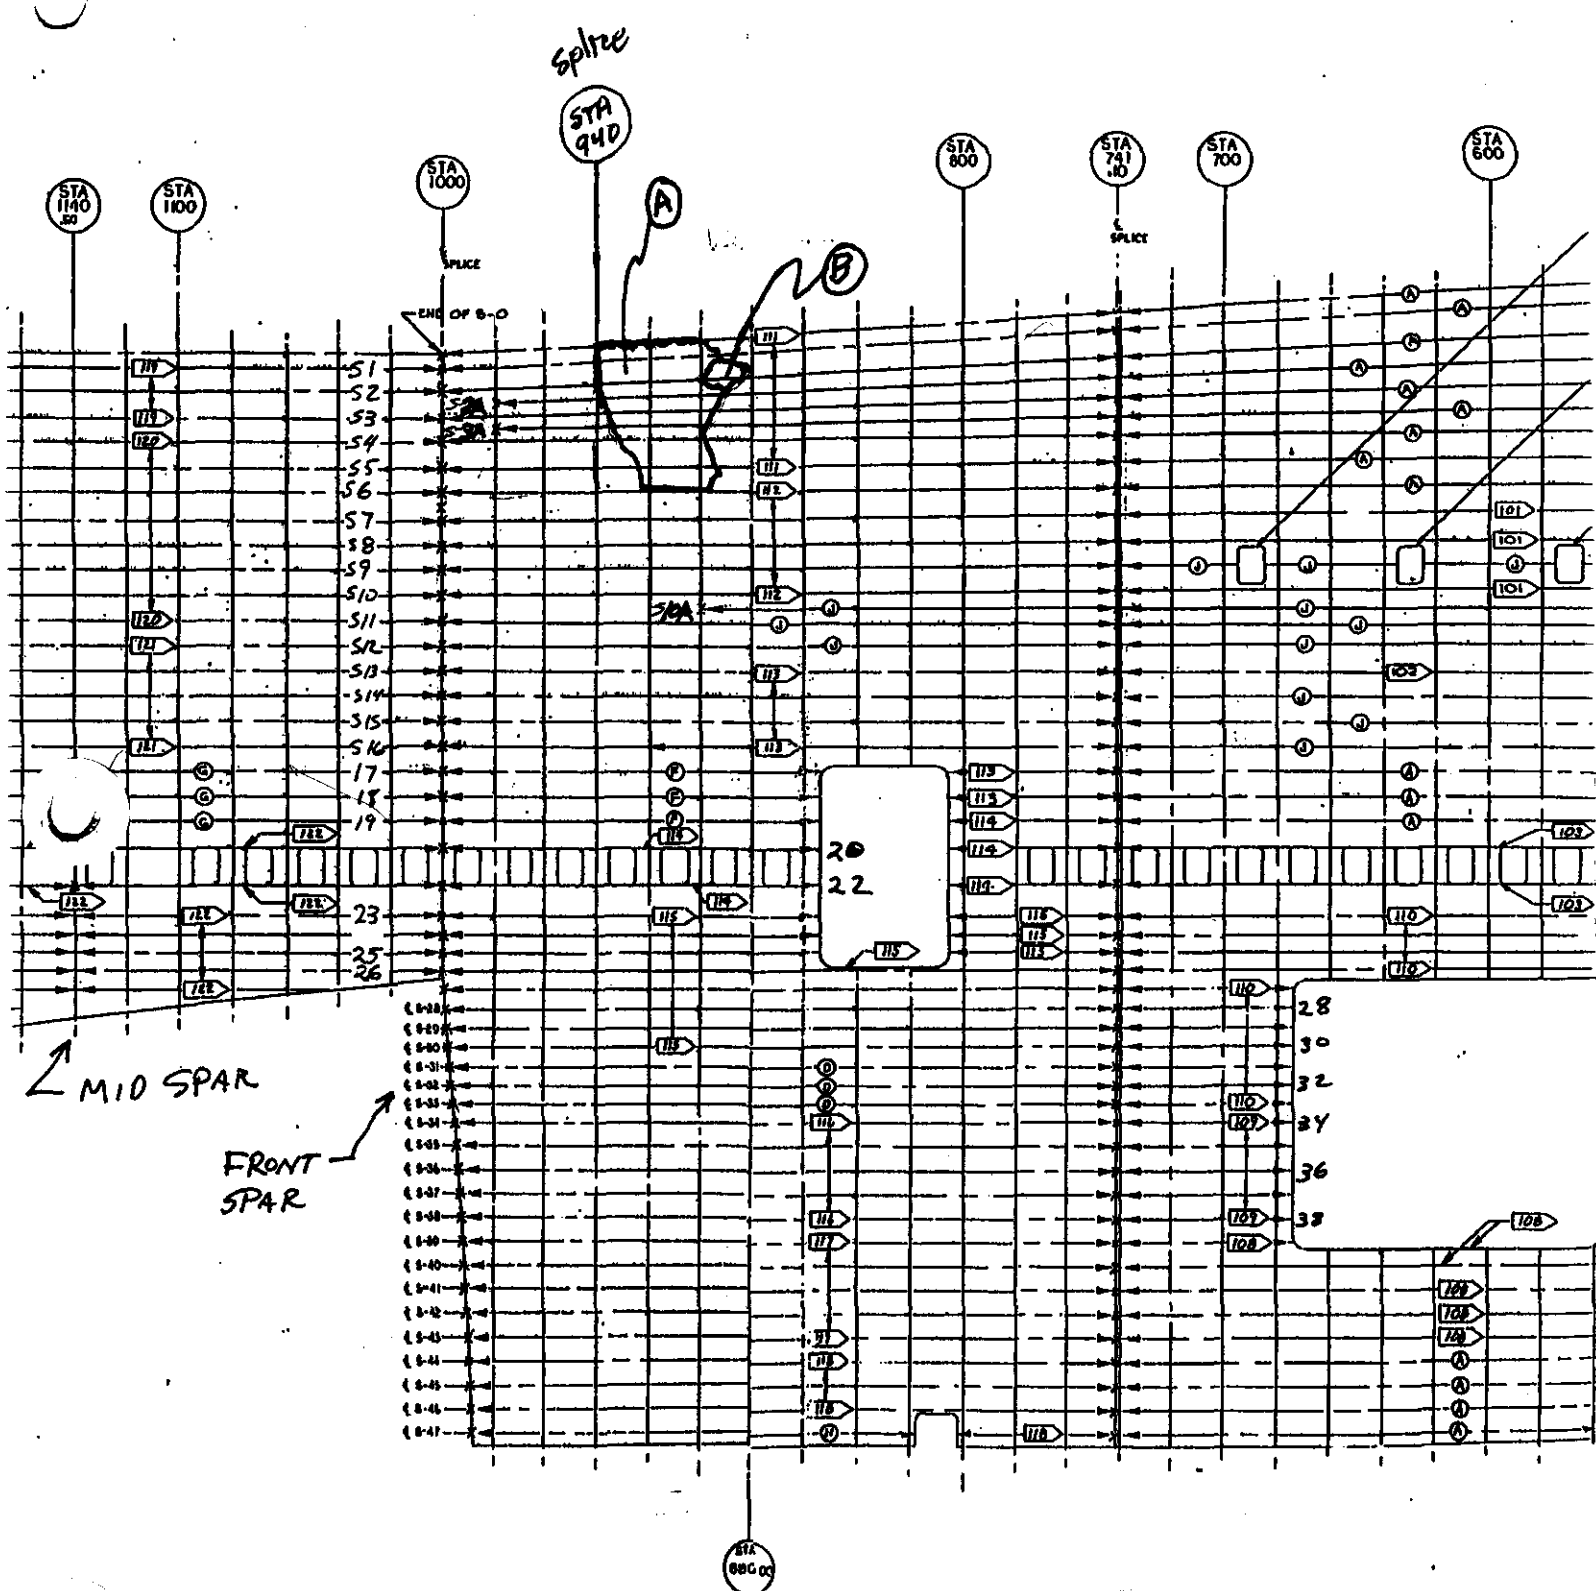
RF 19A

1) THERE IS AN INWARD PUNCTURE 3" FORWARD
OF STATION 920.
