LOG # RF29

DEBRIS FIELD # 3 RED
(near)

RED TAG # A127

PORTION of LIFE RAFT BEAM

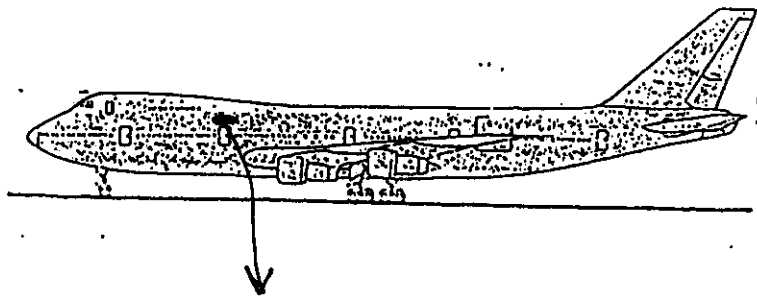
PORTION OF LIFE RAFT BEAM
STA 800-860 (DOOR 2)

STA 800 to 860, from RBL 33 to RBL 63.5 as shown on attached sheet. Majority of the web is bent downward. Beams are both straight except adjacent to fracture face. No evidence of fire damage or sooting.

STA 800
BEAM

upper surface
of web

lower
surface
of web

RBL 53.5

RBL 33

VIEW
LOOKING UP/
FWD

STA 860
BEAM
