LOG # RF37 ^{RF 10/1/96}

Green Tag # C801

RHS skin panel from STA 930 to 1065, S-10R to S-27R.

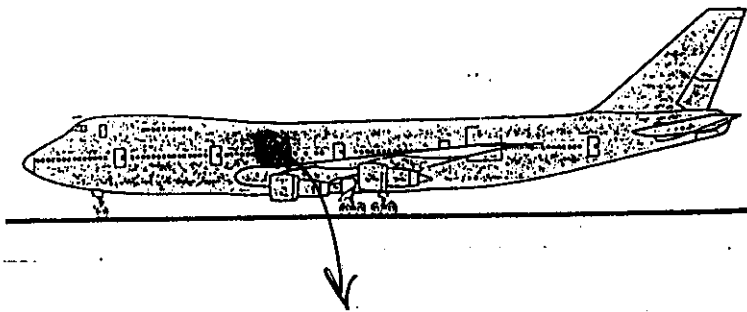
The skin panel is quite sooted on both interior and exterior. In particular, the sooting is heaviest at the upper end of the panel at STA 1000 and the portion of the STA 1000 Bulkhead structure that extends below the panel.

The frames highlighted on the next sheet remain attached to the panel. Almost all stringer segments are attached and intact. This panel has distinctly more sooting than adjacent panels RF34 (green) RF20 and RF 21 (red).
