LOG # RF79
 TARGET # _____
 COORD: LAT _____
 LONG _____

DEBRIS FIELD YELLOW

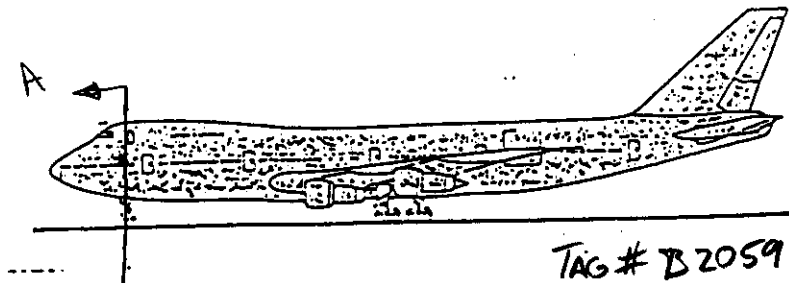
SECTION OF SKIN WITH WINDOW REMOVED.
 WINDOW POSITION IS # 11 RIGHT SIDE OF
 AIRCRAFT SLIGHTLY BEFORE STATION 340 TO
 STATION 360. SKIN HAS TEARING AND
~~TEARING~~ HAS NO TAGS ONLY DATE. 8-7-96-15
 THERE IS NO SIGN OF FIRE DAMAGE OR
 SOOTING. 3ft by 2ft
 Strips 5-19 - 5-22

window forging,
 inner flanges,
 torn

skin
 bent
 out and
 back

window forging,
 inner
 flange,
 is
 buckled

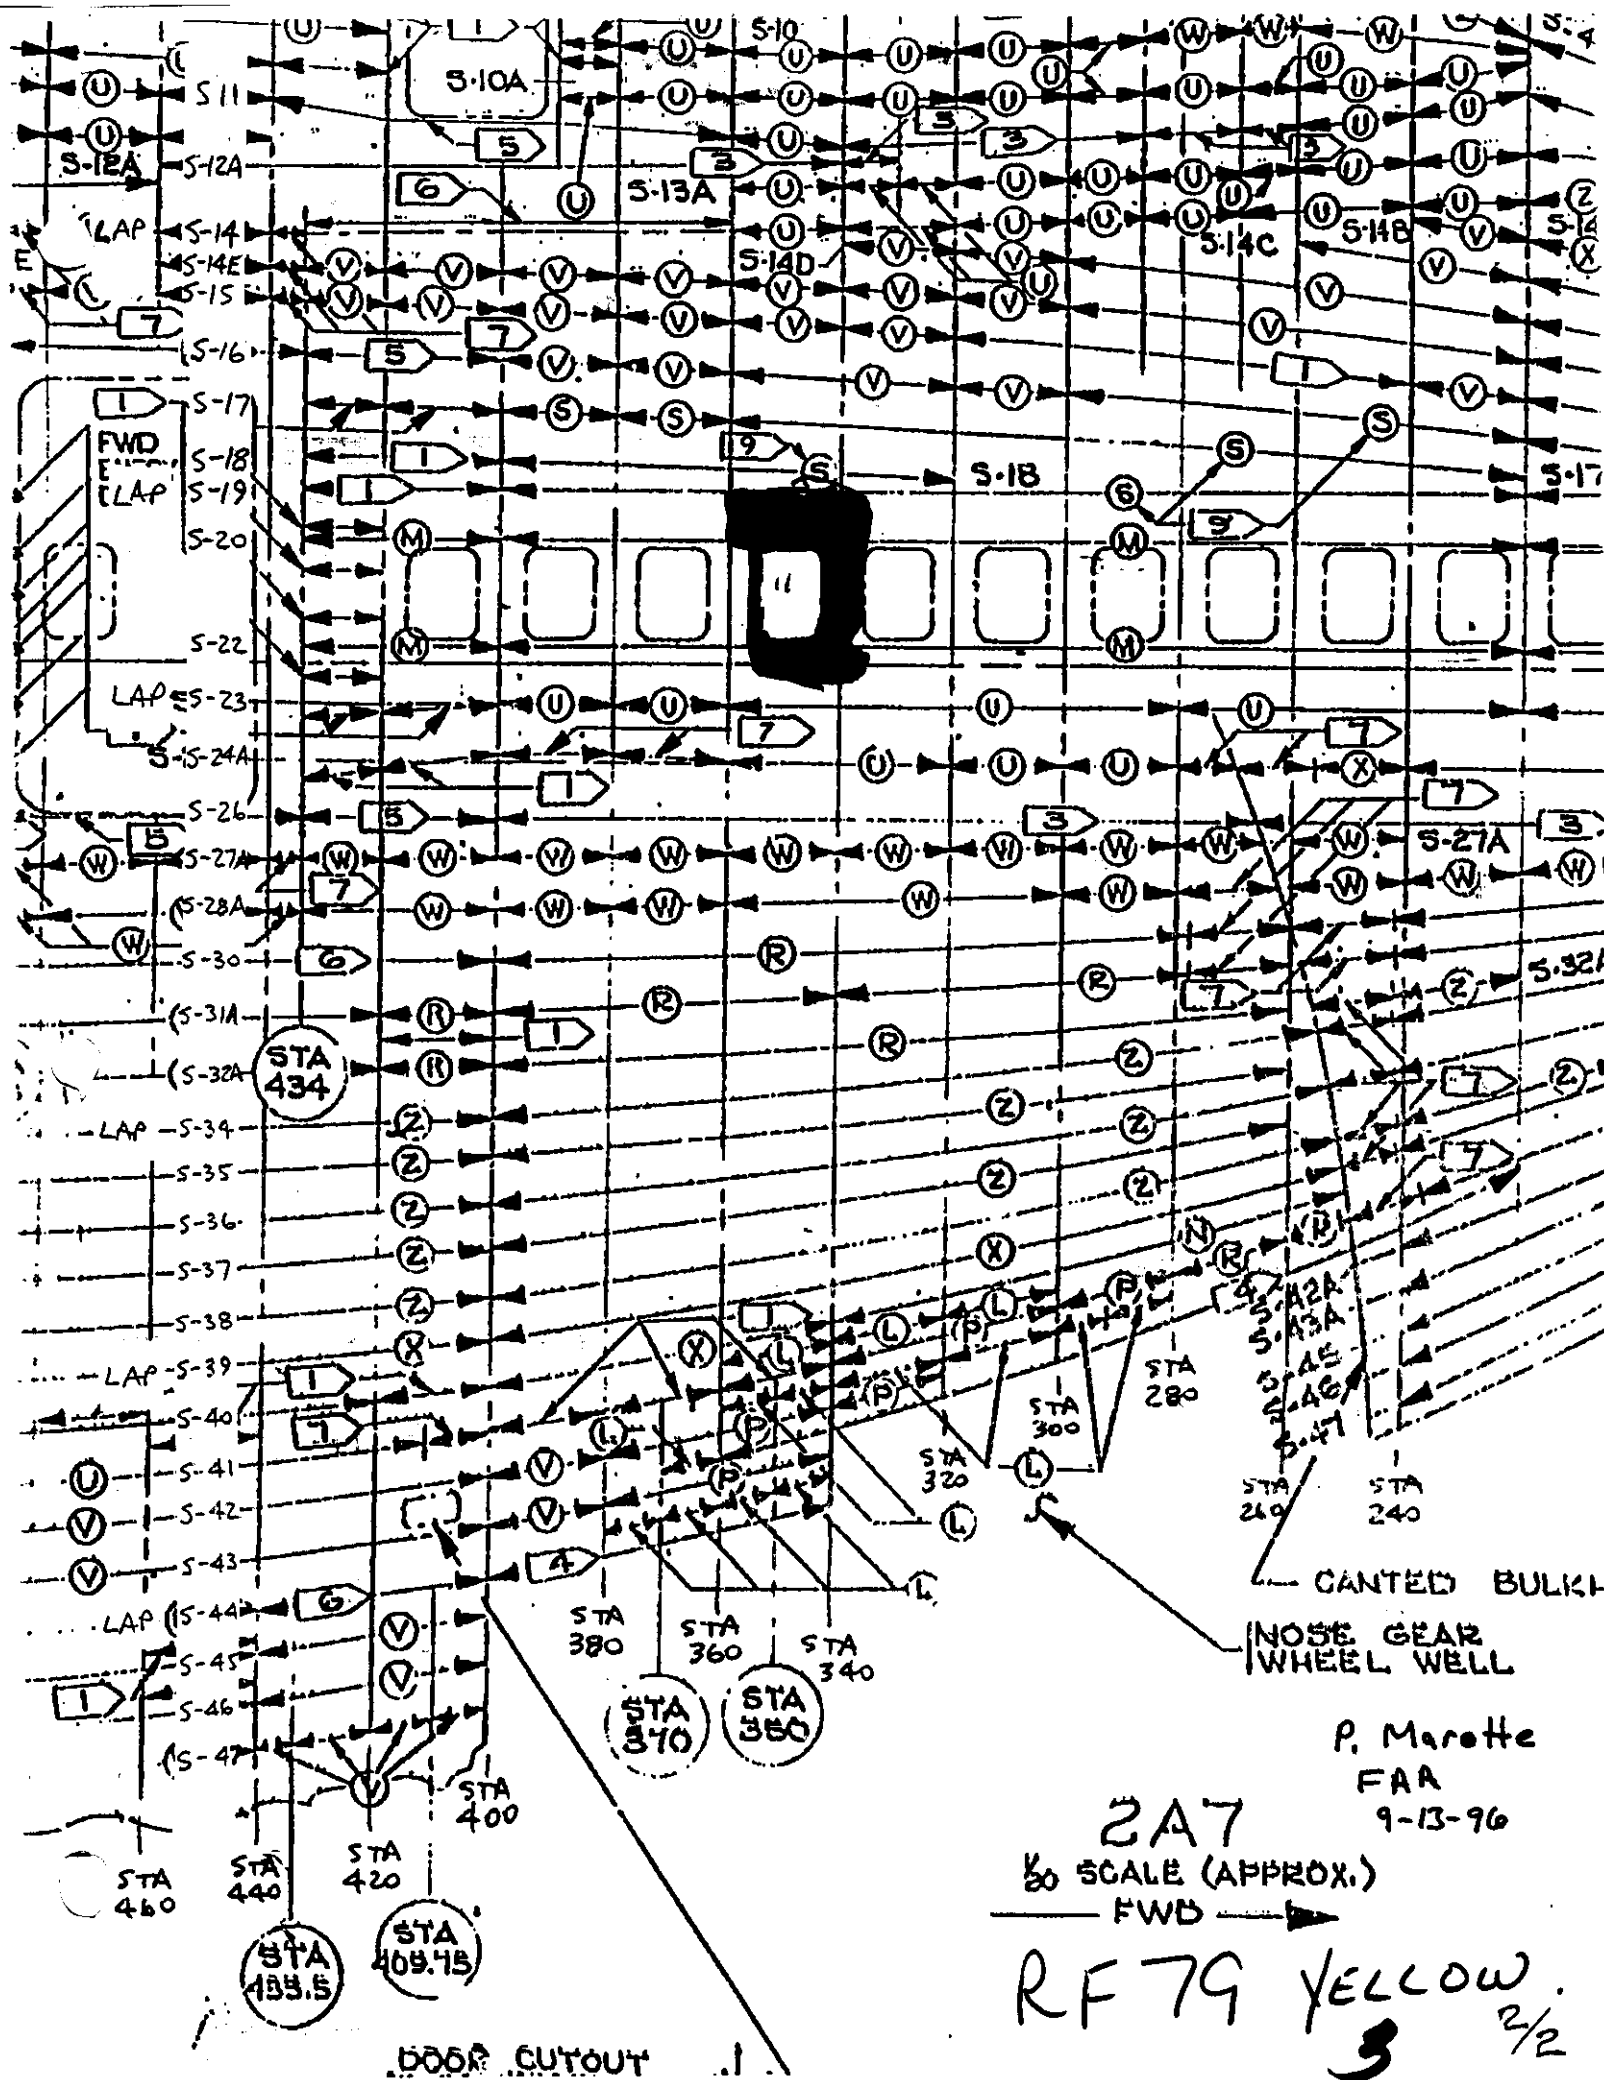
2A7
 1/80 SCALE (APPROX.)
 FWD →

DOOR CUTOUT
