LOG # R/H 94 A-B-C

DEBRIS FIELD Green #
C2222 & C404
C2207

R/H. M.E.D #5

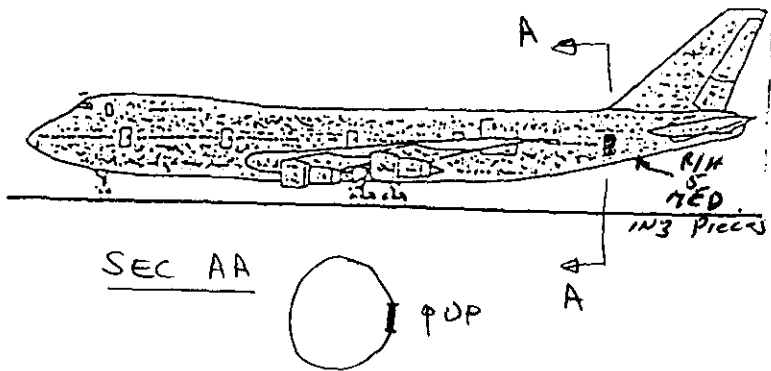
This Door is separated into 3 sections

A) Section upper FLAP seal TAG C2222 Green #1 Field

B) Section 2 ENcompass Part of The window AND EXTENDS DOWNWARD ON THE FWD EDGE FROM ST-18R TO BELOW ST 21R.

AFT Edge of DOOR EXTENDS DOWNWARD FROM ST-18R TO BELOW ST 22R - TAG C404 Green #1 Field

25% OF DOOR MISSING see DRAWING

C) Lower section is between STS-24R & S-25R TAG C2207 Green #1 Field

Lower DOOR FLAP SEAL = MISSING see DRAWING

All of INTERIOR COSMETICS is ABSENT FROM DOOR
NO SIGNS OF BURNT OR SOOT.

EXTERNAL SKIN AROUND WINDOW CURLED OUTWARD

This section IN THE AREA OF
STATION 2231 - 2285
STRINGER S-17R - S26R
