RW 11

Right Wing upper skin

Panel Segment WS 1196 → WS 1280

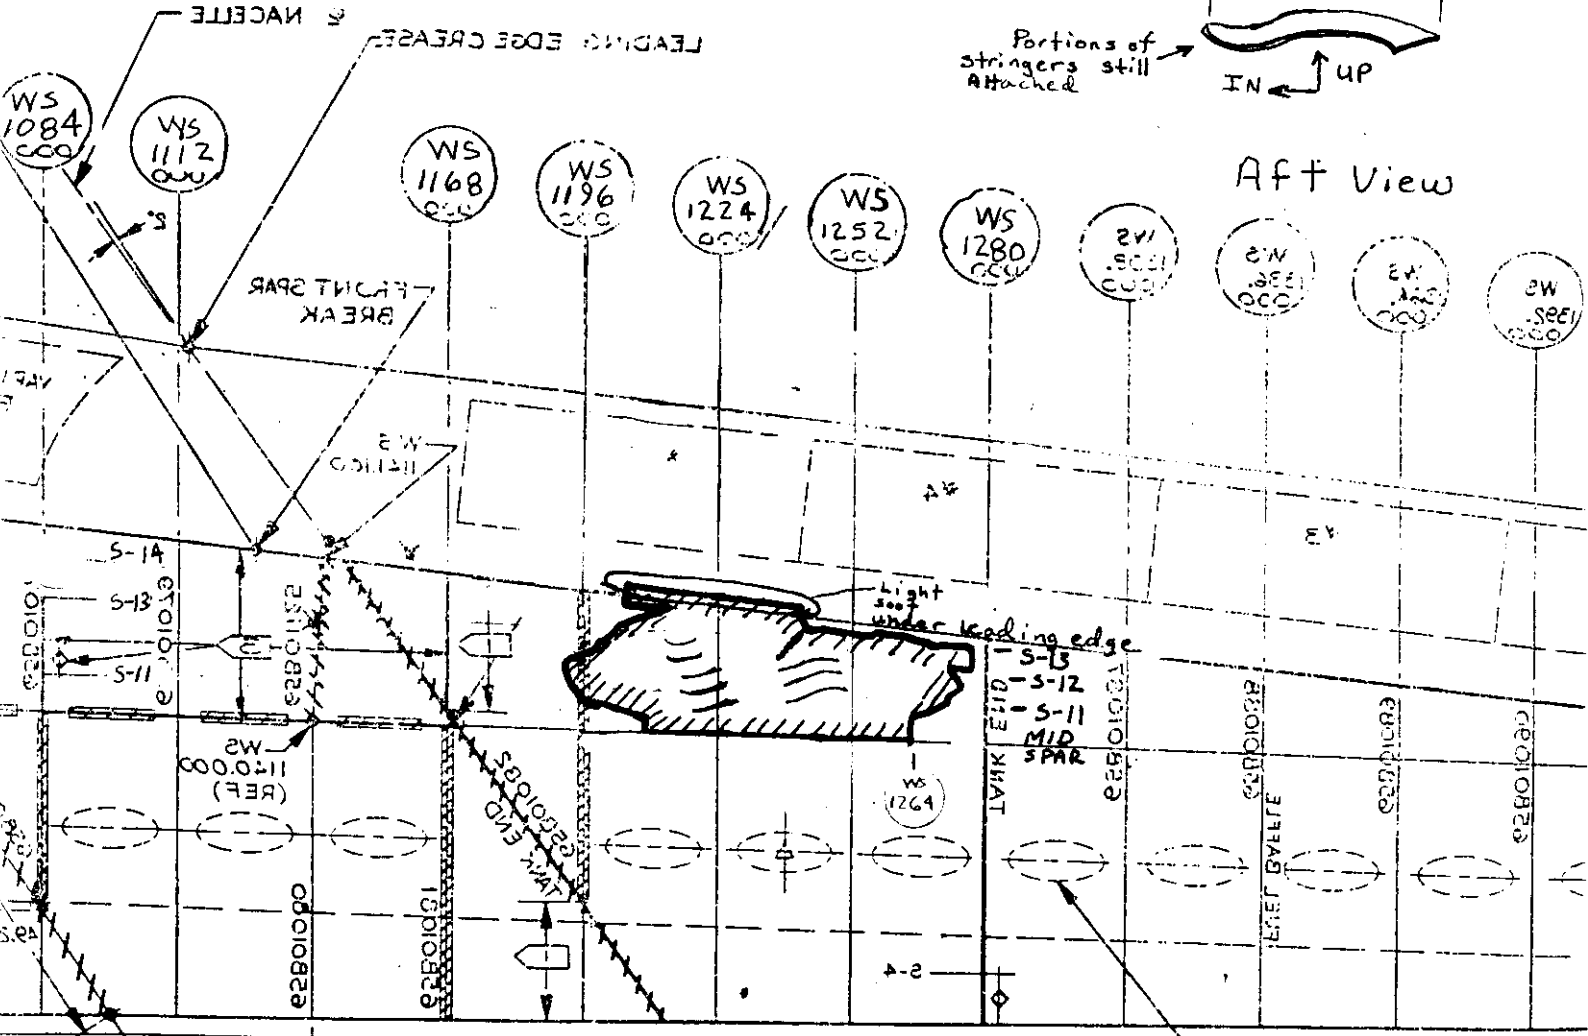
Green Area C804
C804
Worn off

Between leading edge & Mid spar

- No soot on inside or outside surface of skin except under the wing skin in front of the front spar
- No evidence of fatigue

Aft View

RW-11 ~~REPER~~ INDICATE BENDING UP RELATIVE TO
UPPER WING SKIN FROM W.S. 1200 TO W.S. 1280
(APPROX.) [IF PANEL HELD TO RW-8]
