LOG # RW-12
 TARGET # _____
 COORD: LAT _____
 LONG _____

7 FLAP TRACK ASSY DEBRIS FIELD ^{GREEN} C-194

P/N TWA 17721
 S/N 42008

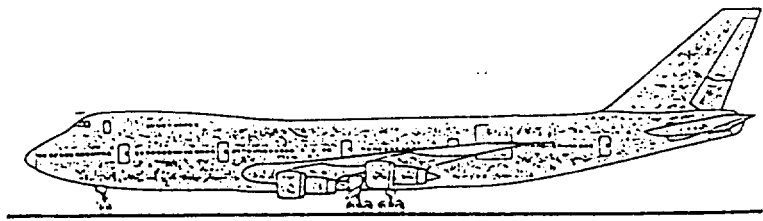
Fwd section has about a 2-foot section of the vent support beam still attached to the fwd mount. Flap carriage assy has a section of the ^{MID} flap still attached (approx 3' x 3'). Appears to be in the retracted position. All mounts are fractured. There is no sign of burn or sooting.
