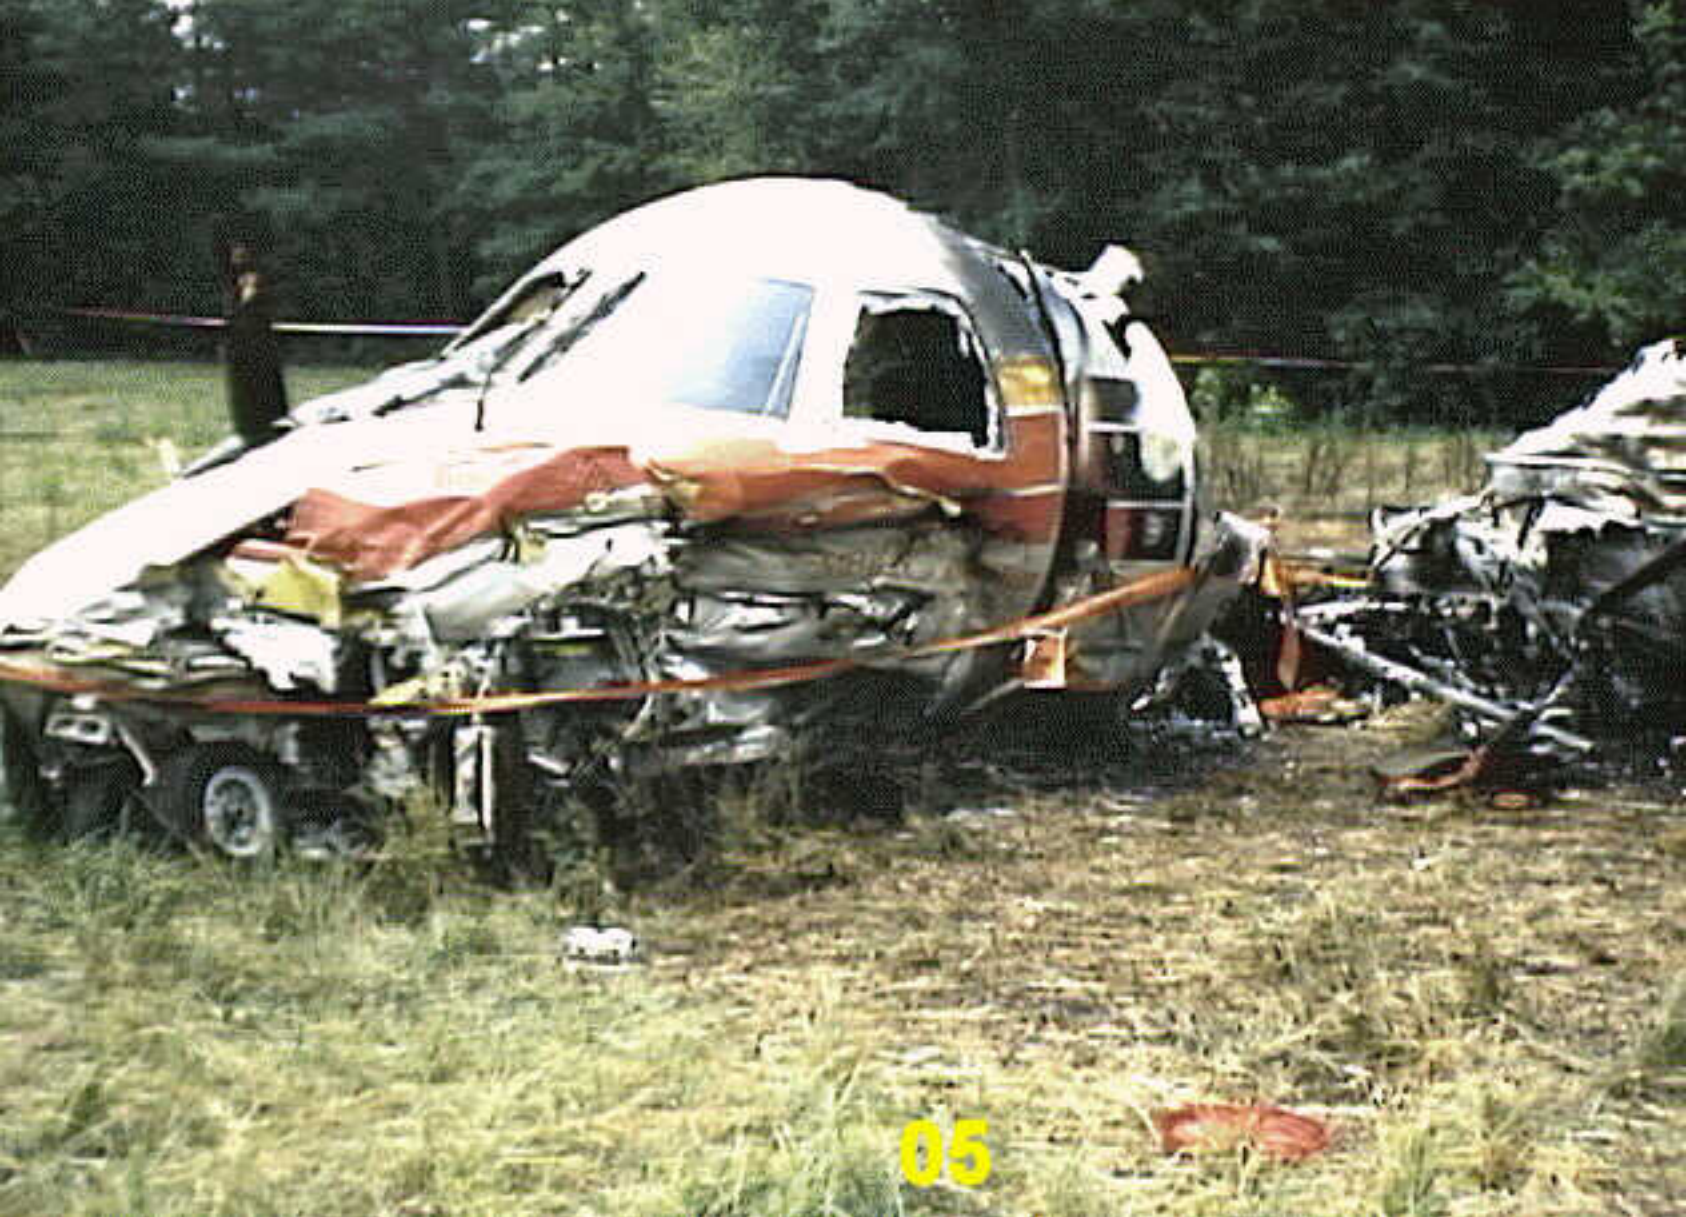
Structures 7A - Photo 05. Inward, upward crushing to left side of forward fuselage.
