Chalk's Ocean Airways  
Miami, Florida  
December 19, 2005  
DCA06MA010

**National Transportation Safety Board  
Washington, DC**

**Attachment 2**

Photographs

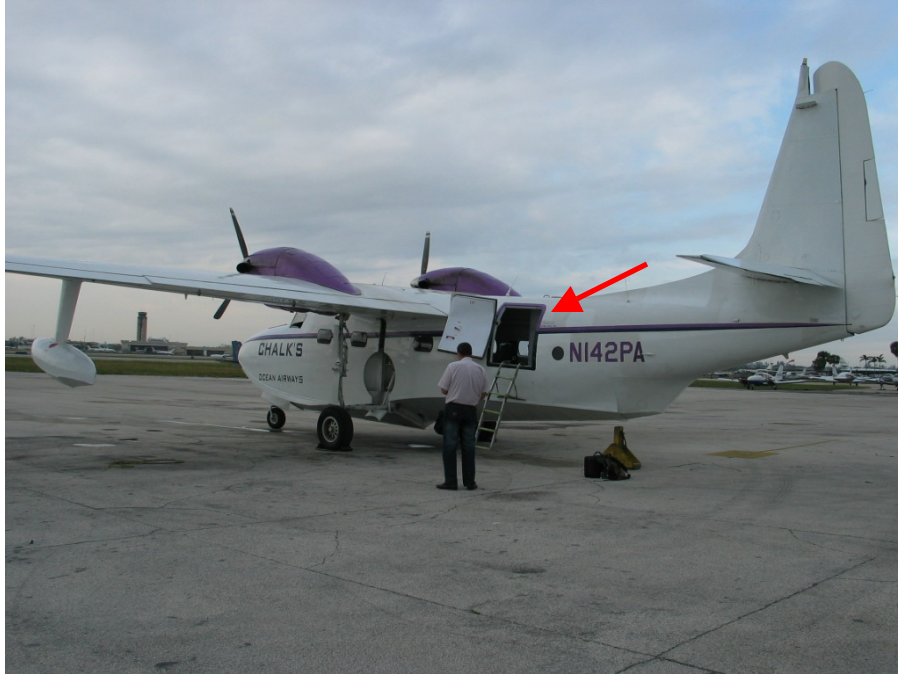
1. View of Chalk's Ocean Airways N142PA Grumman Mallard G-73T sister airplane to the accident airplane.  
Note: The red arrow points to the location of the main cabin door

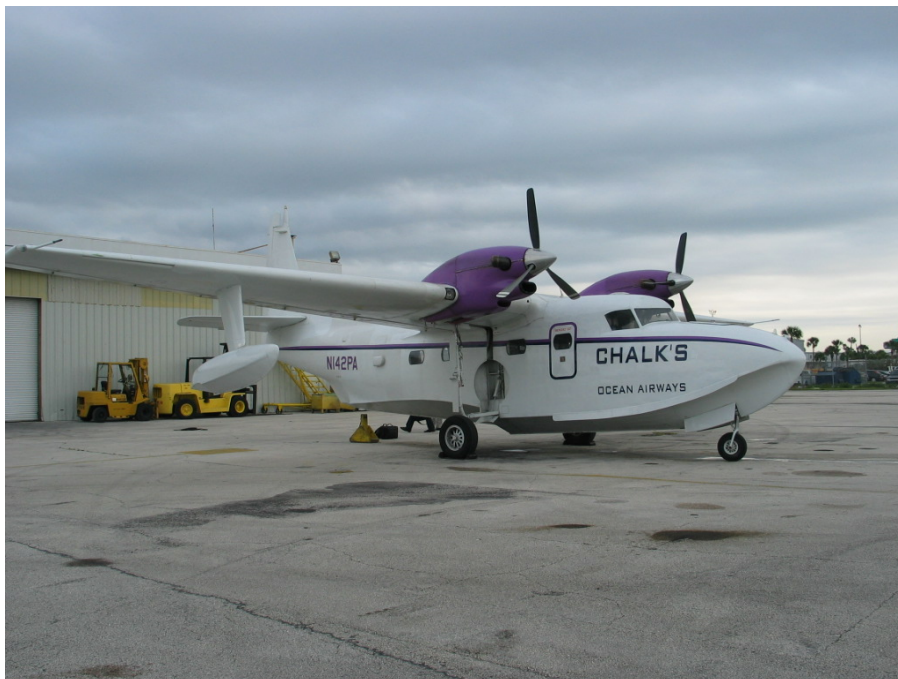
2. View of Chalk's Ocean Airways N142PA sister airplane showing the right side of the fuselage and right wing.

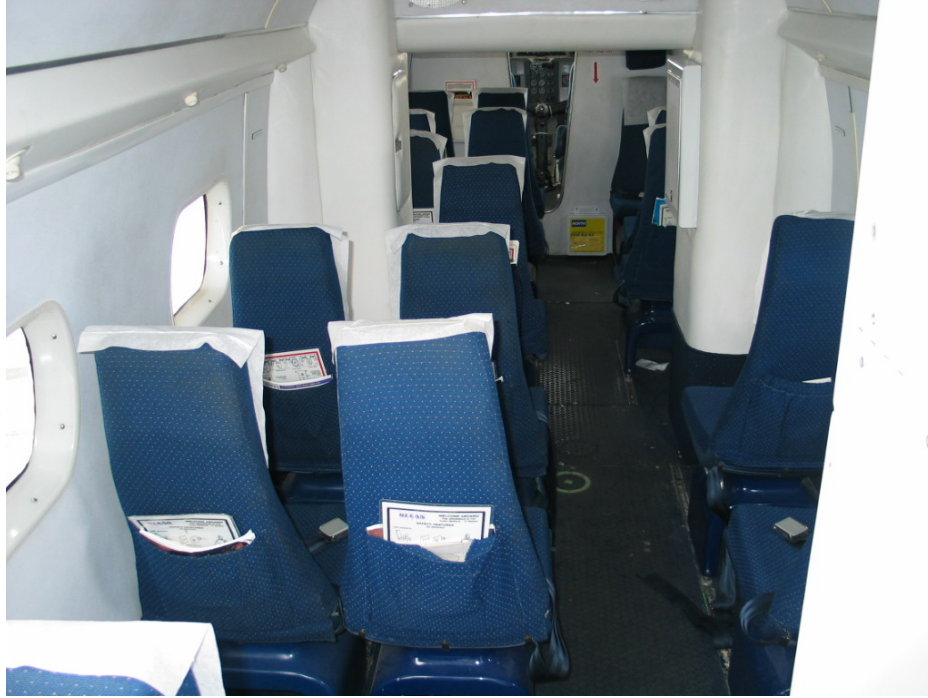
3. View showing N142PA's cabin interior looking forward. The accident airplane's cabin interior was configured the same as N142PA.

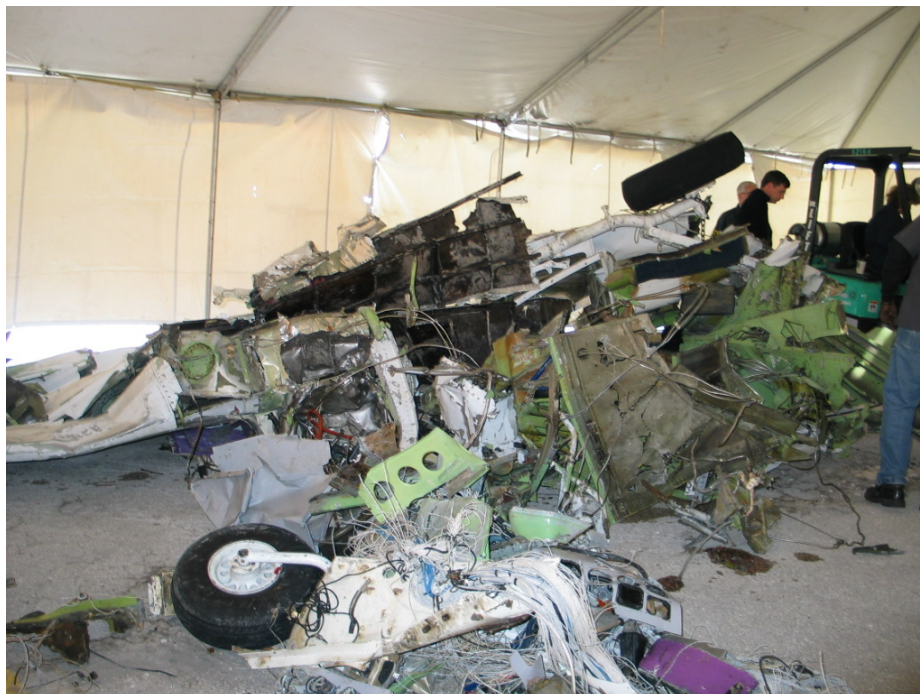
4. View of N2969 wreckage that was recovered from Government Cut.

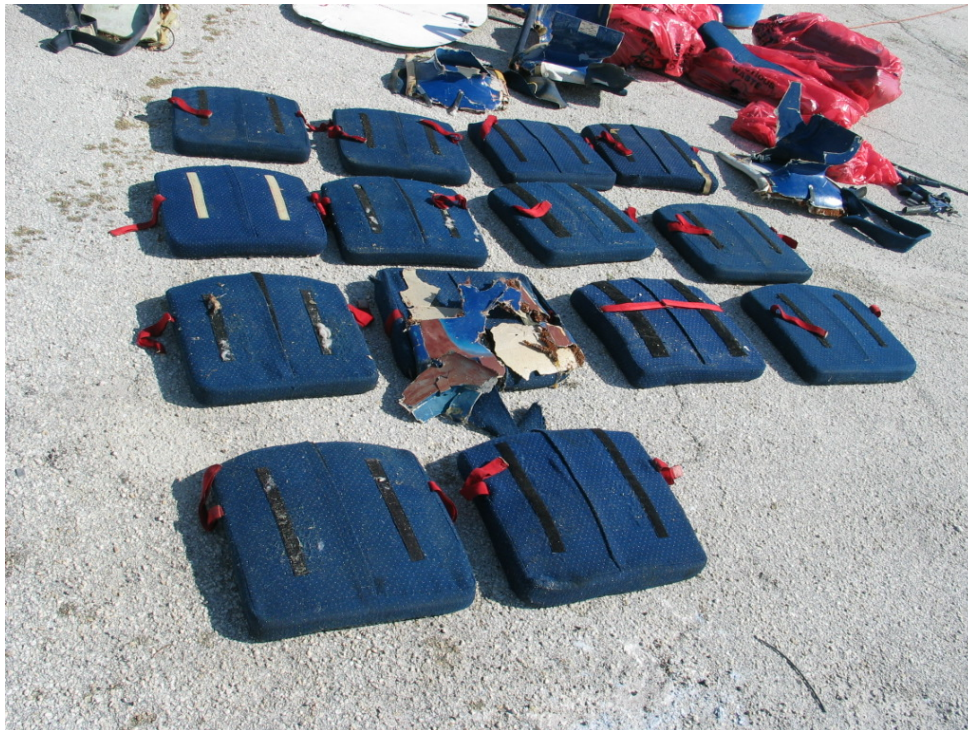
5. View of the 14 passenger seat floatation cushions from N2969.

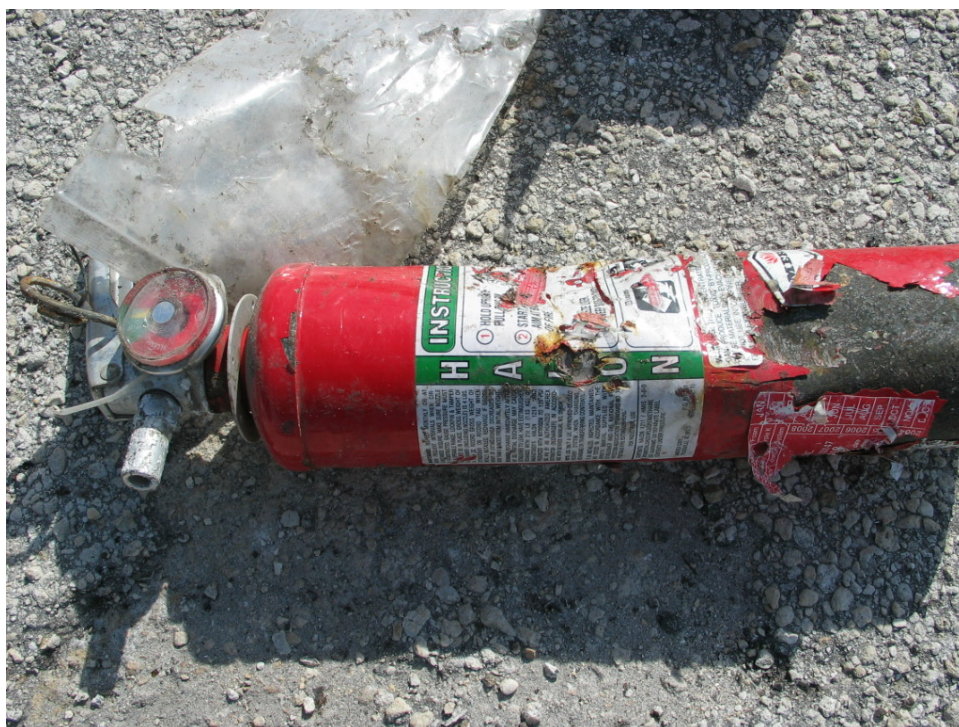
6. View of one of the Halon class C fire extinguishers that was recovered from Government Cut. Note: its gage was found in the charged position.

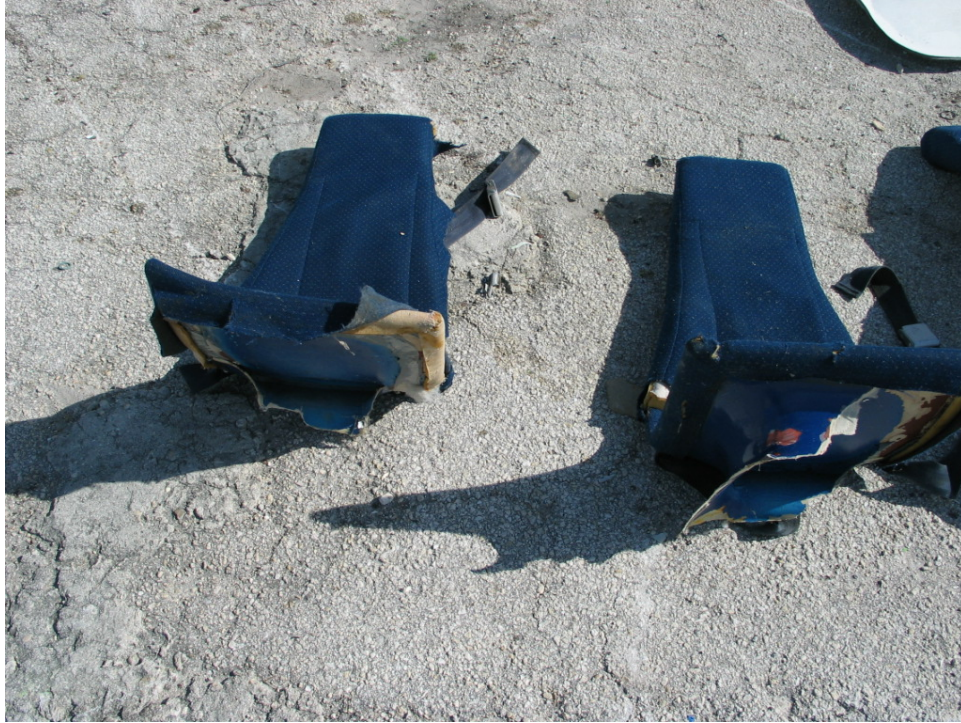
7. View of two passenger seat backs from N2969 that were found intact.

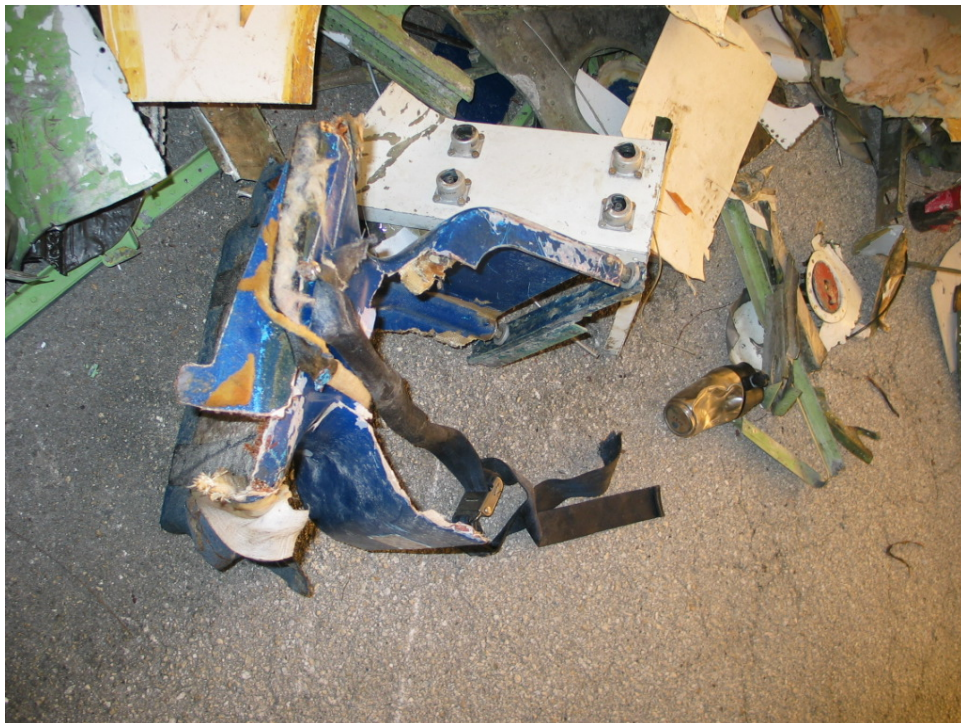
8. View of a fractured passenger seat bottom from N2969.

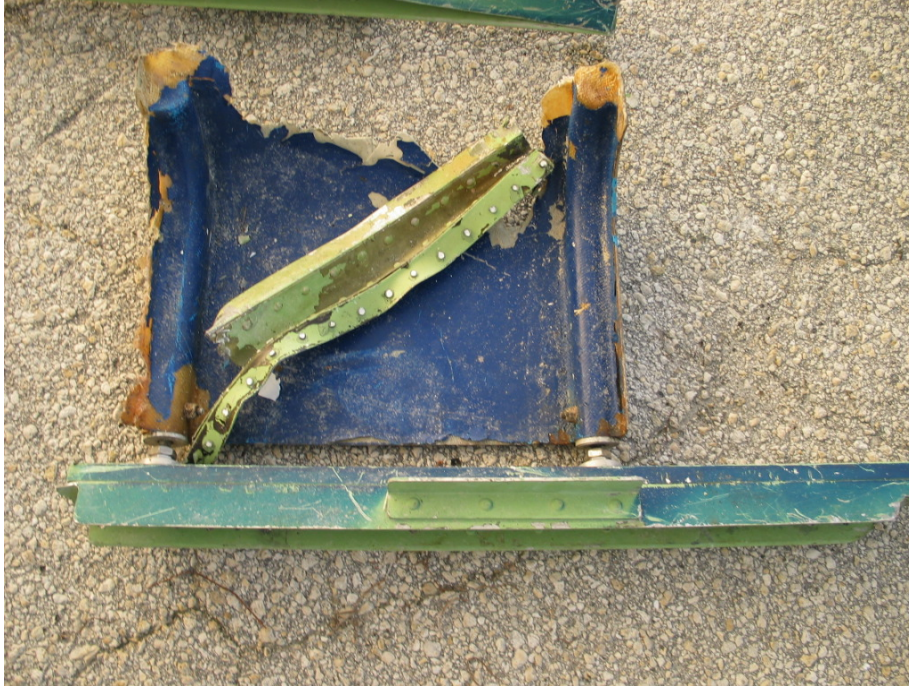
9. View of a passenger seat bottom from N2969, found installed in a fractured section of seat track

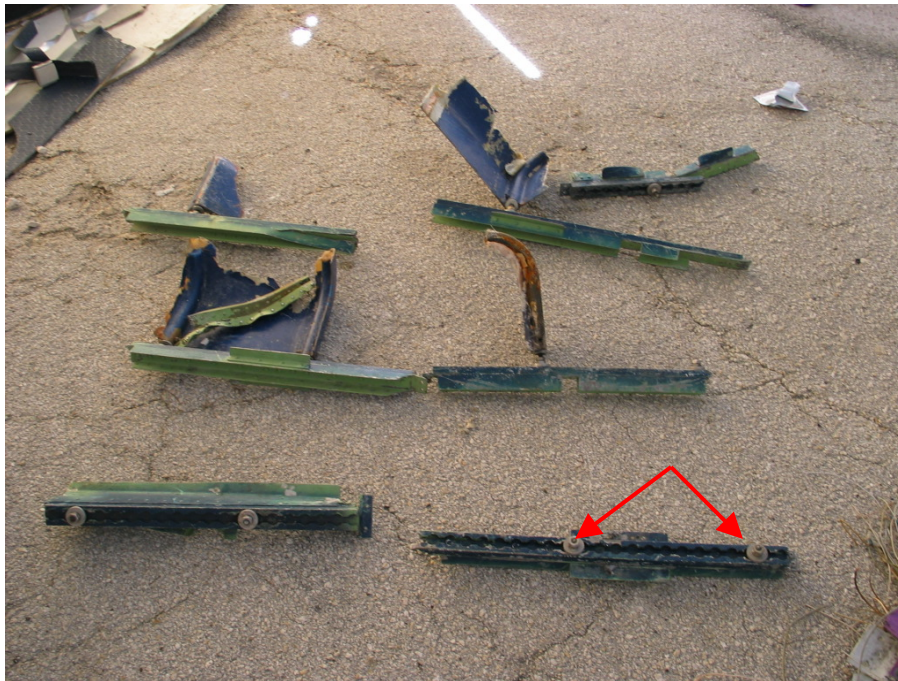
10. View of the 7 sections of fractured seat track that contained fractured seat legs or seat attach fittings in the seat tracks.  
Note: red arrows point to the attach fittings in the seat tracks.

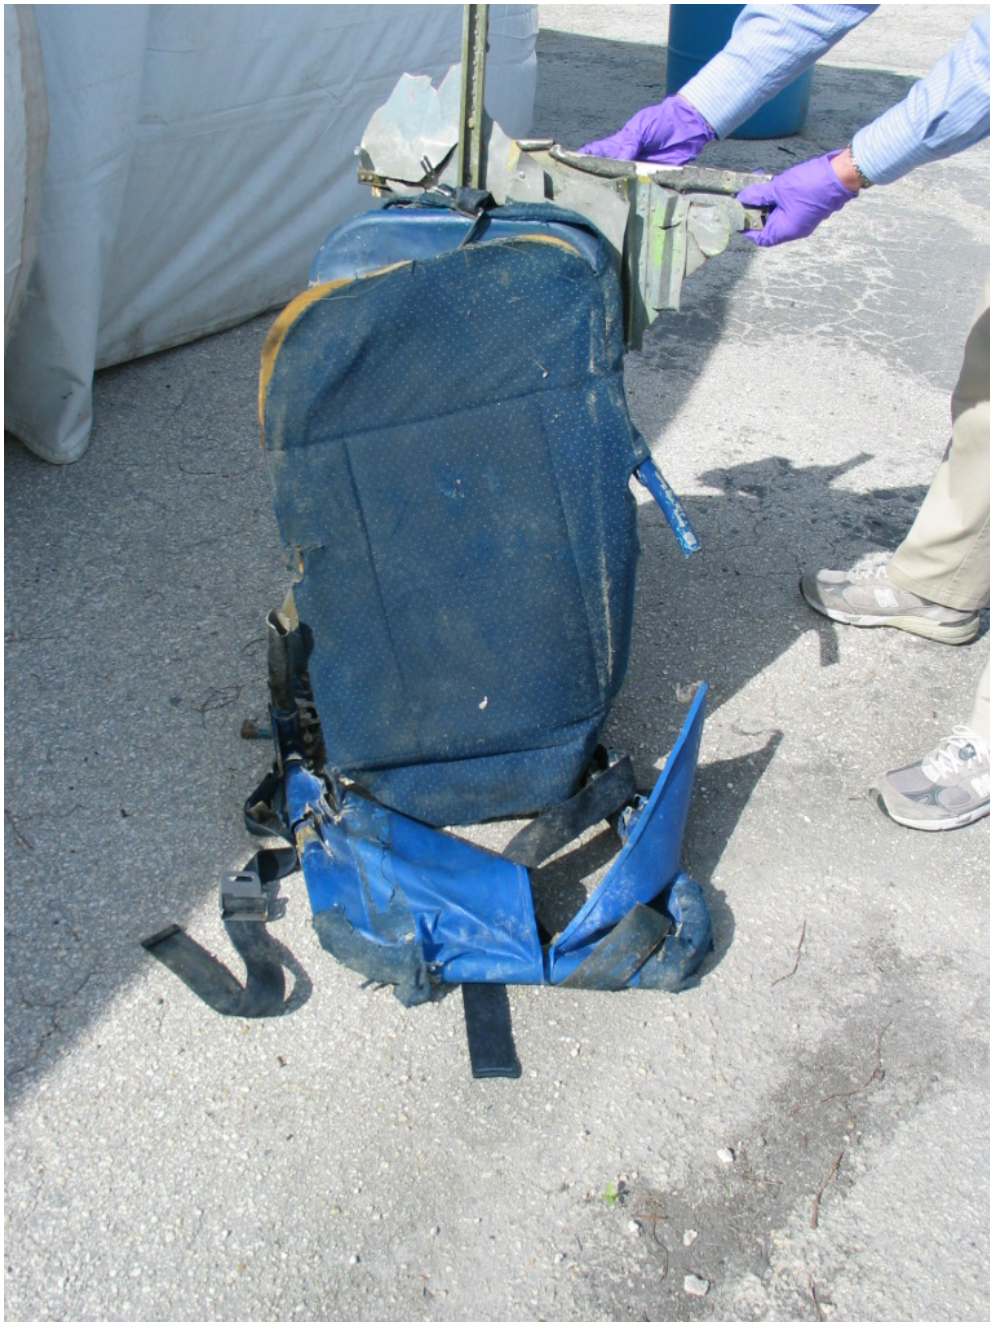
11. View of the Captain's seat from N2969.  
Note: Its seat back remained attached to the cockpit bulkhead.

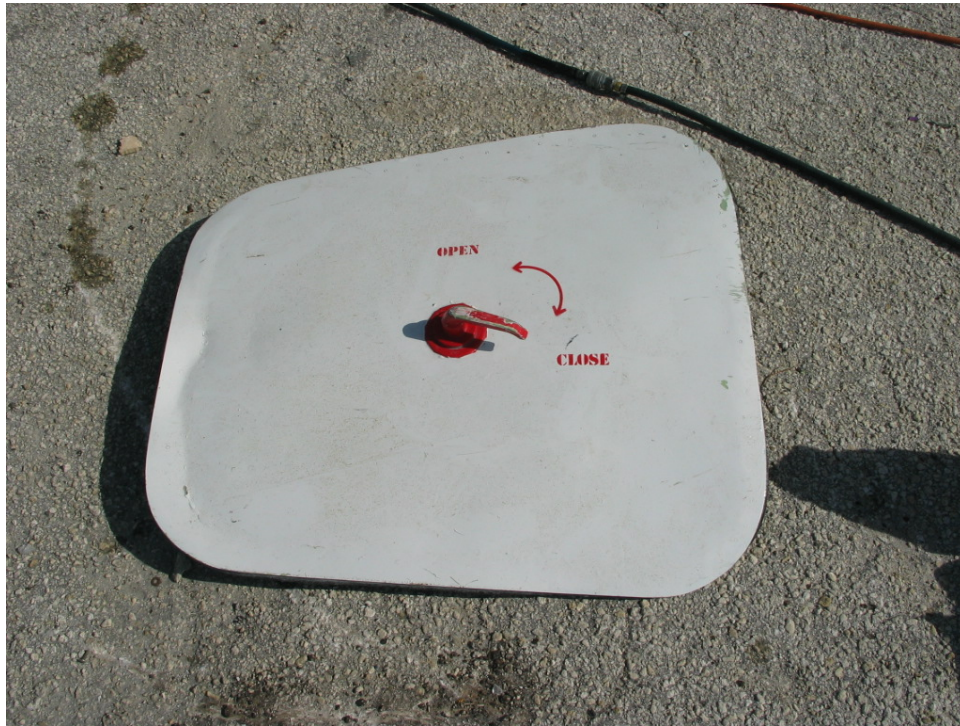
12. View of the forward cargo door from N2969.

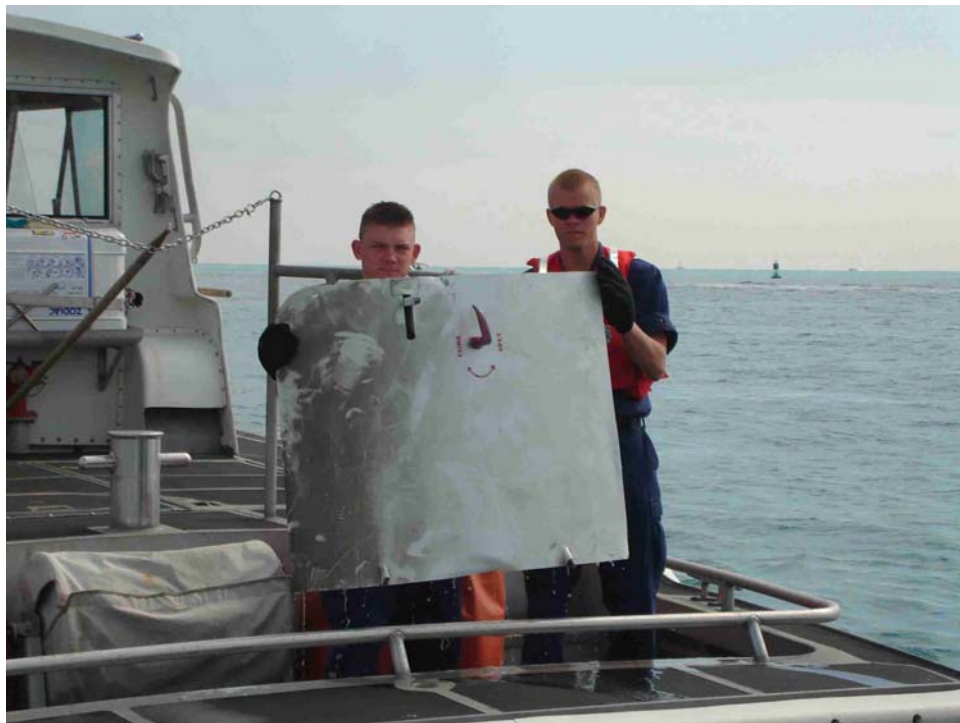
13. View of N2969's main cabin door after being recovered from Government Cut.  
Note: The door's handle was found in the latched position.
