SURVIVAL FACTORS GROUP

IC/NAVISTAR LOADING DOOR TEST

FINAL REPORT

Bus Electronic Entry Door Force Measurement

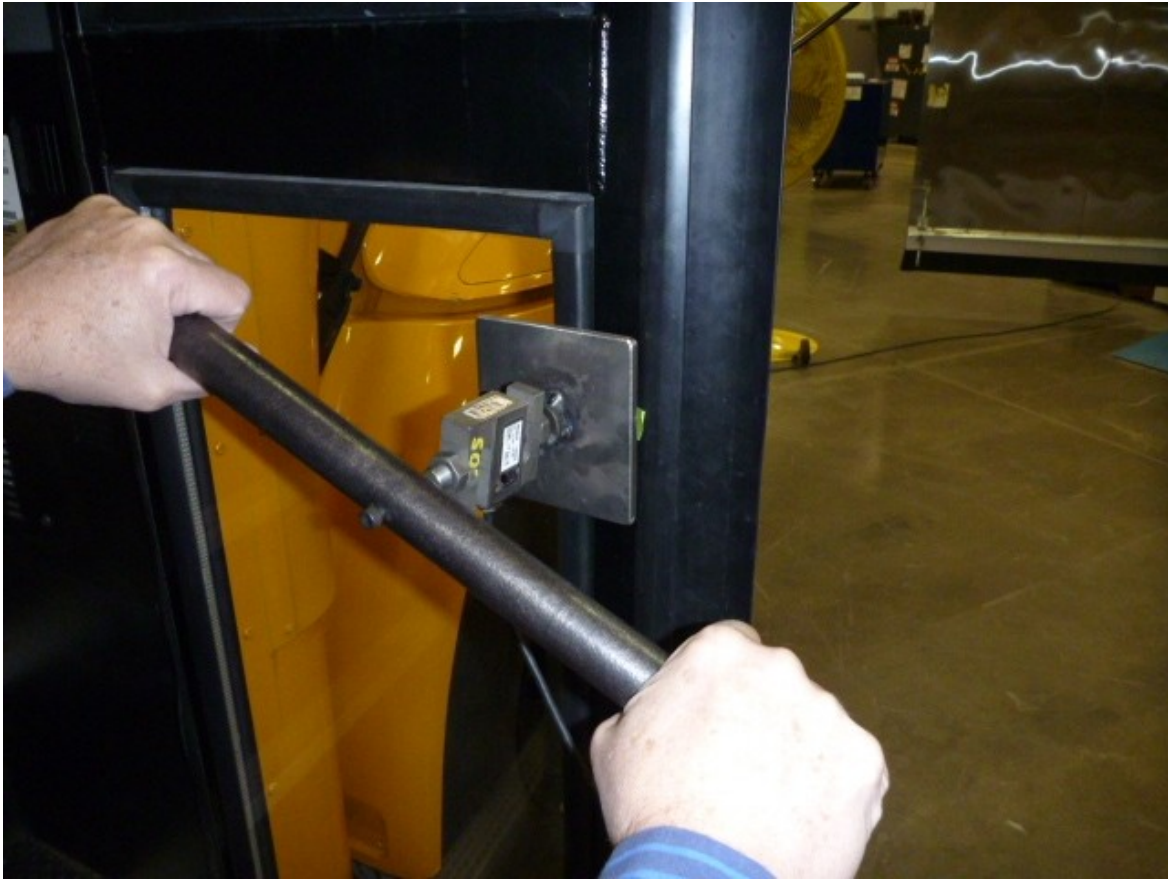
Figure 1: Force applied to open door at a height 36 in from floor lift

The door was closed using the in-cab switch. The "emergency use" handle was push forward. The force was measured at height 36 inches from the floor lift. As the test was complete, the emergency handle was pulled rearward.

After completing Test 1 the door was closed using the in-cab switch. The “emergency use” handle was in disengaged position. Again force was applied to open the door at a height of 36 inches from the floor lift.

Test 3: The door was then locked using the air cylinder mechanism. Force was applied to open the door from inside at a height of 36 inches above the floor lift level. Care was taken to limit the force so as not to damage any components. The length of door opening was measured at different amount of forces.
