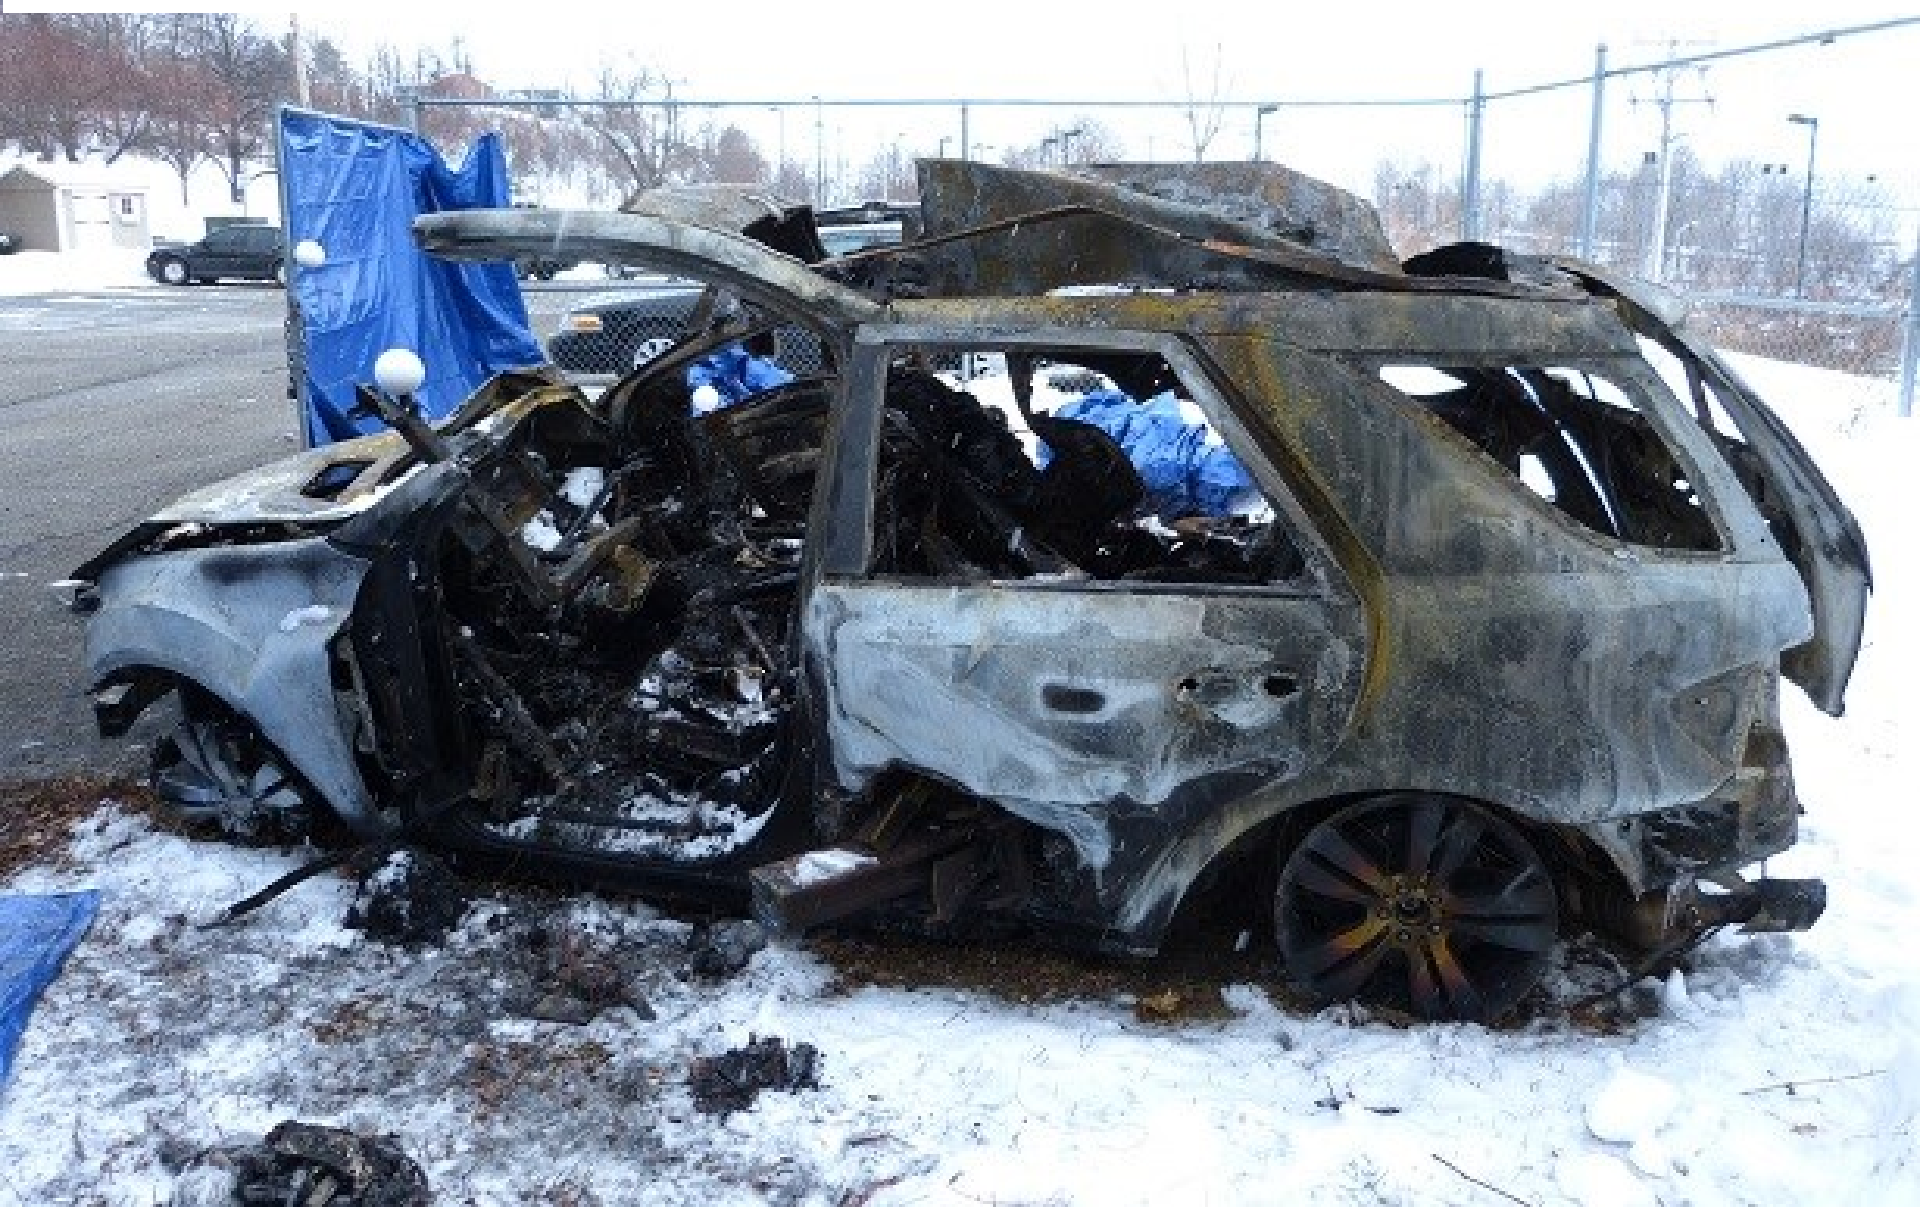
The left side of the SUV is visible. The vehicle is badly fire damaged. Both left side tires are burned away and the lower portion of the left front wheel is missing. The driver door is missing and the A Pillar is displaced.
