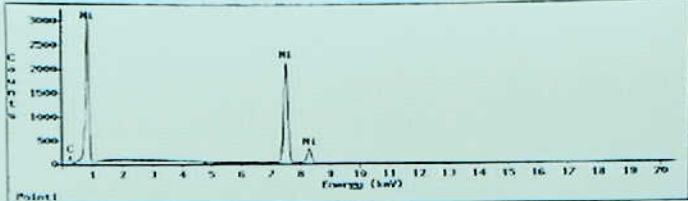
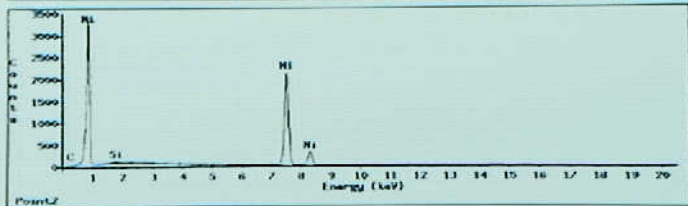
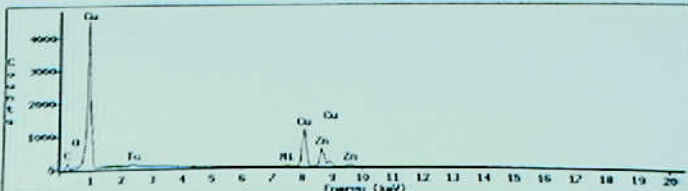
Systems 9 - Exhibit No. 9B - Photo 11b. Figure 11a-2. The areas (1, 2, and 3) of the gouge analyzed using energy dispersive spectroscopy and the resultant
