Systems 9 - Exhibit No. 9B - Photo 16. Figure 16c. The moving contacts of the RTV circuit breaker have a tarnished appearance. White arrows highlights mechanical wear from the making and breaking of the contacts. Black arrow indicates fibrous residue.

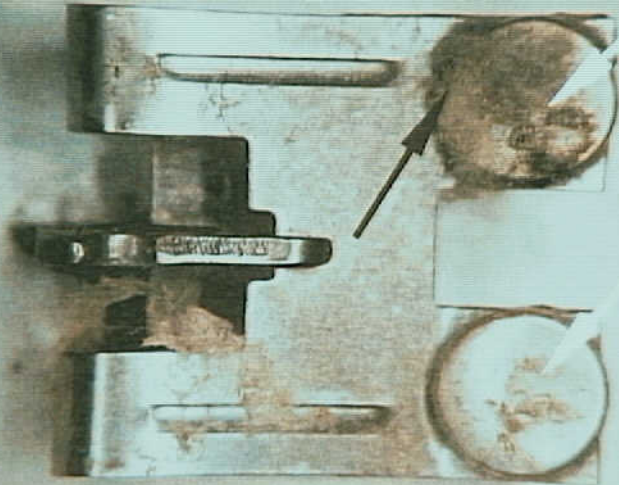
Line Contact

Load Contact

3.1 mm
