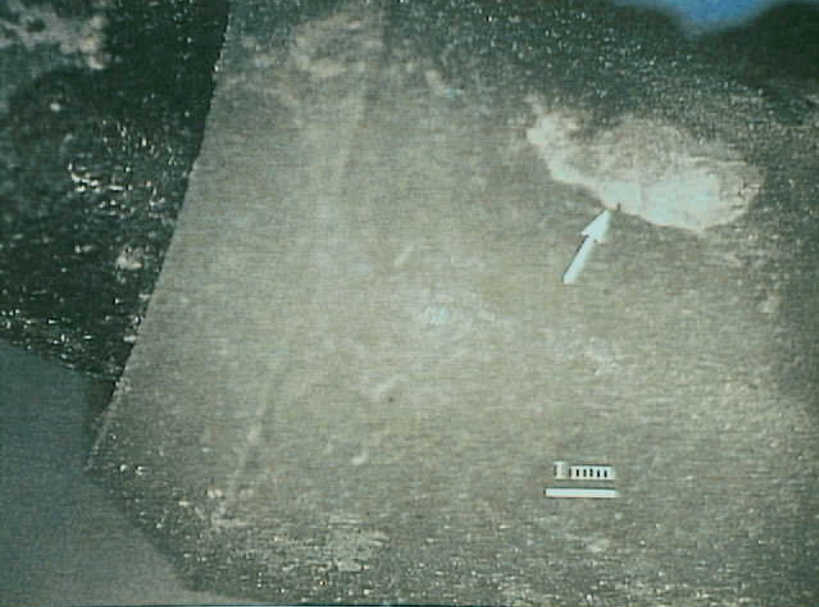
Systems 9 - Exhibit No. 9B - Photo 17. Figure 17a. Right jettison switch plunger guide exhibiting typical mold runner marks (arrow).
