Systems 9 - Exhibit No. 9B - Photo 49. Figure 49g. Fuel probe (model no. FG420A12, serial no. A-9) from N93105 having apparent compression damage to PTFE insulation.

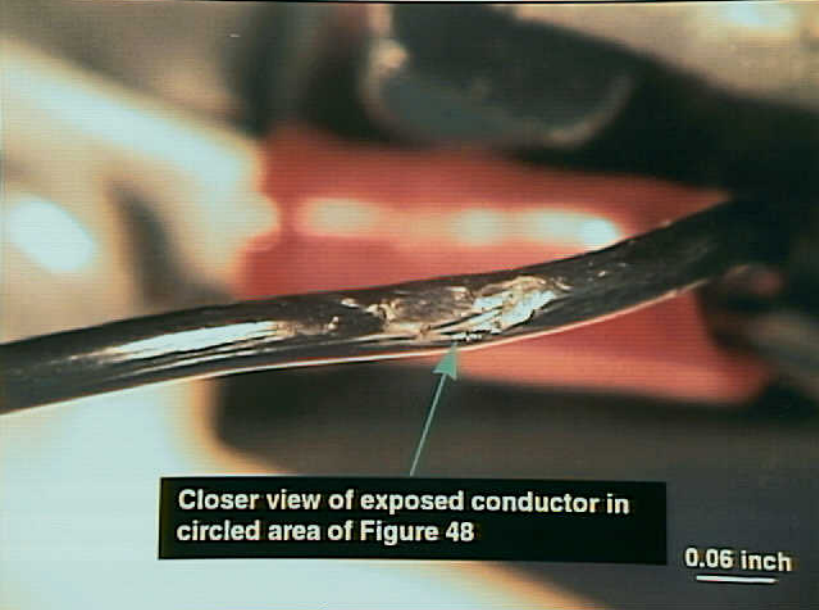
Closer view of exposed conductor in circled area of Figure 48

0.06 inch
