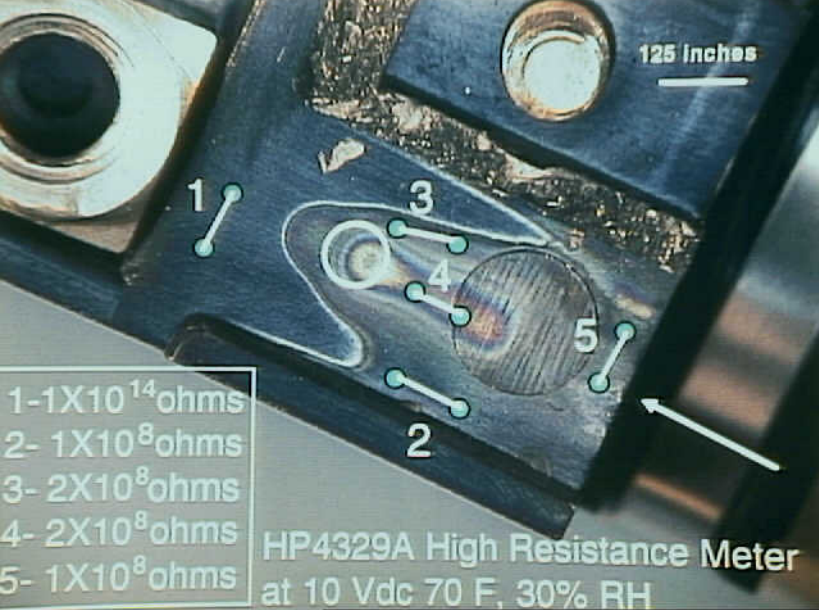
Systems 9 - Exhibit No. 9B - Photo 52. Figure 52g. Hi-Z location on terminal block from probe FG420A12, A-14. Note residue on surface and low electrical resistance. Residue contained high concentrations of silver, copper, and sulfur.
