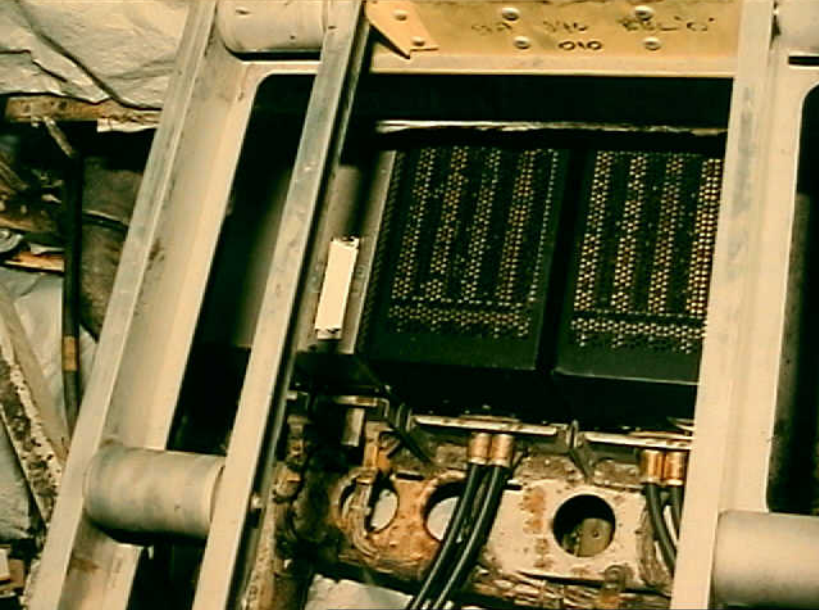
Systems 9 - Photo 33. Airplane 15. B-747 avionics visible beneath forward cargo compartment. Metal shavings are on black boxes near open holes that expose internal circuits and components. (View is down. Top of photo is forward).
