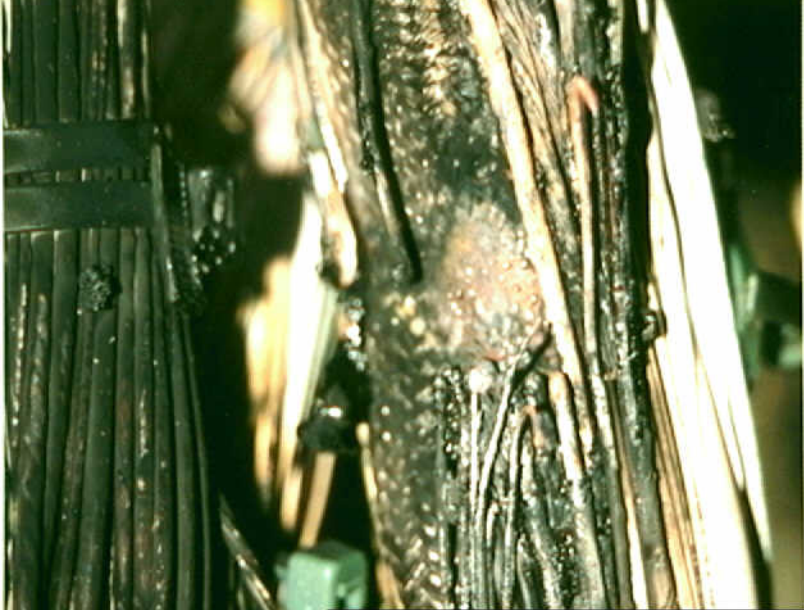
Systems 9 - Photo 42. Airplane 19. B767 detail of burned area of vertical wire bundles. The adjacent burned bundle (to left) had molten holes in wire insulation and was more than an inch away. Wire types were Aromatic Polyimide and XL-ETFE.
