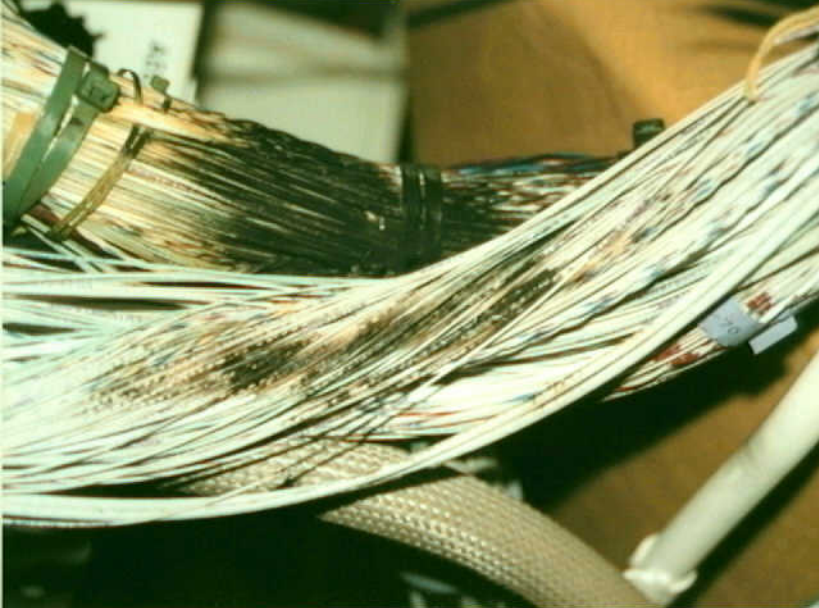
Systems 9 - Photo 43. Airplane 19. B-767 wires within the woven (Varglas) sleeve that the burned wires laid against. The wire insulation is bubbled and blackened.
