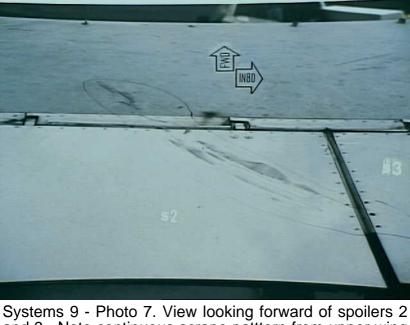
and 3. Note continuous scrape pattern from upper wing skin across both spoiler panels.
