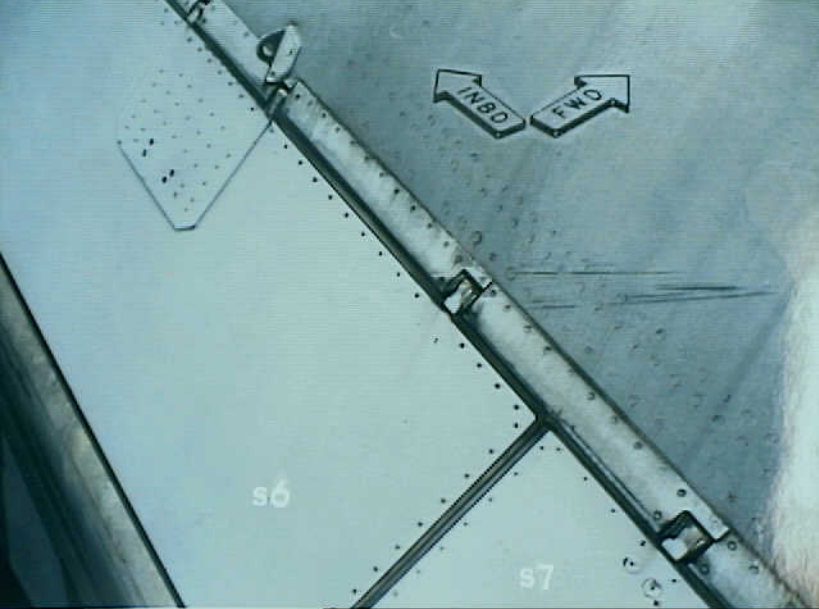
Systems 9 - Photo 8. View looking inboard of spoiler 6. Note continuous scrape pattern from wing skin onto the spoiler panel.
