# **NATIONAL TRANSPORTATION SAFETY BOARD**

## **TRACK & ENGINEERING GROUP FACTUAL REPORT**

| NTSB Accident Number: | DCA17FR009 |
| Location of Accident: | Queens Village, New York |

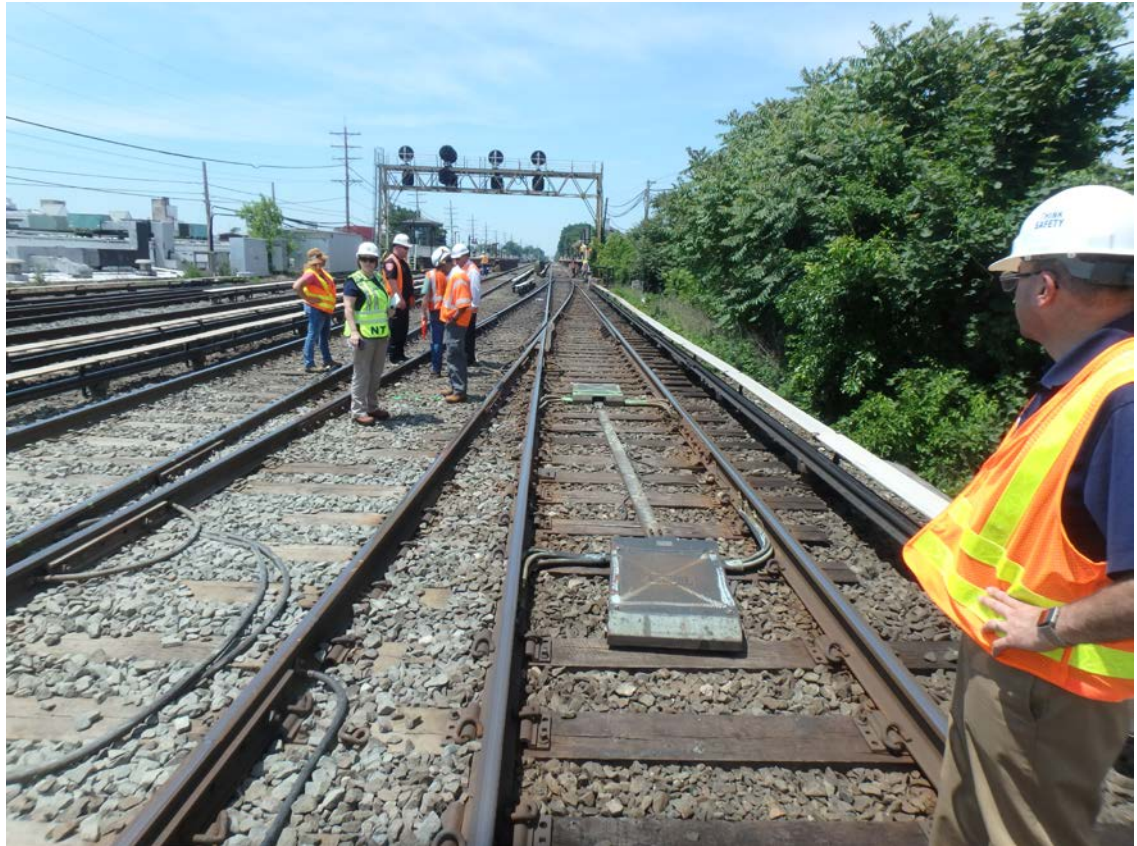
**Figure 1. Photo showing NTSB investigator standing across from the approximate point of impact (MP13.3). Photo taken facing west toward Queens Village station. main track 3 is to the right of photo.**

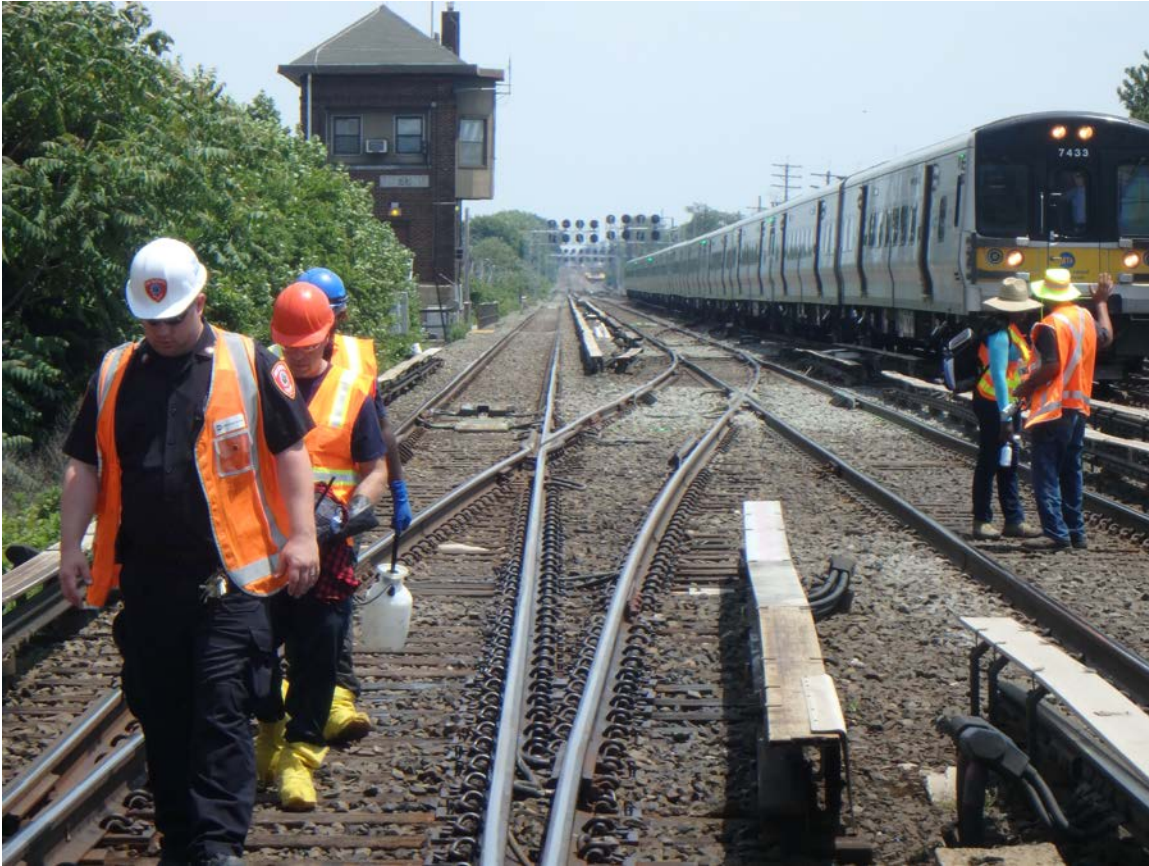
Figure 2. Photo showing accident location taken facing east toward direction of accident train approach.
