NATIONAL TRANSPORTATION SAFETY BOARD

17 - Video Factual Report

**Specialist's Factual Report
by Bill Tuccio**

Location: Rexburg, Idaho
Date: June 15, 2012
Aircraft: Roetman Eagle
Registration: N106BD
Operator: Private
NTSB Number: WPR12LA265

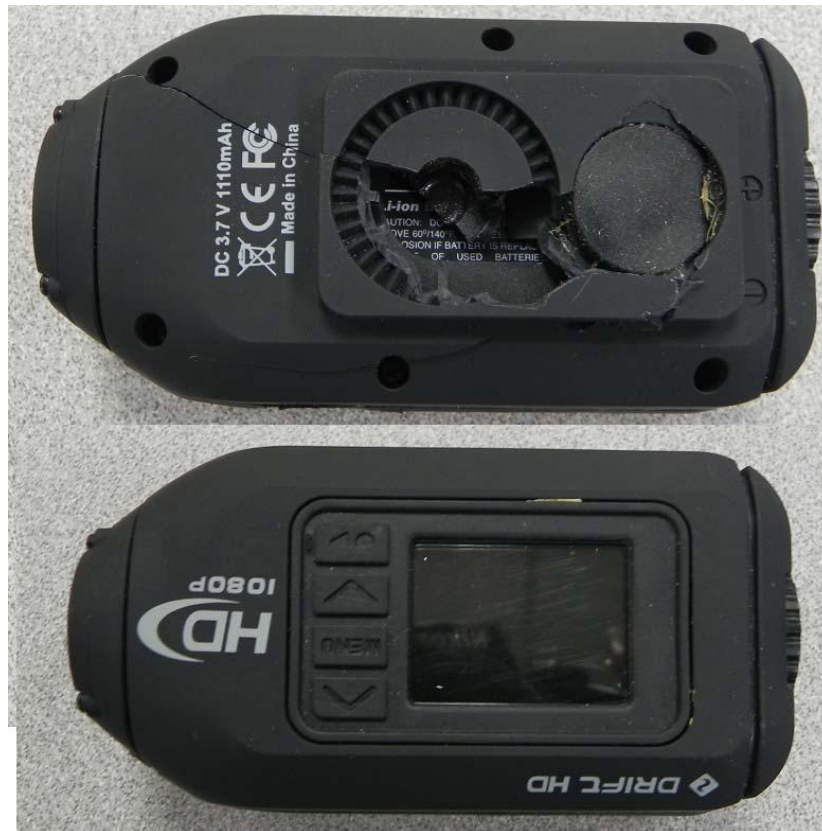
Figure 1. Photo of left and right sides of Drift HD.

Upon arrival at the Vehicle Recorder Laboratory, an exterior examination revealed that the unit had sustained minimal damage (see figures 1-3). An internal inspection revealed broken wires to the speaker and structural damage to the battery compartment, though the rechargeable Lithium-ion battery was undamaged. The micro SD card was removed from the unit and the contents downloaded normally, without difficulty.

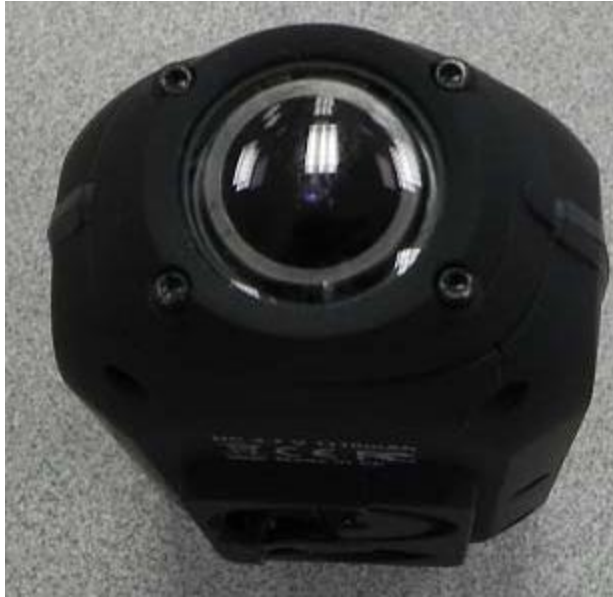
Figure 2. Photo of front of Drift HD.

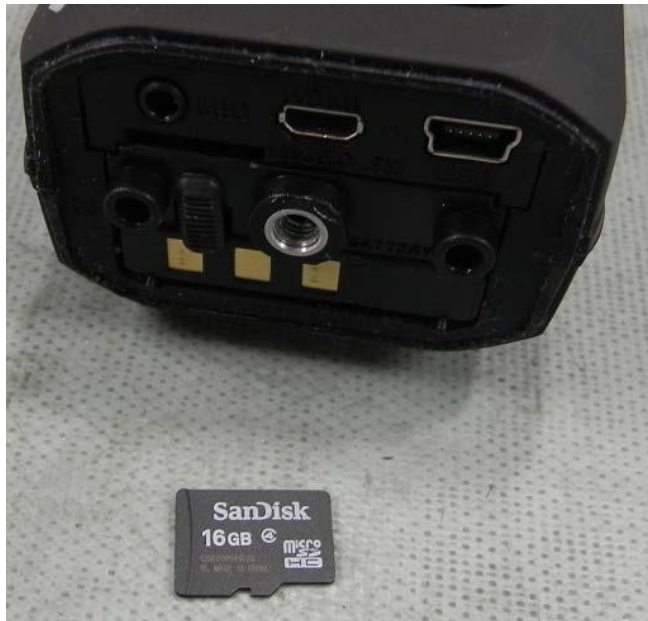
Figure 3. Photo of back of Drift HD with micro SD card removed.
