LJ-1775, N508GT

C90-GT, King Air

NTSB Accident Number ERA12FA409

HBC - GPS Waypoint Index

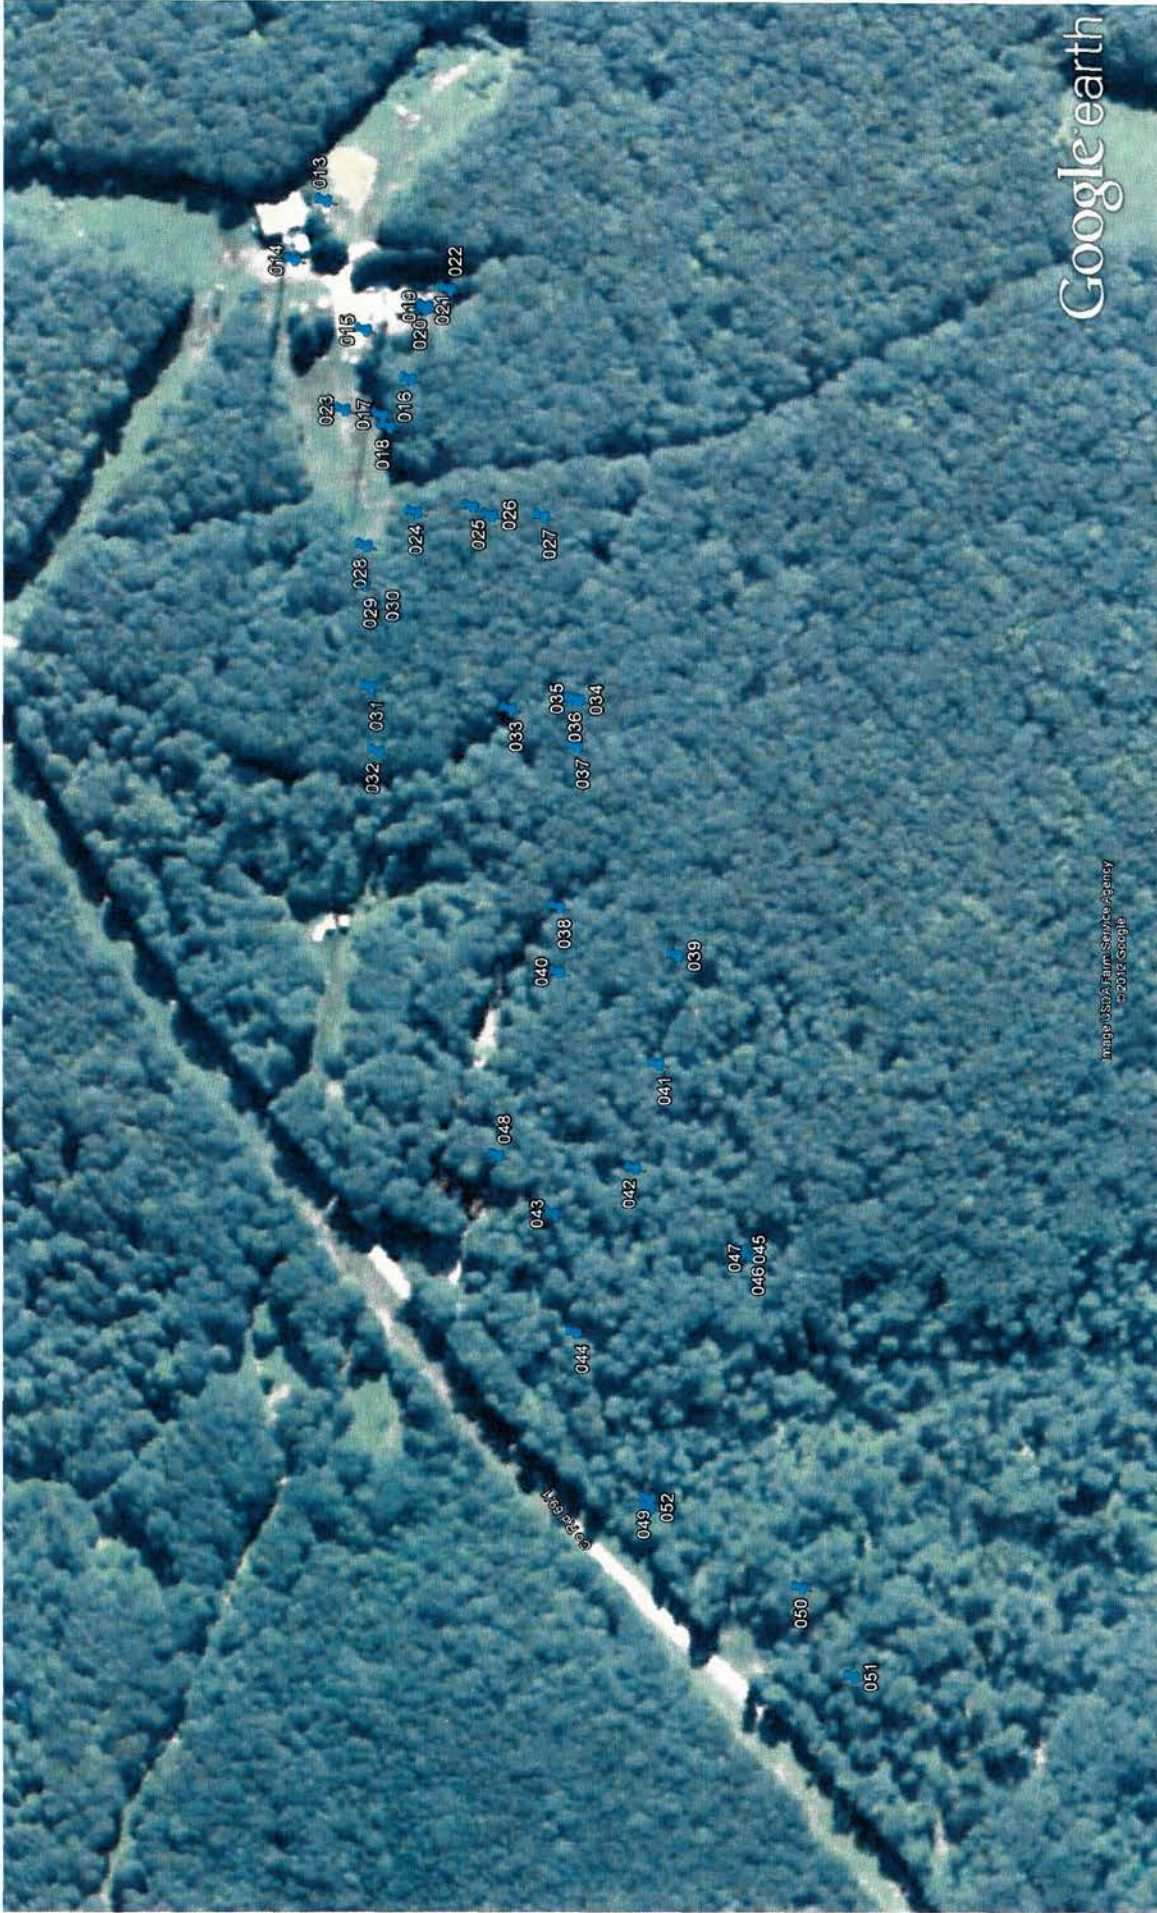
13. Roof of antenna tower building
14. Base of tower struck by airplane
15. Oil soaked fragment with ground strap
16. Fuel bladder fragment
17. Separated tower antenna
18. Side of antenna with black marks
19. Oil access door
20. Engine cowling fragment with fire detector
21. Same as 20
22. Fragment with 4 inch diameter impact mark
23. Fragment of right propeller spinner with thread mark
24. Nose landing gear door
25. Right wing tip – Outboard of right aileron
26. Left horizontal stabilizer and left elevator
27. Oil access door
28. Right propeller blade S/N K36272 – separated 32 inches from shank
29. Top of vertical stabilizer with strobe light
30. Fragment of engine fire detector

31. Right wing
32. Fragment of antenna access ladder with fragment of airframe attached
33. Top of right engine nacelle – nacelle baggage compartment – burned

34. Luggage and clothing
35. No component at this location
36. Right elevator balance weight
37. Engine mounting truss fragment
38. Electro mec actuator
39. Fragment of oil scavenge line

40. Right propeller hub and 3 propeller blades – One blade broken at 17.5 inches from hub
41. Right main landing gear wheel, tire and brake with separated portion of strut

42. 12 foot 4 inch portion of antenna access ladder
43. Propeller counterweight
44. Left engine and propeller – all four blades present
45. Propeller counterweight

46. No component at this location
47. Antenna ladder fragment – 44 inches in length
48. Right propeller dome
49. Right engine compressor and turbine section

50. Right engine ground impact crater
51. Right engine accessory section and data plate
52. Fuselage, left wing, left aileron, left inboard and outboard flap, vertical stabilizer, rudder, right horizontal stabilizer and elevator
