Preliminary Report HWY24FH002

Fatal Grade Crossing Crash between Pickup Truck and Intercity Passenger Train

Melbourne, Florida
January 12, 2024

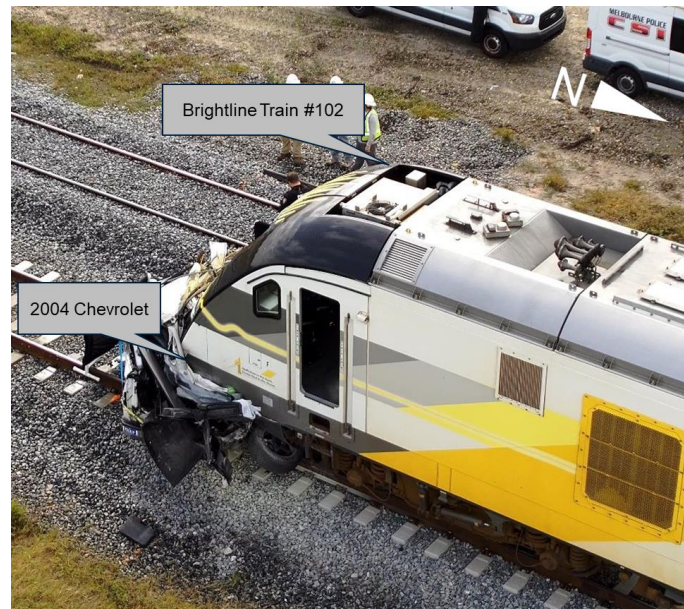
Figure 1. Photograph of the January 12, 2024, crash showing the pickup truck and passenger train at final rest. (Source: Melbourne Police Department)

On Friday, January 12, 2024, about 12:51 p.m. eastern standard time, a 2004 Chevrolet Avalanche pickup truck, occupied by a driver and one passenger, was traveling west on W H Jackson Street in Melbourne, Brevard County, Florida. According to preliminary evidence, the pickup truck approached a railroad grade crossing, consisting of two main tracks, located west of the intersection of W H Jackson Street and South Harbor City Boulevard. As the pickup truck reached the grade crossing, the grade crossing the gates had already lowered and the flashing lights and bells were on. The pickup truck drove around the lowered gate and entered the grade crossing. At the same time, the southbound Brightline passenger train #102 was traveling about 78 mph on the east main rail, entered the grade crossing, and struck the pickup truck (see figure 1). The driver and passenger in the pickup truck died from injuries sustained in the crash.
