From: Alexander, Scott (FAA) [REDACTED]
Sent: Monday, August 31, 2020 9:39 AM
To: Scott Arnold
Cc: Cook, Jon (FAA); Grimm, Wendy L (FAA)
Subject: N9325H - Zelianople - 2019 Accident
Attachments: N9325H Air Filter Gasket.jpg; N9325H Carburetor Intake.jpg; N9325H Carburetor Intake2.jpg

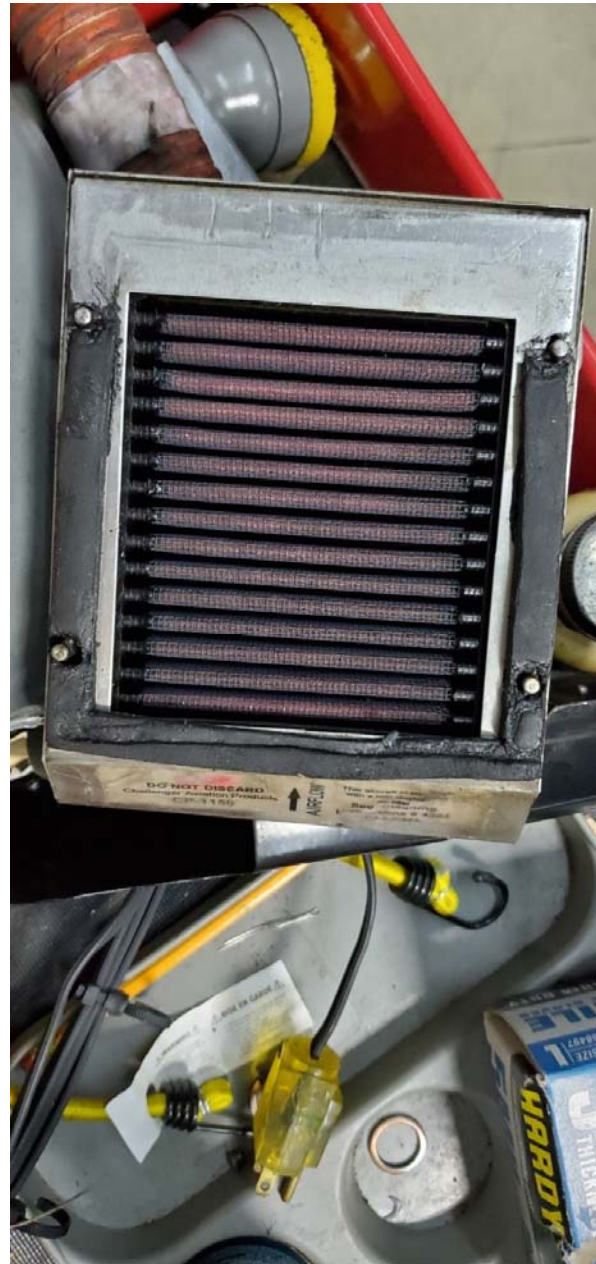
Photo 1 – The condition of the air filter gasket, as found by Chuck Potts, supervising mechanic. Note gasket seal is missing from the top of the air filter (Chuck Potts photo)}

I've just received a phone call from the mechanic in Zelianople who's been working occasionally on the Champ. He has discovered something a bit more substantial as to why the engine quit. From the photos he sent, pieces of the air filter gasket appear to have migrated into the carburetor intake. Please note the folded pieces of gasket material in the carburetor intake.

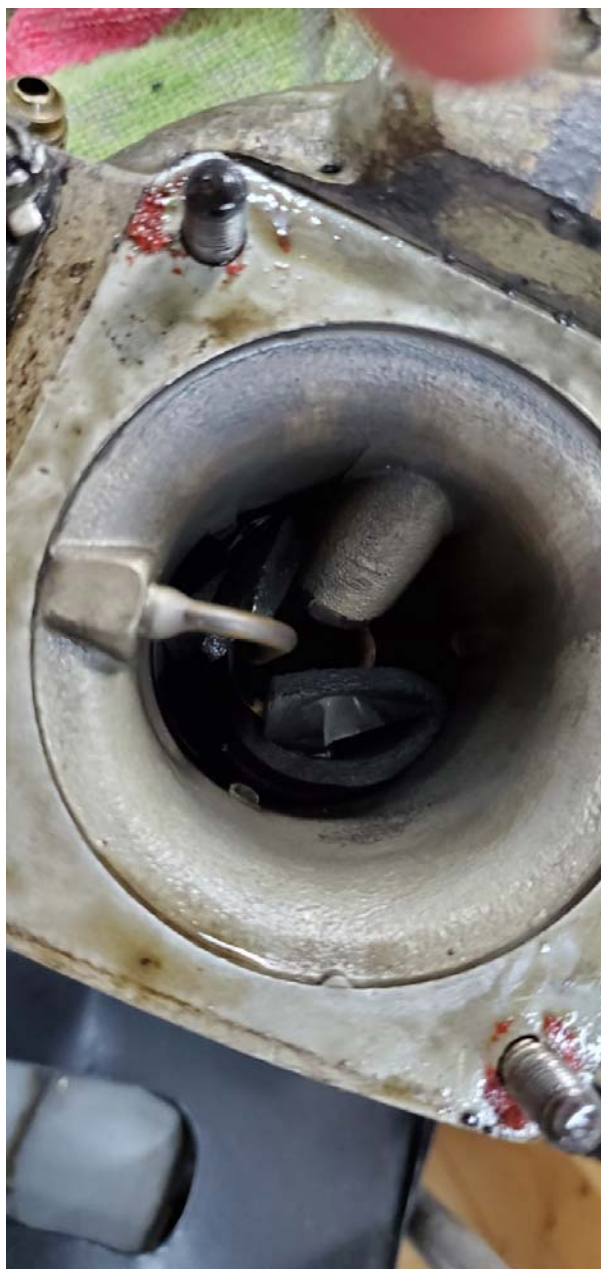
Photo 2 – Carburetor intake. Note the air filter gasket in the throat (Chuck Potts photo)

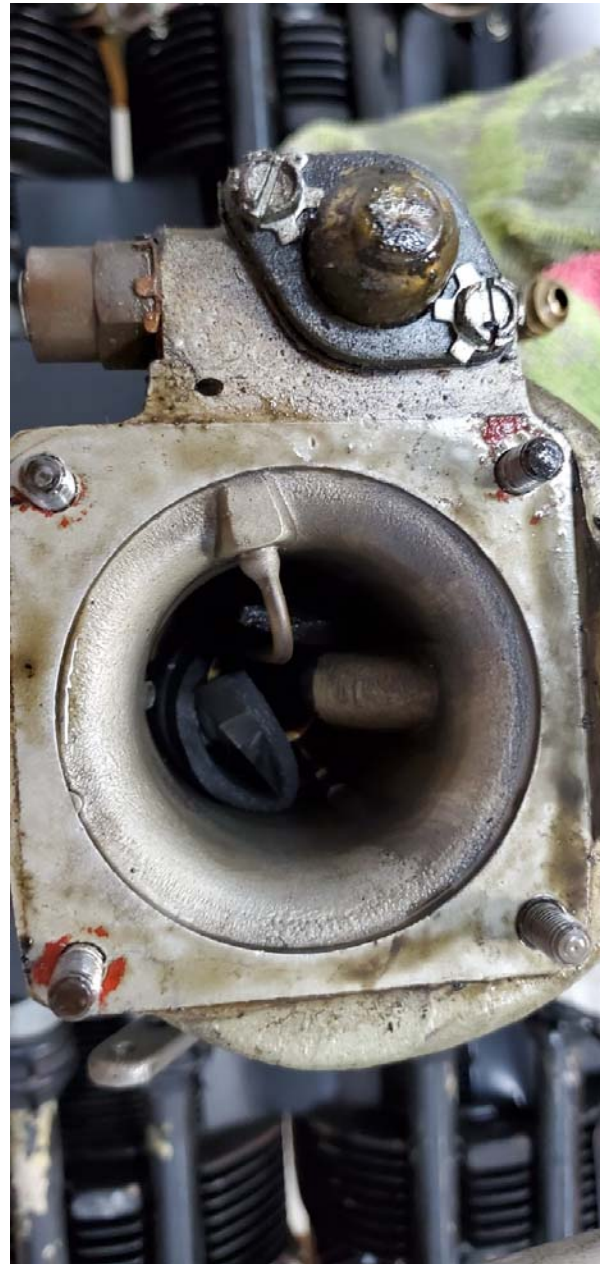
Photo 3 – Another view of the carburetor intake with a piece of the air filter gasket in the throat (Chuck Potts photo)
