NATIONAL TRANSPORTATION SAFETY BOARD

Addendum - Personal Electronic Devices

Specialist's Factual Report By W. Deven Chen

Location: Calabasas, California
Date: January 26, 2020
Aircraft: Sikorsky S76-B
Registration: N72EX
Operator: Island Express Holding Corp.
NTSB Number: DCA20MA059

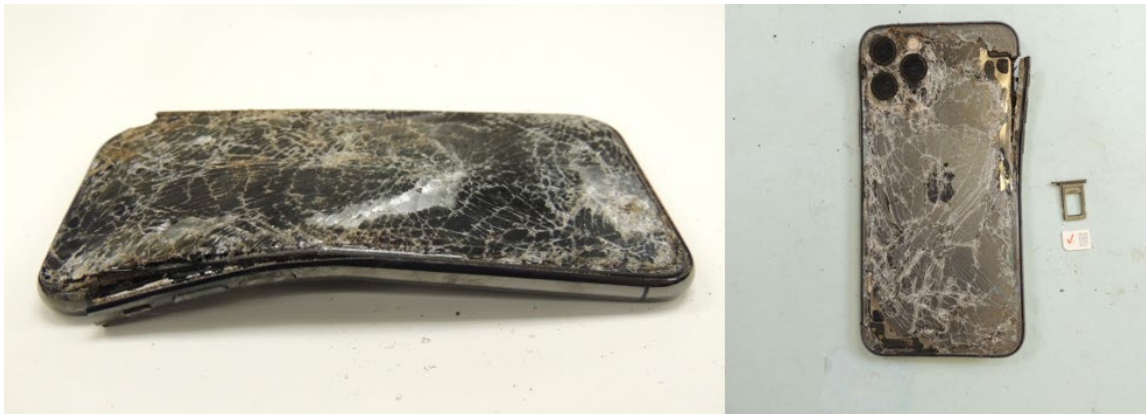
Upon arrival at the Vehicle Recorder Division, an exterior examination revealed the device had severe impact damage, as shown in Figure 1. The device's motherboard was removed and was found to have deformed, as shown in Figure 2. The motherboard did not power up on a surrogate device. The extent of the damage precluded normal and advanced recovery procedures at the lab and additional attempts were unsuccessful in powering up the device. In a discussion with the Investigator-In-Charge, the device was sent to a commercial data recovery facility for repair. The phone powered up on a surrogate after repair and was locked with a 4-digit passcode. As of November 23, 2020, no passcodes were provided to the Vehicle Recorder Division. The phone was sent to the D.C. Department of Forensic Sciences for data extraction assistance.

Figure 1: Front and back of Apple iPhone 11 Pro as received.

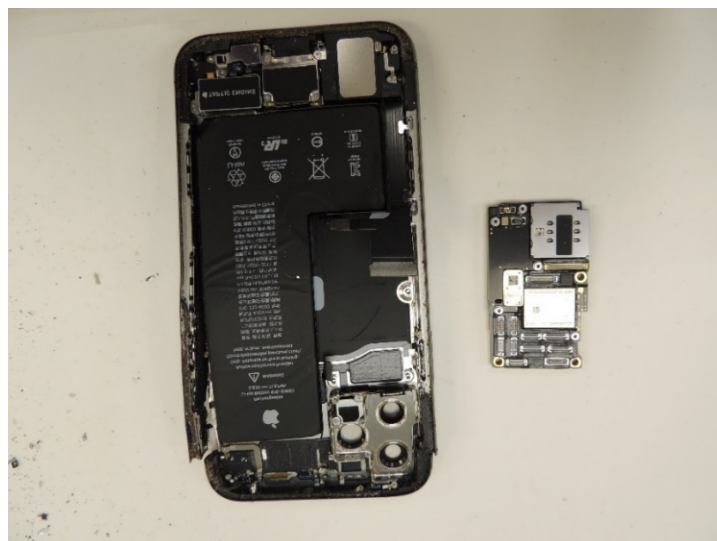
Figure 2: Motherboard of Apple iPhone 11 Pro in deformed condition.
