Carburetor Icing Probability Graph – CEN23FA077

Airplane: Cessna 150H

Accident Date: 1/11/2022

Accident Location: Auburn, NE

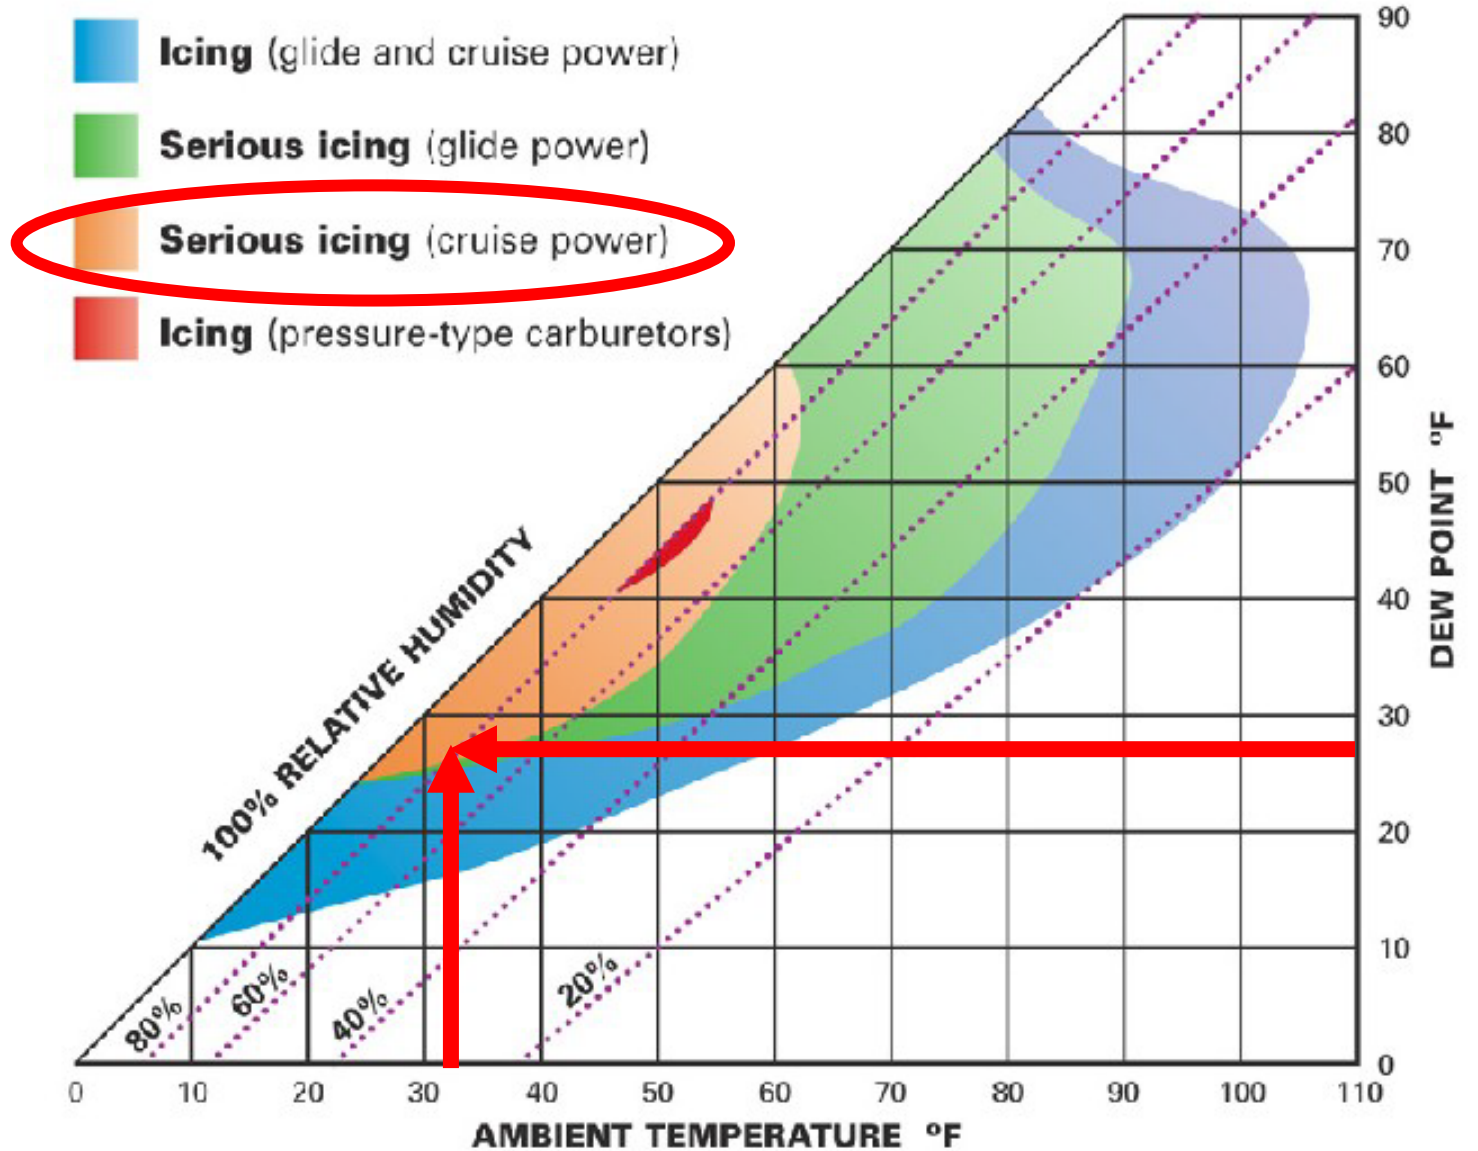
Weather: METAR KAFK 120115Z AUTO 01012KT 10SM
SCT120 00/M02 A2990

Temperature, 0° C = 32° F

Dew Point, -2° C = 28.4° F

Source: Federal Aviation Administration

Special Airworthiness Information Bulletin CE-09-35

Carburetor Icing Prevention
