# National Transportation Safety Board

ERA23FA001

## **ONBOARD RECORDERS**

Specialist's Factual Report

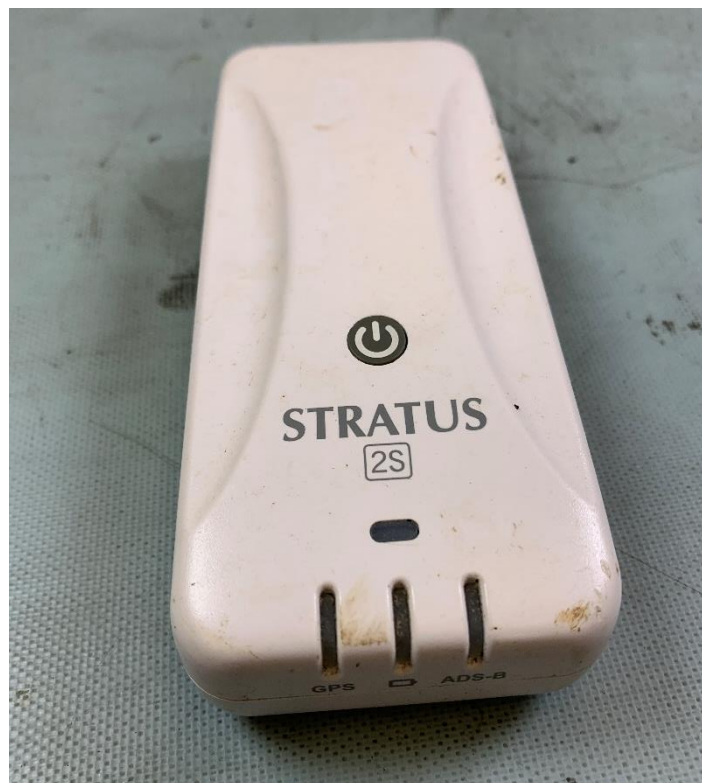
Upon arrival at the Vehicle Recorder Laboratory, an exterior examination revealed the unit had sustained minor damage as shown in Figure 1. However, the device was able to be powered on and the data were downloaded normally using the manufacturer’s procedure.

**Figure 1.** Photo of the Stratus 2S showing minor scuffs and scratches.

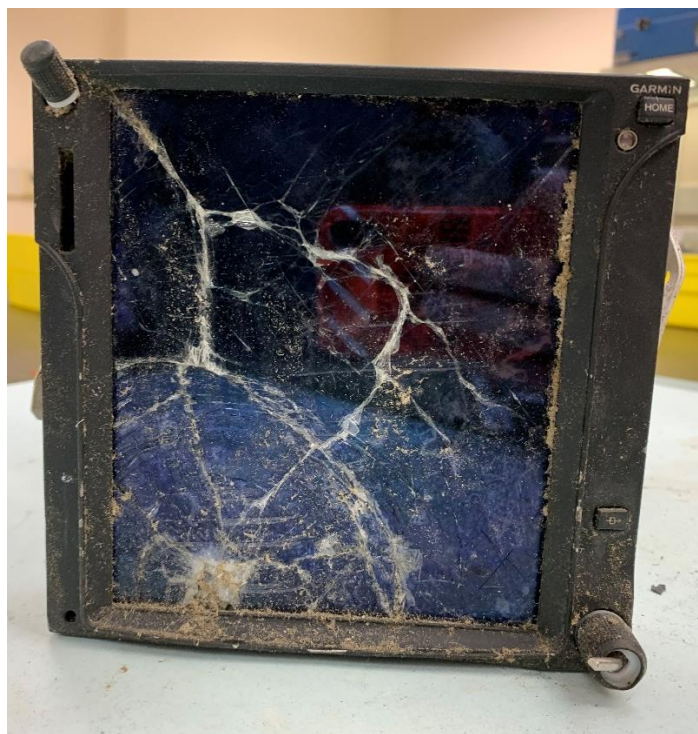
Upon arrival at the Vehicle Recorder Laboratory, an exterior examination revealed the unit had sustained impact damage, as shown in Figure 2, which prevented the device from being powered. An SD card was located along with the device, which, when read, was determined to be a supplemental data card with charts and navigation information, but no recorded flight data. An additional SD card was recovered from within the unit; however, the card did not contain any recorded flight data. Therefore, no data were recovered from this device.

**Figure 2.** Photo of Garmin 750 showing impact damage.
