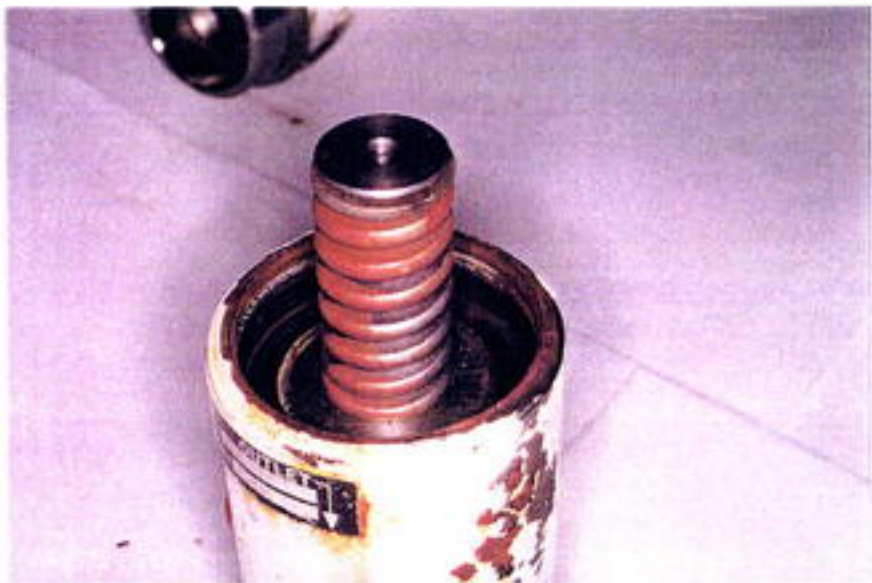
Figure 4.7 Accident Pilot Valve with Cover Removed
