February 23, 2018 Test of Yard Line at 3534 Espanola – Test Connection at Meter

February 24, 2018 Test of Gas Main

(Test conducted jointly by PHMSA, Texas Railroad Commission, Atmos and BakerRisk)

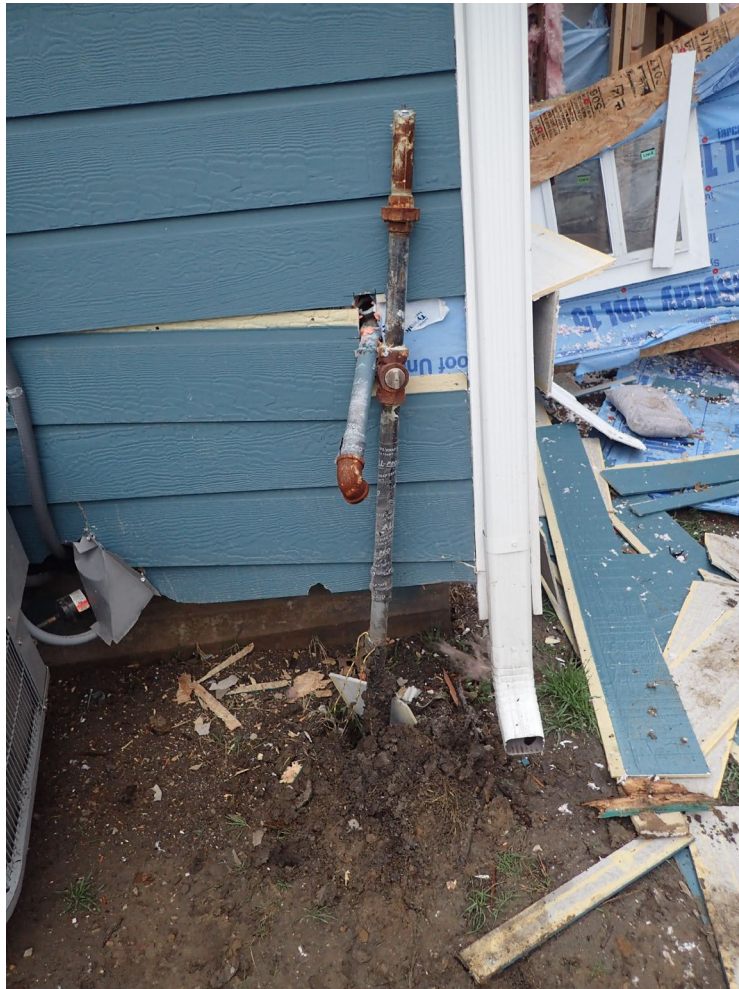
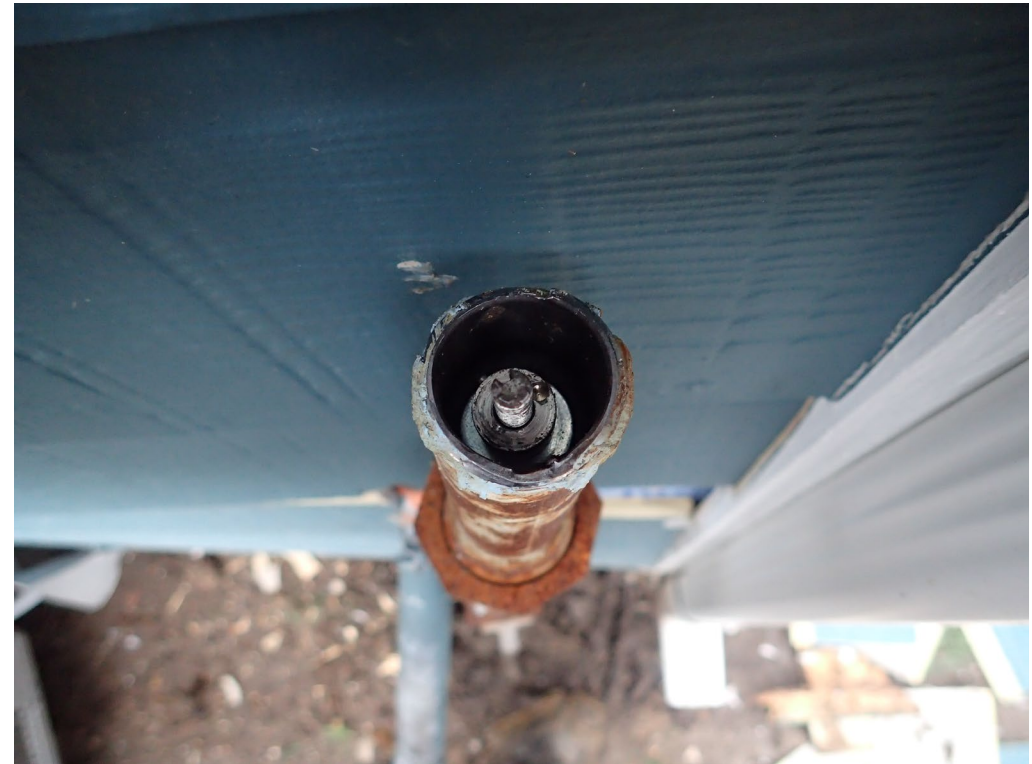
February 23, 2018 - 3534 Espanola Yard Line Plugged Where Pipe Broken at House

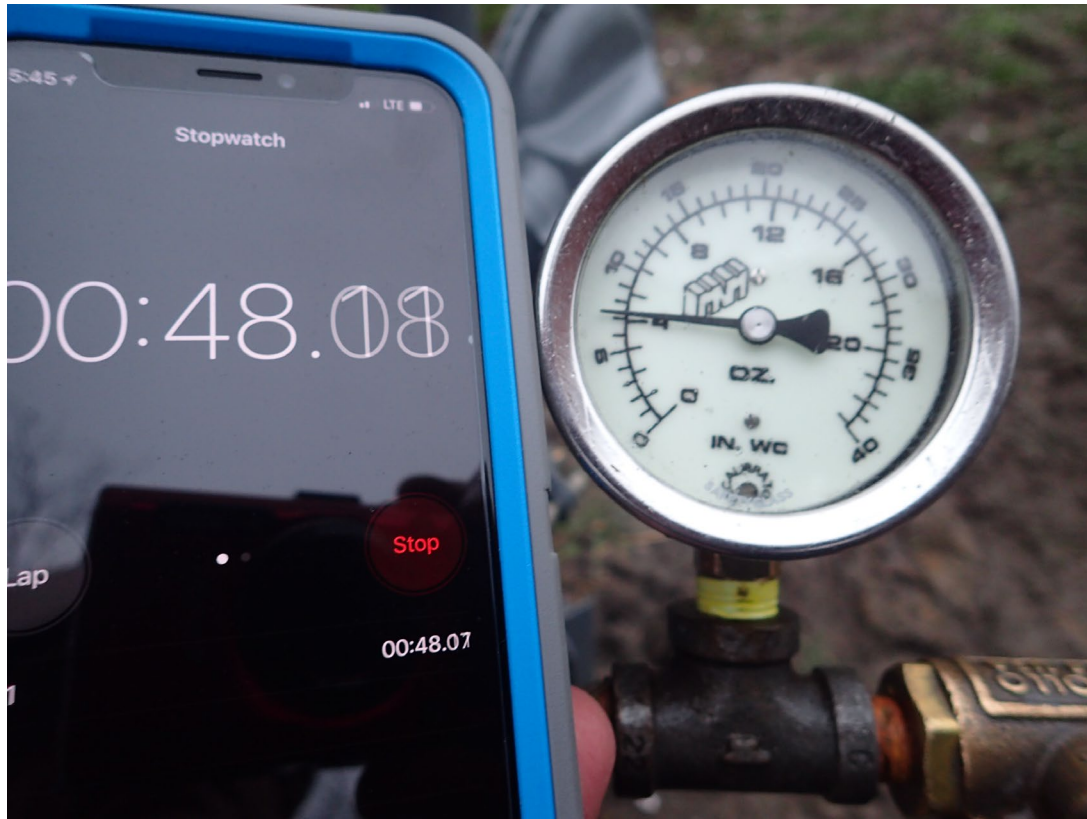
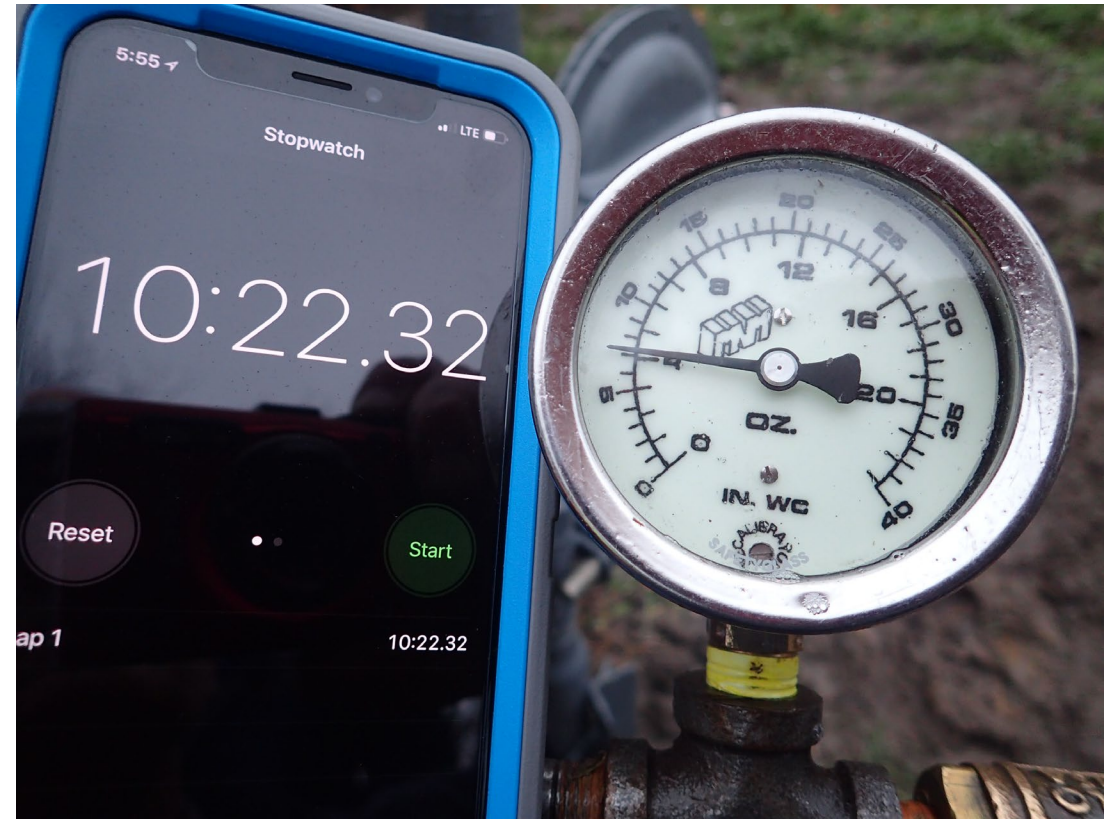
February 23, 2018 - Ten-minute Pressure Hold Test of 3534 Espanola Yard Line

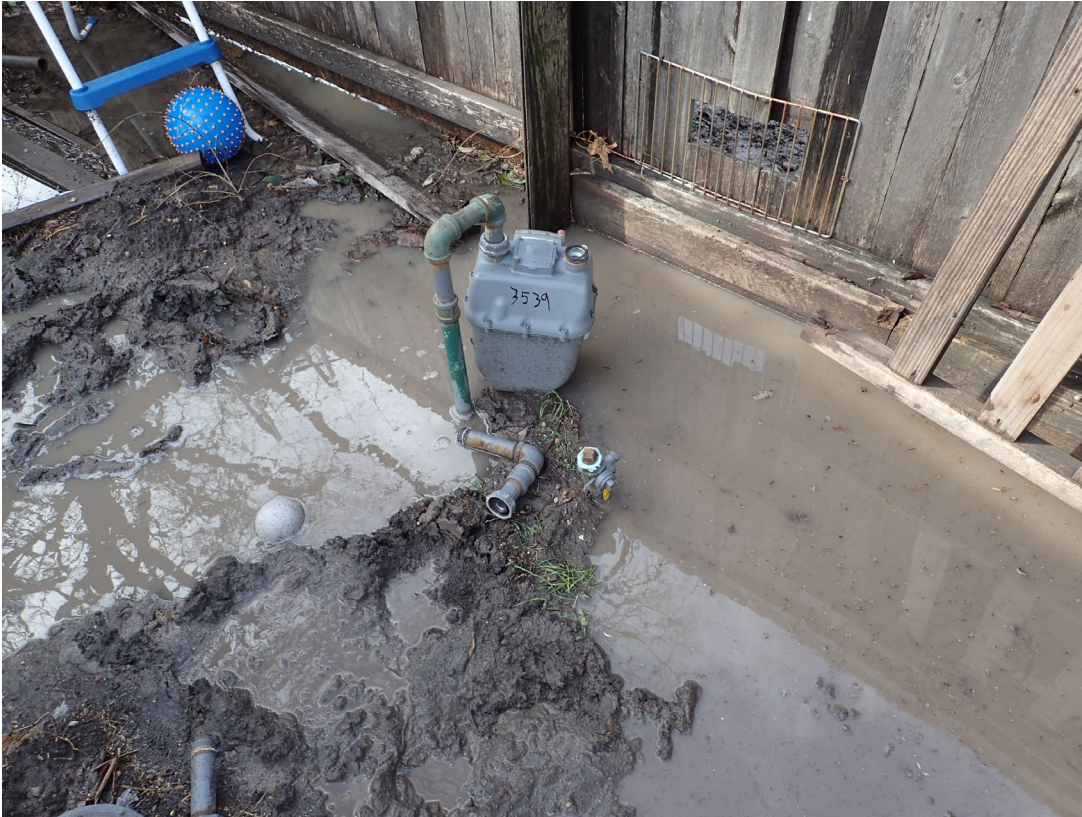
All gas meters disconnected from main along alley and connections plugged

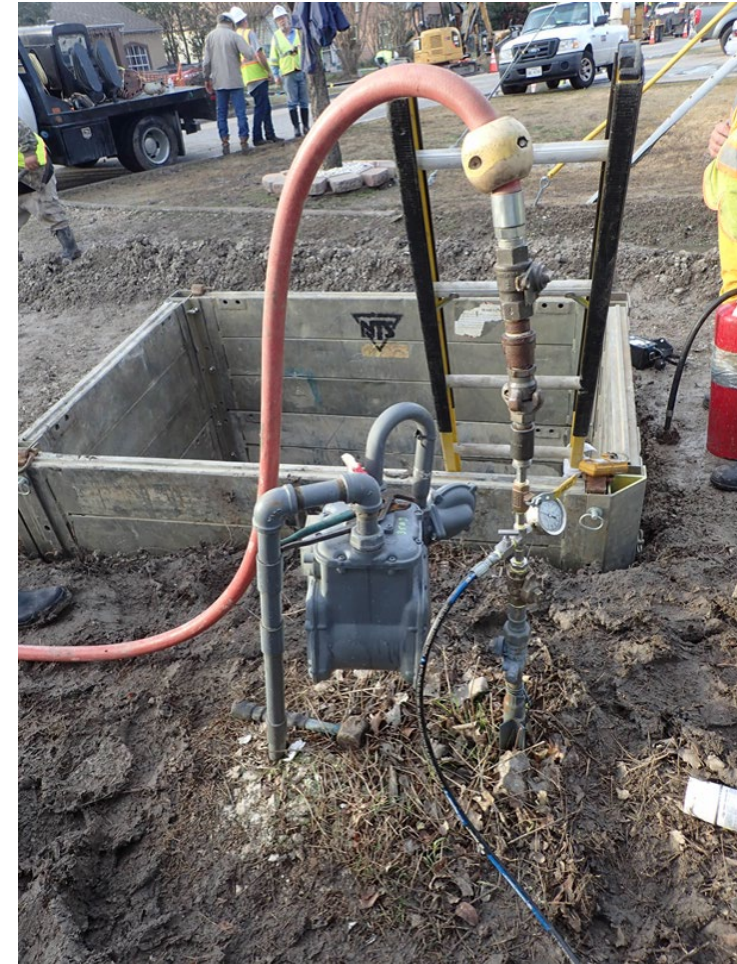
Air supply and pressure gauge connected to the riser for 3503 Durango

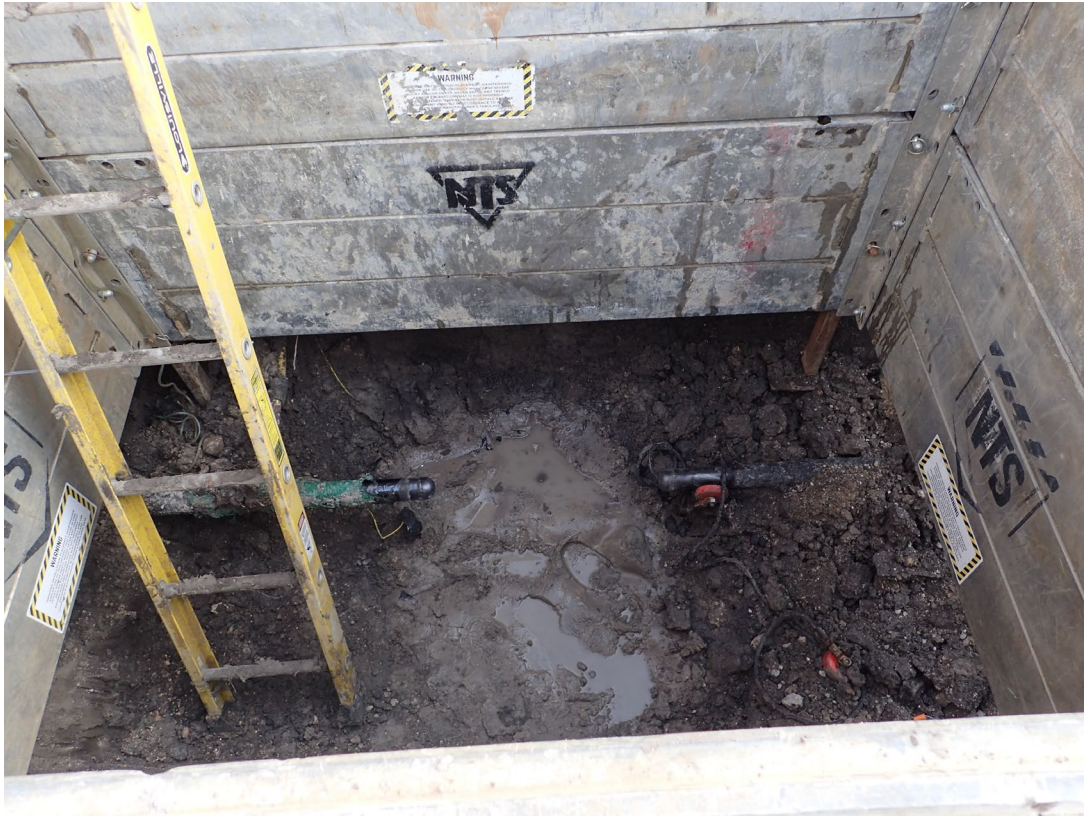
Gas main cut and capped at west
end of alley

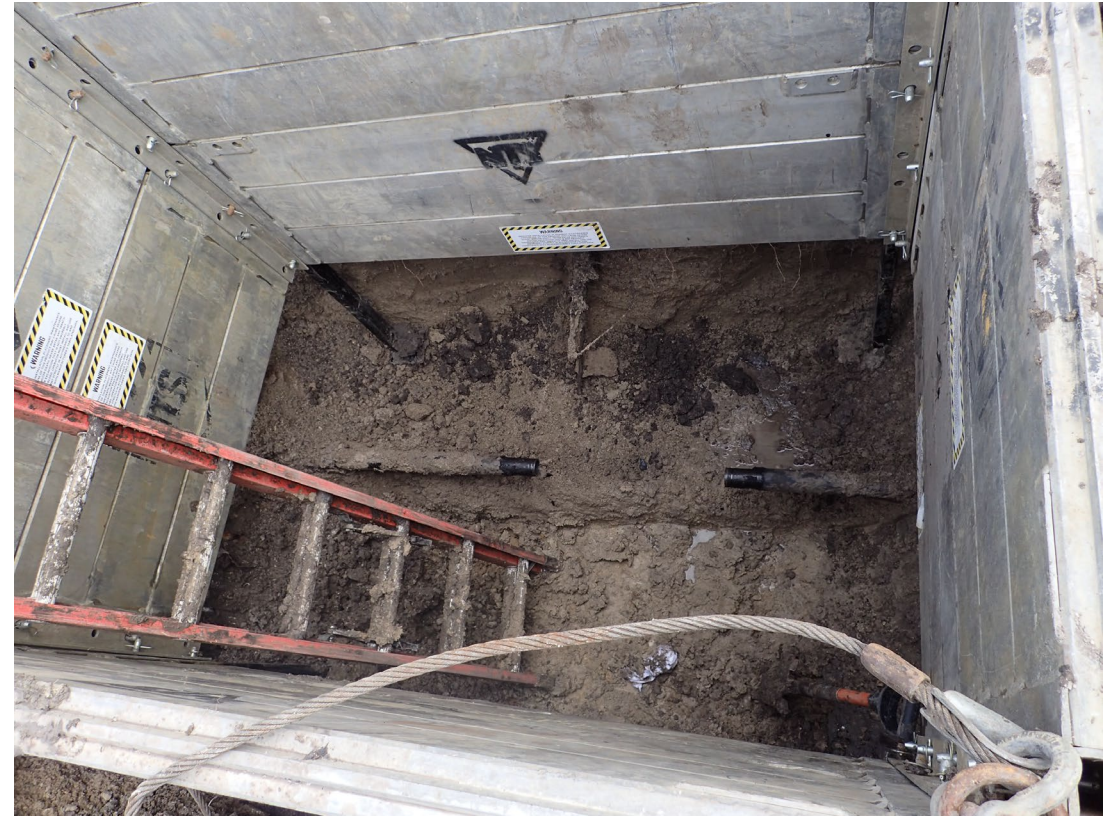
Gas main cut and capped at east
end of alley
