# PRELIMINARY REPORT

## HIGHWAY

### HWY21MH008

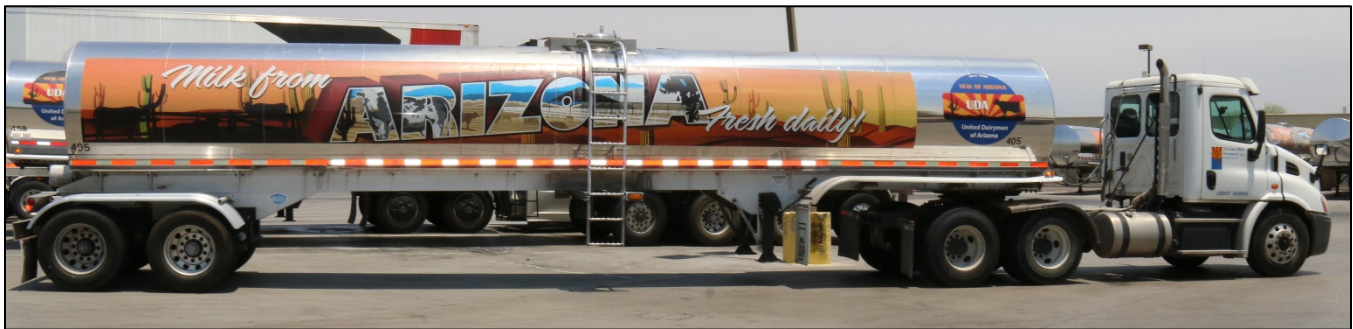
The crash sequence began with an eastbound 2016 Freightliner Cascadia truck-tractor combined with a fully loaded 2015 Walker stainless equipment tank trailer (combination unit), driven by a 47-year-old male driver. The combination unit, operated by Arizona Milk Transport, Inc., was transporting milk from a local dairy to the United Dairymen of Arizona cooperative plant (under Transportation of Agricultural Commodities operations in the Phoenix area).<sup>1</sup> See figure 1.

**Figure 1.** Exemplar Arizona Milk Transport, Inc. truck-tractor and United Dairymen of Arizona tank trailer.

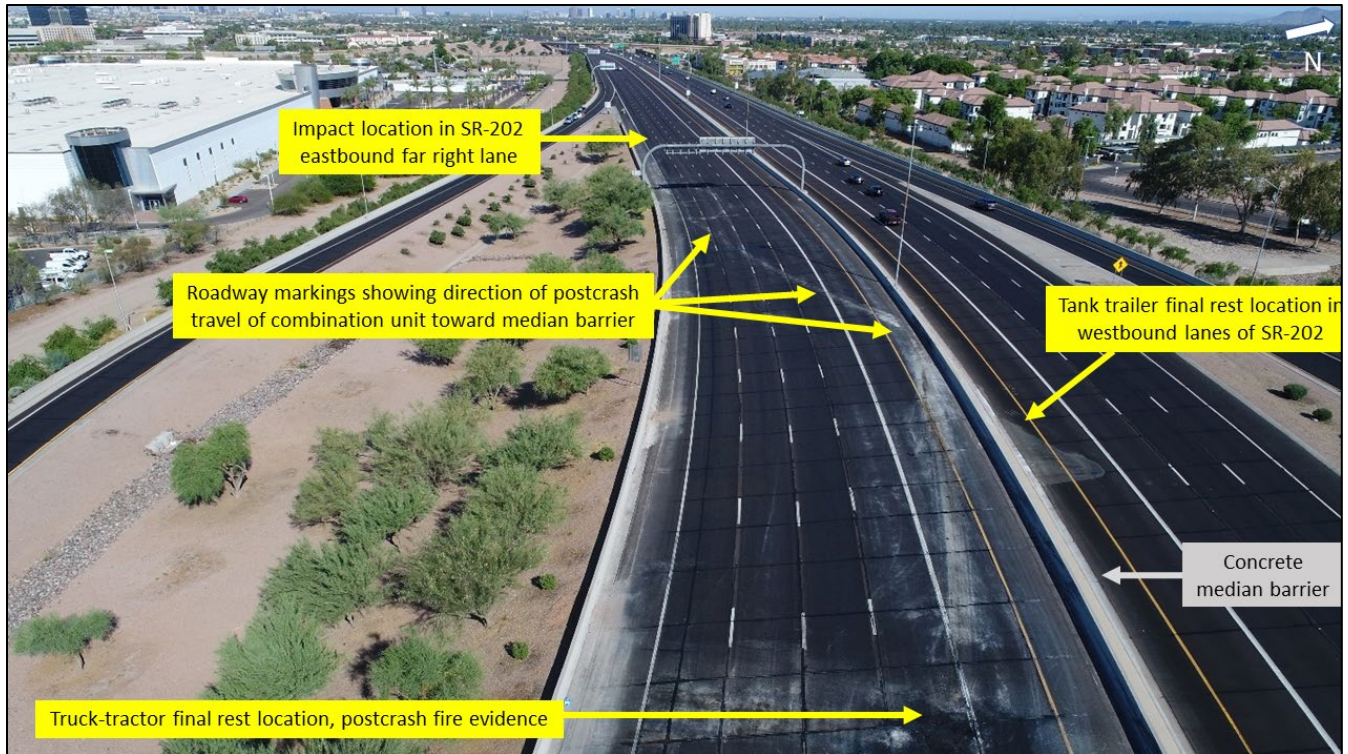
At mile marker 4, just beyond the off-ramp for the 52nd Street exit, the truck driver did not stop for slowed traffic that had formed a queue in the far-right lane, and the combination unit struck multiple vehicles. During the collision sequence, the truck crossed all four travel lanes to the left, struck the center median barrier, and then crossed back to the right before coming to rest in the far-left eastbound lane. When the combination unit struck the center median barrier, the tanker separated from the truck-tractor, overrode the barrier, then landed in the westbound shoulder and adjacent left travel lane (see figure 2).

**Figure 2.** West-facing view of eastbound SR-202 crash location and roadway evidence.
