NATIONAL TRANSPORTATION SAFETY BOARD

MATERIALS LABORATORY FACTUAL REPORT

Report No. 21-097

Place : Farmersville, TX
Date : June 28, 2021
Vehicle : Natural gas pipeline
NTSB No. : PLD21FR002
Investigator : Sara Lyons

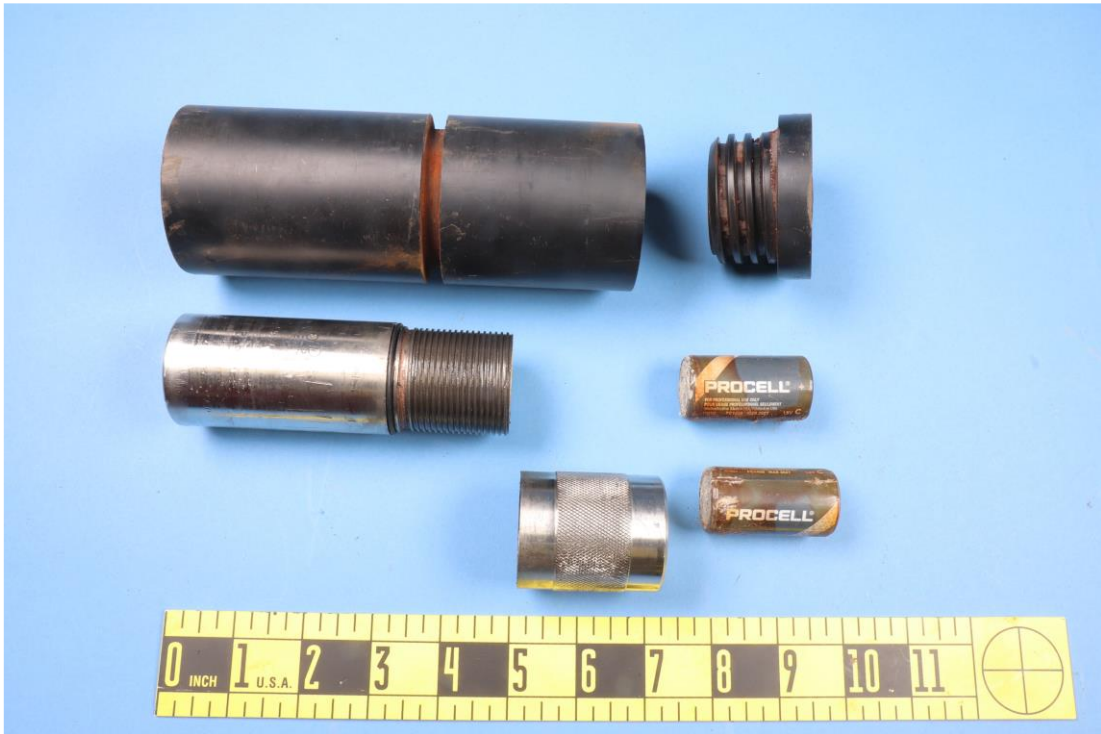
Figure 1: Transducer components as received.

Transducer recovered from gauge pig assembly (Figure 1)

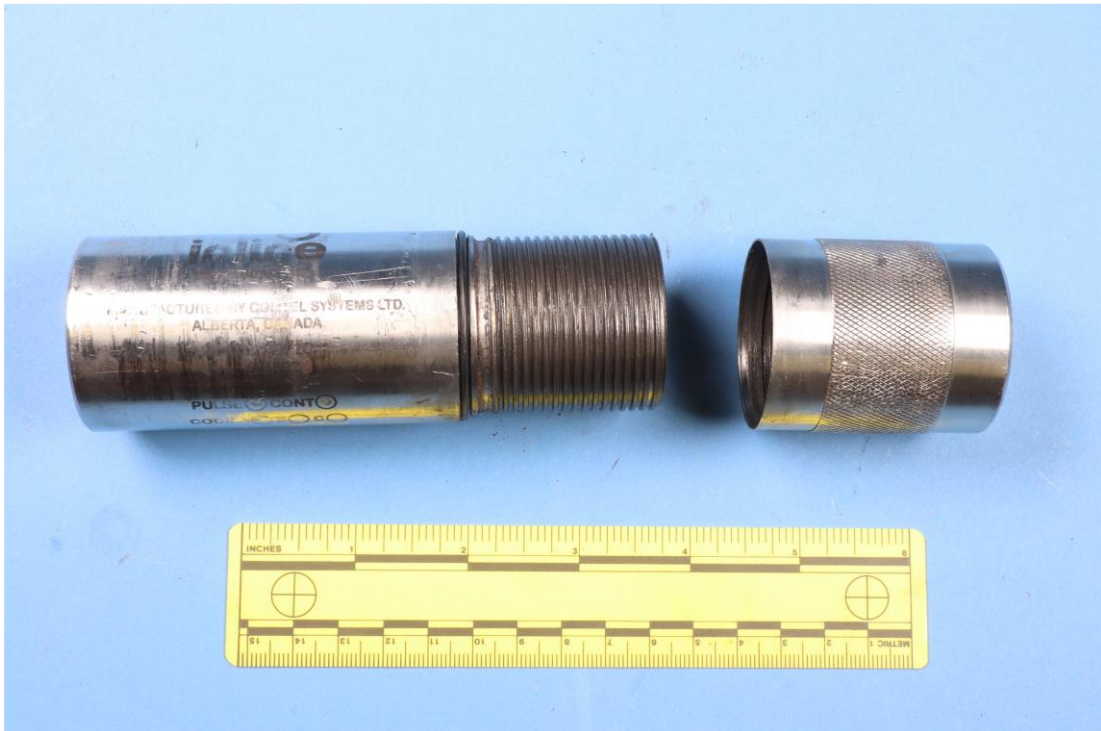
Figure 2: Transducer body.

The transducer body was cylindrically shaped and constructed from stainless steel with a screw-on end cap (Figure 2). The threaded portion of the transducer body was approximately 1.5 inch long with an O-ring seal. The stainless steel transducer was contained within a black plastic cylindrical container with a screw-on end cap. The transducer was powered by two 1.5 Volt PROCELL brand C-cell alkaline batteries with an expiration date of March 2027 (Figures 3, 4, 5). The alkaline batteries were corroded and exhibited deposits on the exterior consistent with electrolyte salts. The batteries did not exhibit any signs of thermal distress.

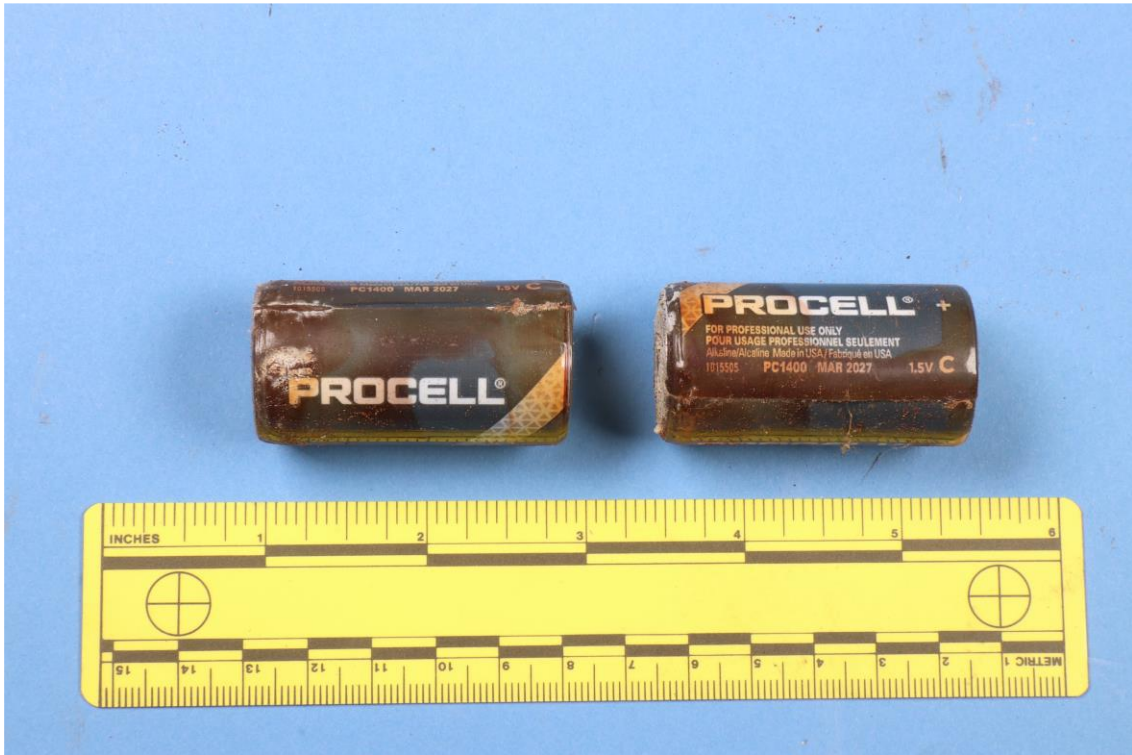
Figure 3: Transducer batteries.

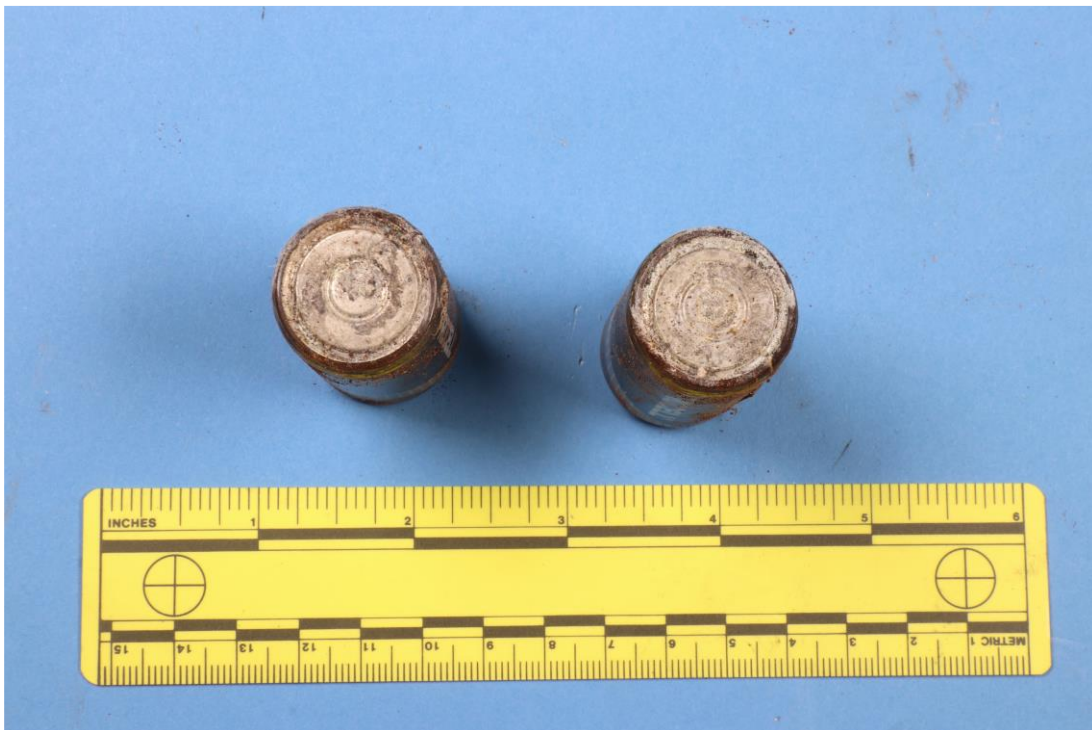
Figure 4: Transducer batteries negative pole.

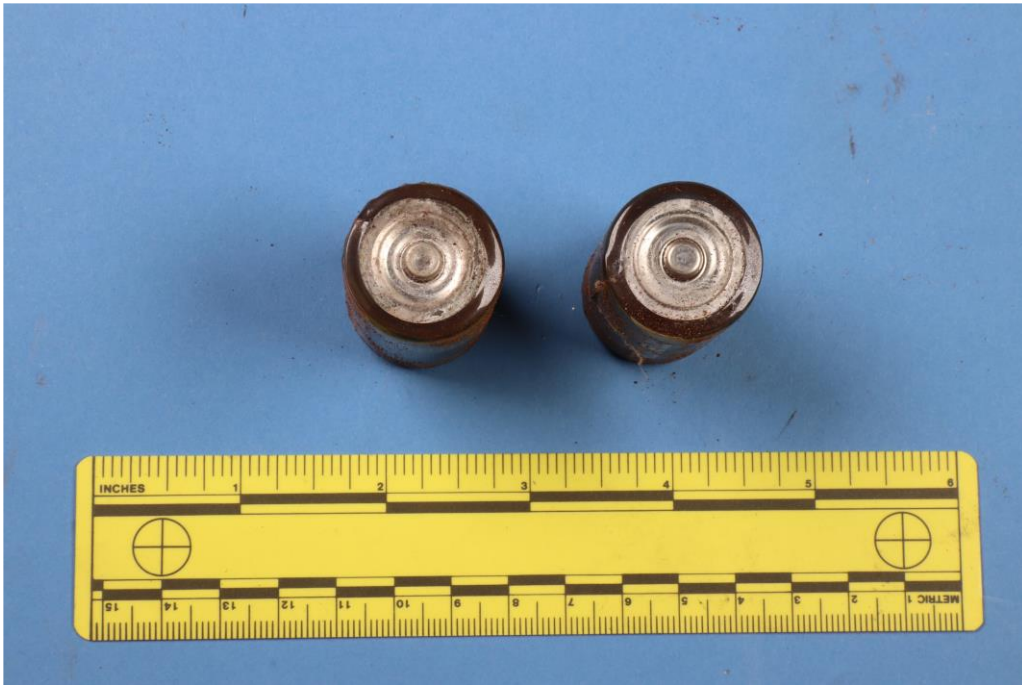
Figure 5: Transducer batteries positive pole.
