MEMORANDUM FOR RECORD

Accident Number: ERA18FA120
Subject: ADS-B N106ER Route¹ of Flight Views. Courtesy of ERAU

ADS-B N106ER Route/Track of Accident Flight provided by ERAU Director of Safety upon request.²

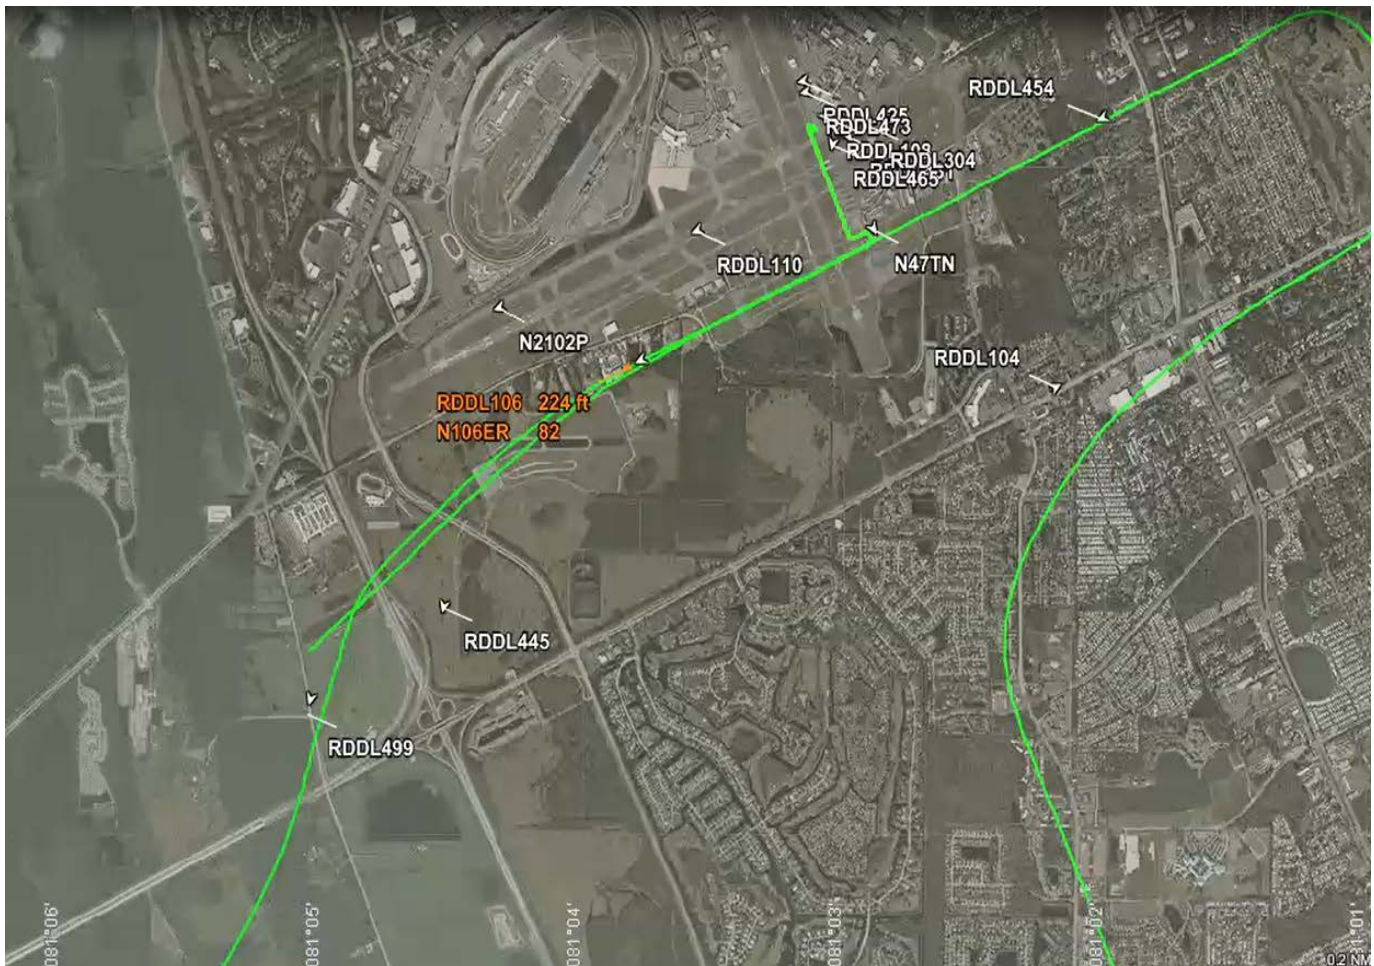
Figure 1- N106ER on initial climb after departing DAB runway 25L.

¹ N106ER (RDDL106) is colored amber and the route is indicated by the green line.

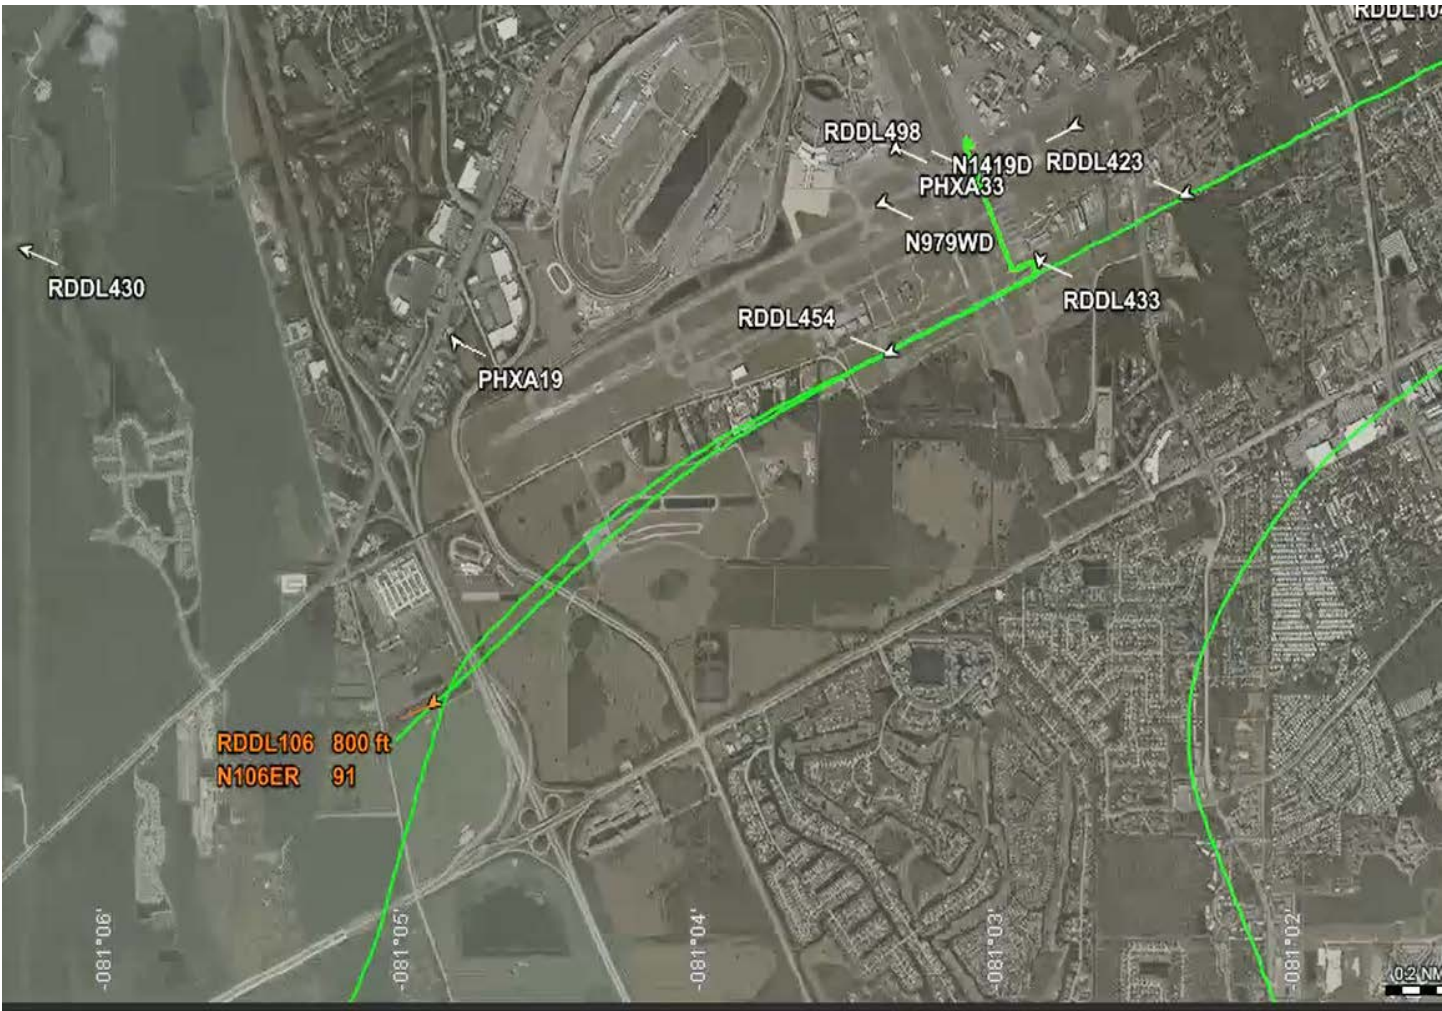
Figure 4-RDDL106 After touch and go during upwind climb immediately preceding accident.
