# NATIONAL TRANSPORTATION SAFETY BOARD

MATERIALS LABORATORY FACTUAL REPORT

Report No. 01-22

Place : Bellingham, Washington  
Date : June 10, 1999  
Vehicle : Olympic Pipe Line Company, 16-inch diameter gasoline pipeline  
NTSB No. : DCA99-M-P008  
Investigator : Allan Beshore

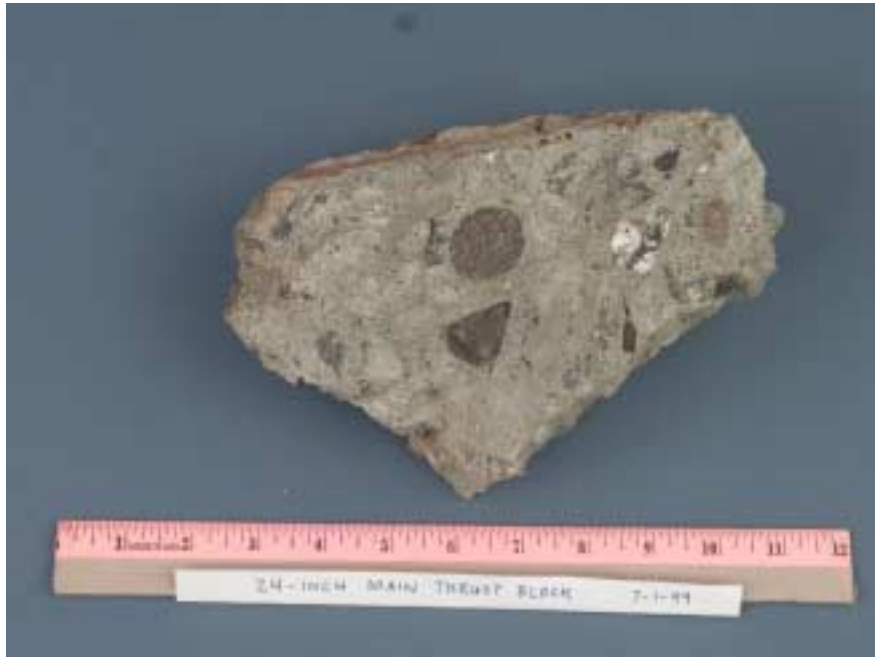
ImageNo:101A0082, Project No:A00137

Figure 1. View of a concrete sample identified as "24-inch Main Thrust block".

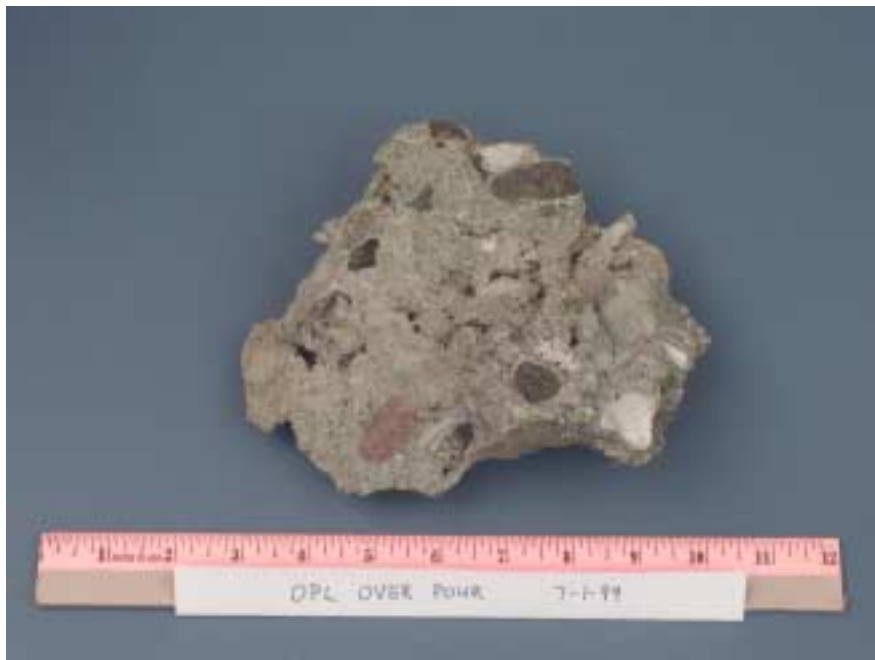
ImageNo: 101A0084, Project No:A00137

Figure 2. View of a concrete sample identified as "OPL Over pour".

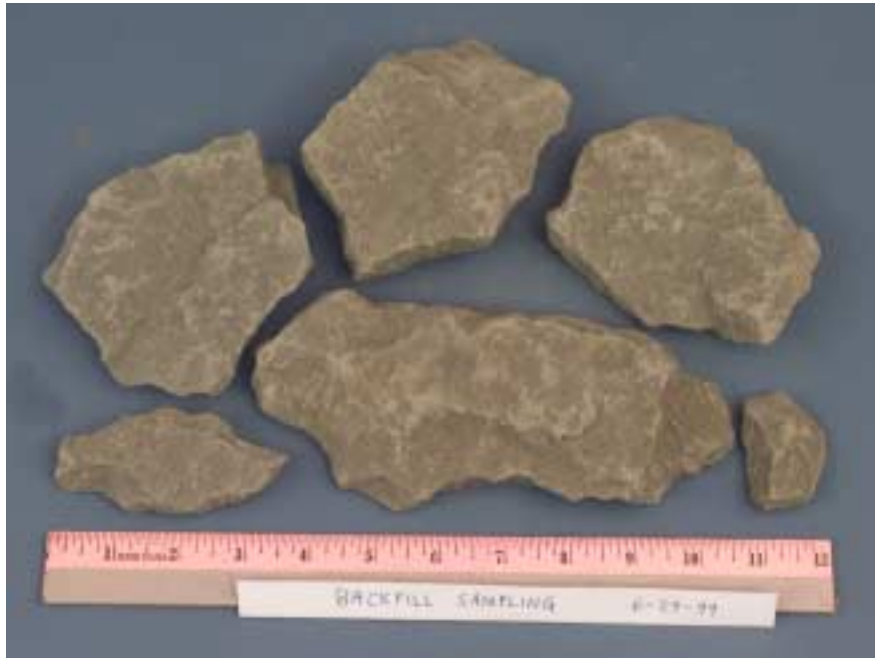
ImageNo:101A0081, Project No:A00137

Figure 3. View of a sample identified as "Backfill Sampling".
