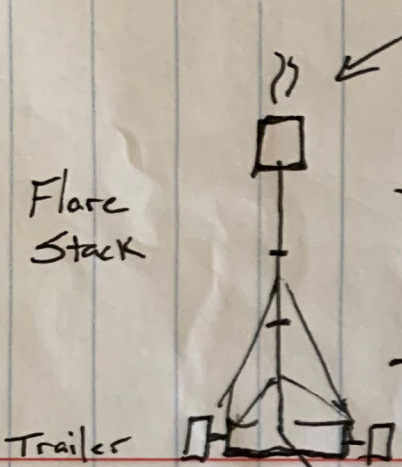
gas indications found on
flare stack w/ RMLD
no sustained readings ~~was~~ found

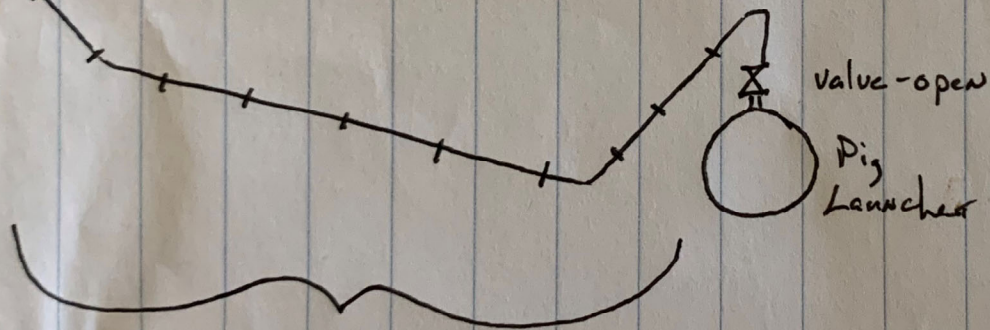
(2) unions on flare
stack shot from (4)
different directions w/ RMLD
- NO leaks found

Each segment of vent pipe
has an internal O-ring. CGI
was used on every union and
no leaks were found
