# National Transportation Safety Board

RRD20LR005

Union Pacific Railroad Company  
Train Derailment with Bridge Strike and Fire  
Tempe, Arizona  
July 29, 2020

## Operations Group Chairman Factual Report

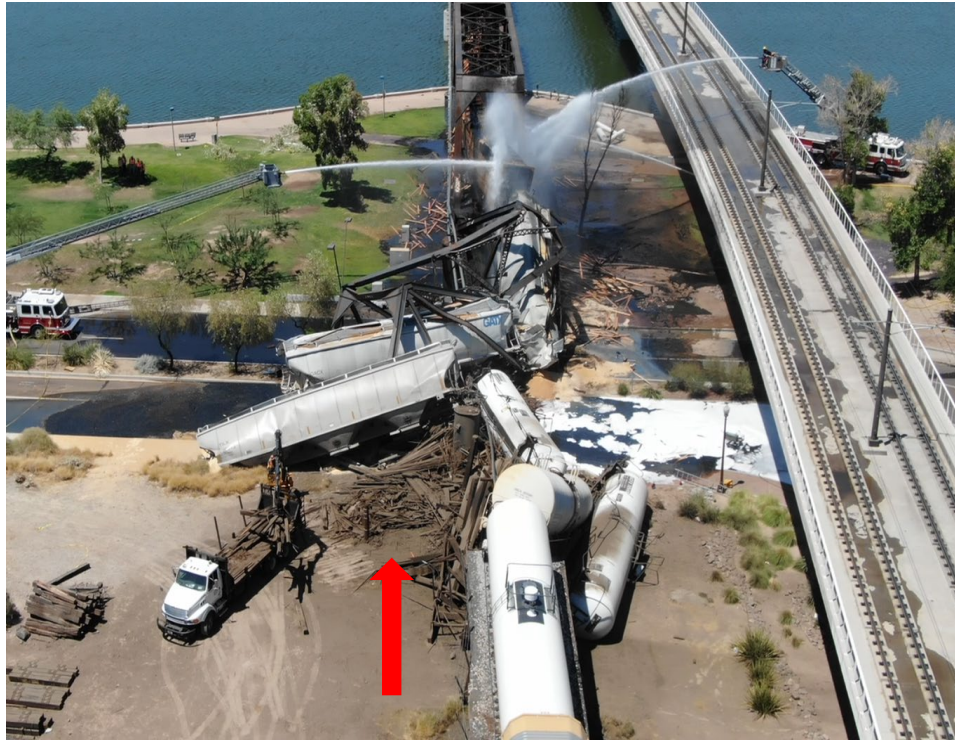
**Figure 1.** Aerial photo of the derailment site. Red arrow shows direction of train. Light rail operation to the east of UP's right-of-way.
