NATIONAL TRANSPORTATION SAFETY BOARD

Personal Electronic Devices

Specialist's Factual Report By Sean Payne

Location: Hurricane, Utah
Date: December 10, 2015
Aircraft: Vans Aircraft RV-7
Registration: N307AB
Operator: Private
NTSB Number: WPR16FA036

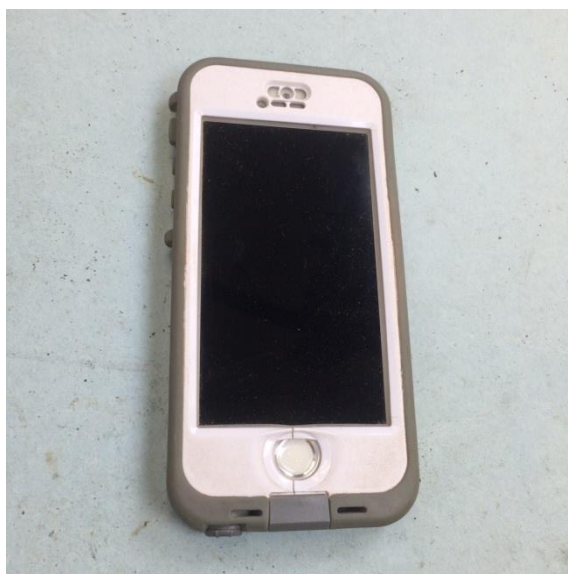
The device arrived to the laboratory in a hard plastic case (figure 1). The hard plastic case was removed and the device was inspected. The device exhibited light structural damage to its aluminum chassis. The device was minimally deformed; the screen was intact and showed no sign of damage. Power was applied to the device using the manufacturer's charging cable which resulted in the device functioning normally.

Figure 1. Photo of damaged iPhone 5S (White) IMEI 352006063813415.

The device was password protected and could not be accessed. The password for the device could not be obtained.

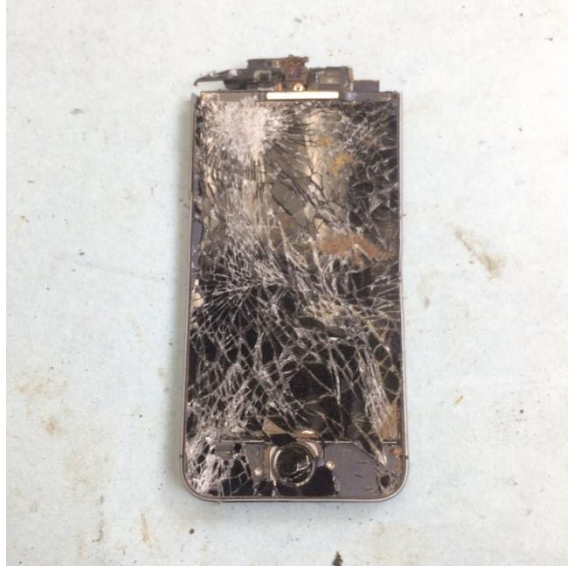
The device arrived to the laboratory exhibiting severe structural damage. The screen was shattered. The top portion of the device containing the camera and ear piece was not present and assumed destroyed. The device's screen was removed. The device's main board was intact but bent. The main board was removed from the phone and connected to a surrogate device. The surrogate device was able to power the phone, however, the device failed to power the screen of the surrogate device. The device was connected to a PC to attempt a forensic read out. The PC could not access the contents of the PED.

Figure 2 is a photo of the device as received.

Figure 2. Photo of damaged iPhone 5S (Black) IMEI 352008062716573.

The device was sent to a third party data recovery laboratory. The third party laboratory was not able to get the device to function, nor was the laboratory able to recover any electronic data.

The device's main board failed to power the screen in the surrogate device. Additionally, the device could not be examined when connected to a PC.
