RECORD OF EMAIL

Date: April 14, 2021
Person Contacted: Mr. Keenon Wood (Federal Aviation Administration)
NTSB Accident Number: CEN21LA178

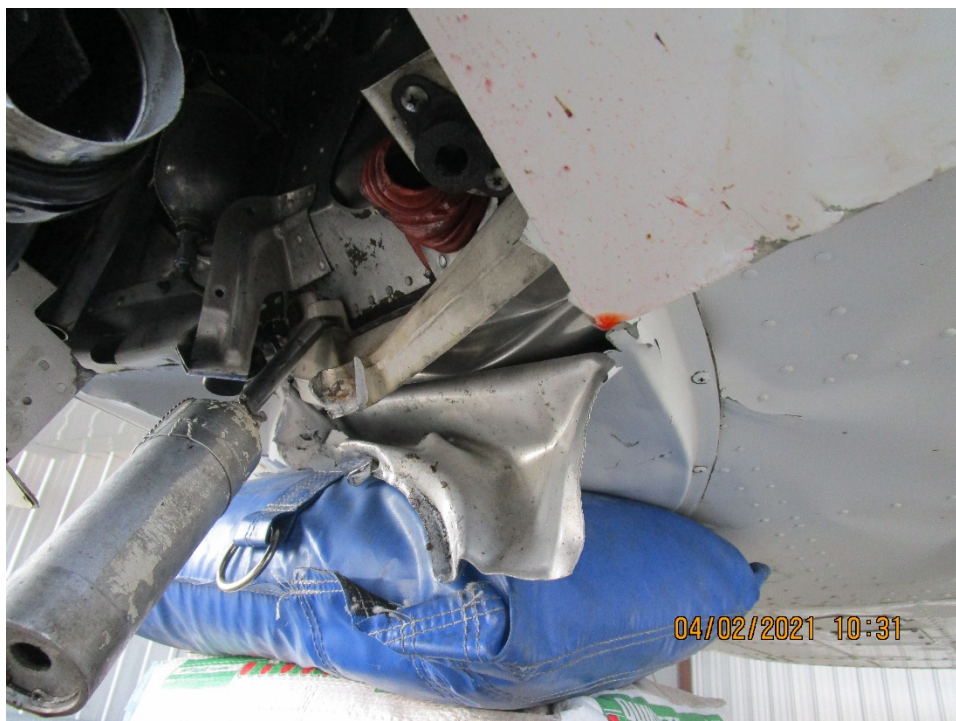
- The airplane's firewall exhibited horizontal ripples near the nose gear attachment point, as well as an overall large vertical bend.
- Mr. Wood examined the brake system, and he did not note anything abnormal that would have precluded normal operations
- He shared the following photos of the airplane's damage.

Figure 1: Horizontal Ripples in Firewall

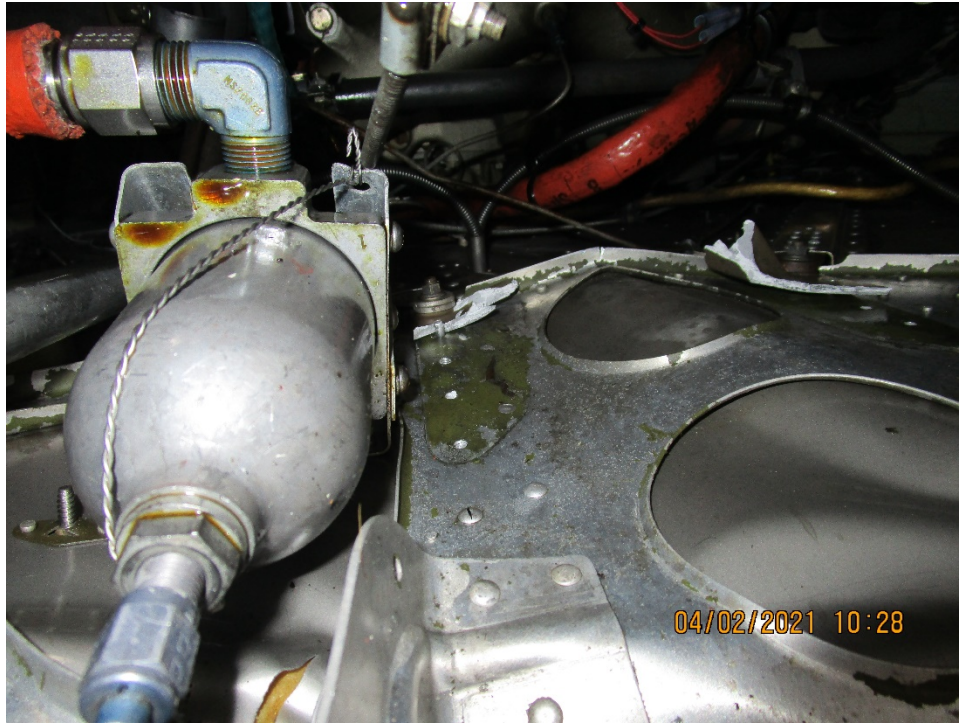
Figure 2: Overall Vertical Bend
