Preliminary Report HMD23LR002

Safety Performance of DOT-111 Tank Cars

Reed Point, Montana

June 24, 2023

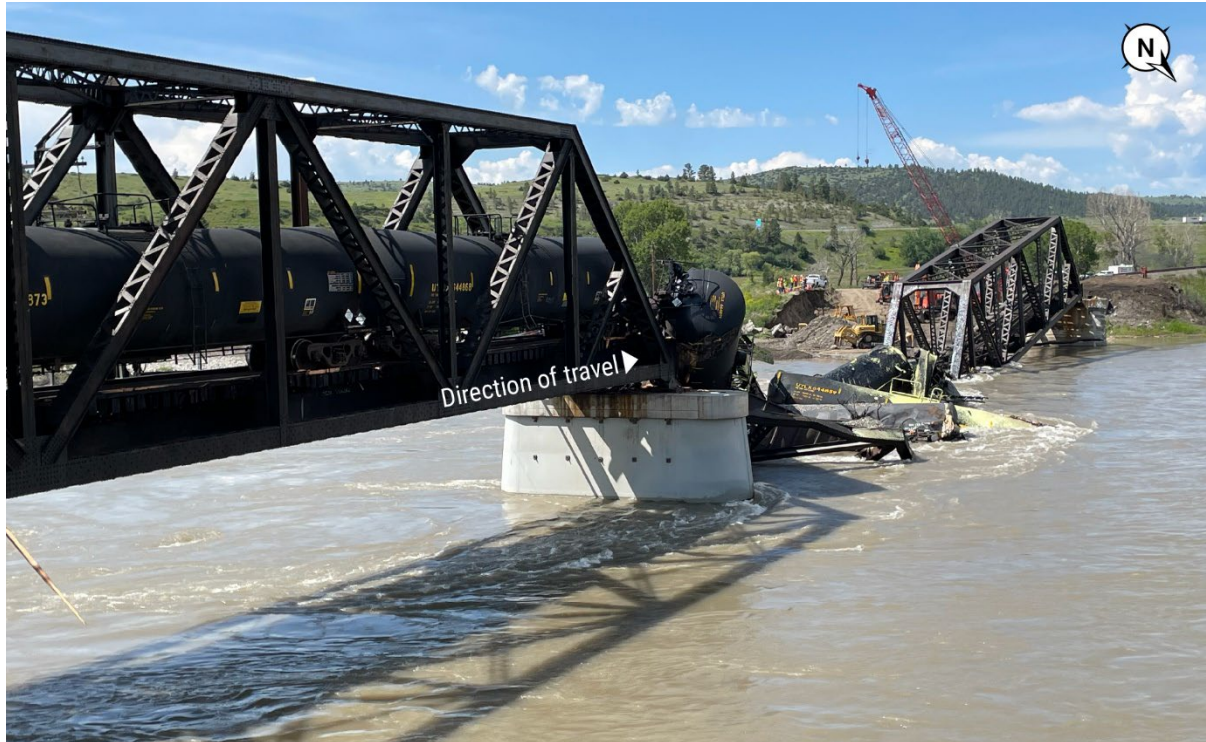
Figure. View of the accident scene.
