PRELIMINARY REPORT

Survey Report No.: MS-2021-11046

Re: PRELIMINARY DAMAGE INVESTIGATION
MV "MARQUETTE WARRIOR" & TOW - GROUNDING
MM 538 LMR / GREENVILLE, MS.

DOI: November 21, 2021

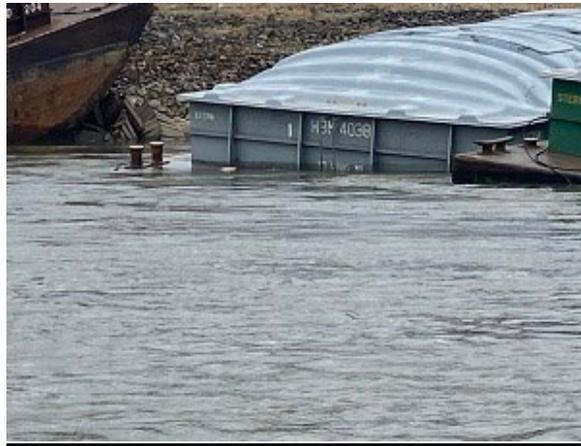
PRELIMINARY DAMAGE INVESTIGATION
COVERED HOPPER BARGE
"HBM-4038"

Damages noted in way of **CHB "HBM-4038"**, which appeared to be of recent vintage and, in the opinion of the undersigned marine surveyor, were **attributable** to the incident as described were noted as follows:

1. In way of the bow rake starting at the aft bulkhead and extending forward 16' the rake bottom plate is set in 0-6" for width.

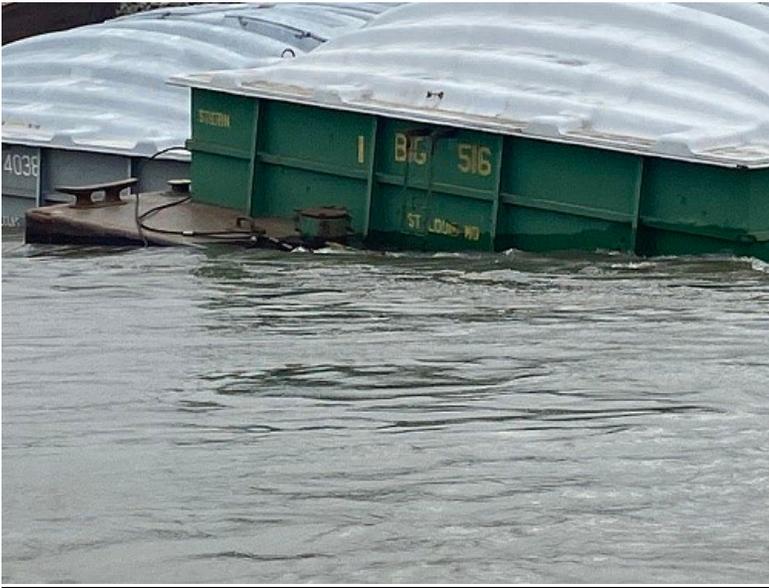
PRELIMINARY DAMAGE INVESTIGATION
COVERED HOPPER BARGE
"BIG-516"

Damages noted in way of CHB "BIG-516", which appeared to be of recent vintage and, in the opinion of the undersigned marine surveyor, were **attributable** to the incident as described were noted as follows:

1. In way of the bow rake starting at the aft bulkhead and extending forward 16' the rake bottom plate is set in 0-6" for width.

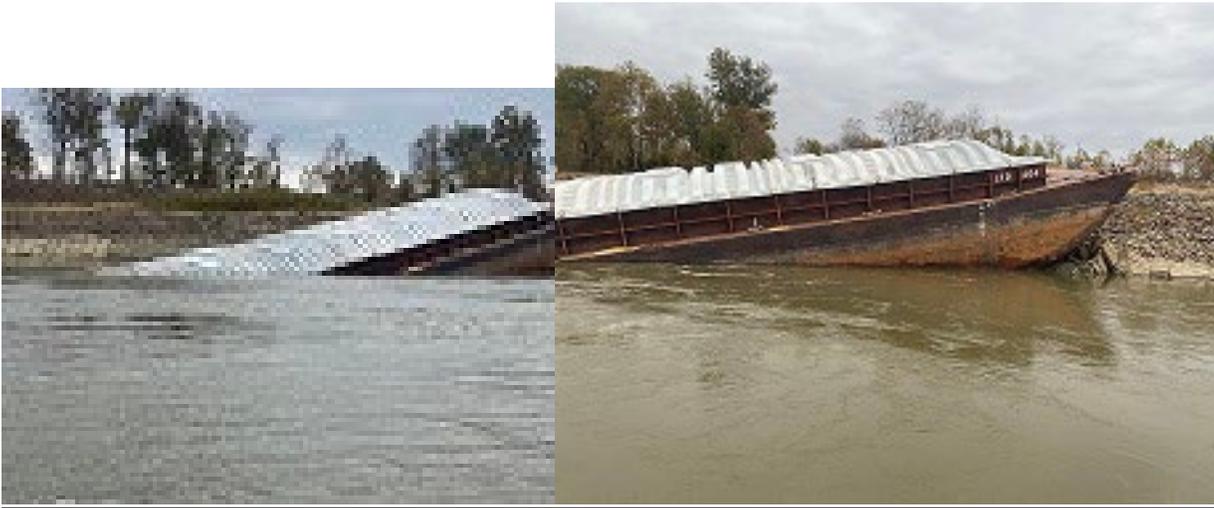
"LTD-204"

Damages noted in way of CHB "LTD-204", which appeared to be of recent vintage and, in the opinion of the undersigned marine surveyor, were **attributable** to the incident as described were noted as follows:

1. In way of the bow rake starting at the aft bulkhead and extending forward 16' the rake bottom plate is set in 0-6" for width.

0900 hours – The salvors completed dewatering the hopper and began making repairs to the fractures in the hopper.

1000 hours – The salvors welded up the fractures in the hopper of the "LTD-204".
