MARINE SAFETY ALERT

Safety Alert 06-20

RECOGNIZING FIRE HAZARDS & PROPER CARGO STOWAGE ON RO-RO VESSELS

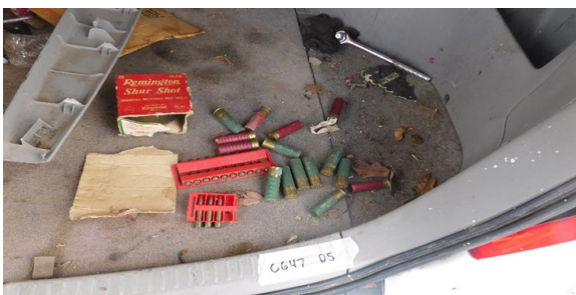
Ammunition found in trunk of vehicle from deck 5 of cargo ship, taken in June 2020, provided by the Coast Guard.

- Protect vehicle batteries against short circuiting, for example by disconnecting the battery if appropriate;
- Remove all personal and combustible material from vehicles prior to loading them onto a vessel;
- Inspect and remove leaking vehicles from the vessel prior to sailing and do not permit vehicles known to be leaking to be loaded onto the vessel;
- Verify receiving guidelines of shippers and charterers are in alignment with the IMDG Code to include fuel levels prior to loading.

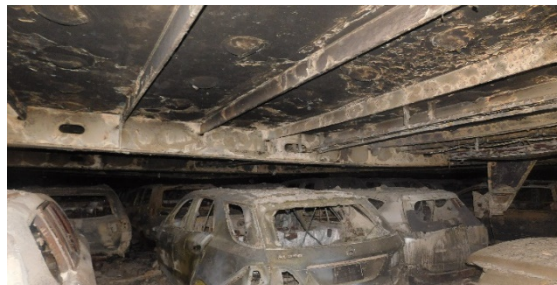
Cargo and structural fire damage on deck 8 of a cargo ship, taken in June 2020 provided by the Coast Guard.

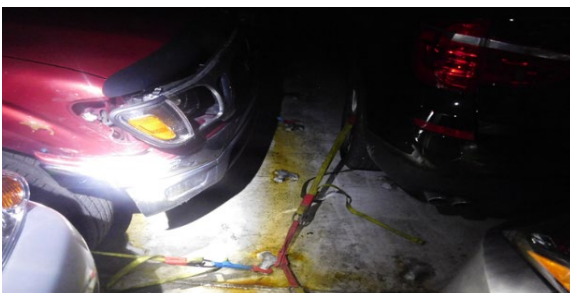
Leaking fuel from vehicle on deck 1 of cargo ship taken in June 2020, provided by the Coast Guard.

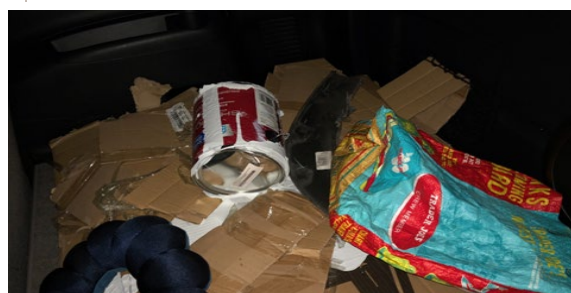
Paint and cardboard in a vehicle on deck 5 of cargo ship, taken in June 2020, provided by the Coast Guard.

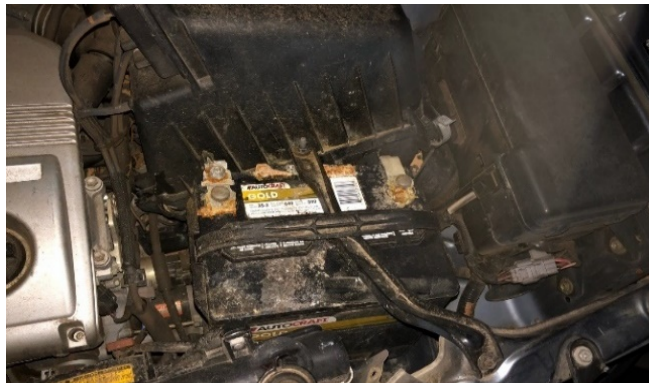
Heavily corroded battery with terminals still connected found in vehicle on Ro-Ro, taken in June 2020, provided by the Coast Guard.
