## $WPR22LA324\ Accident\ Pictures-courtesy\ of\ FAA$

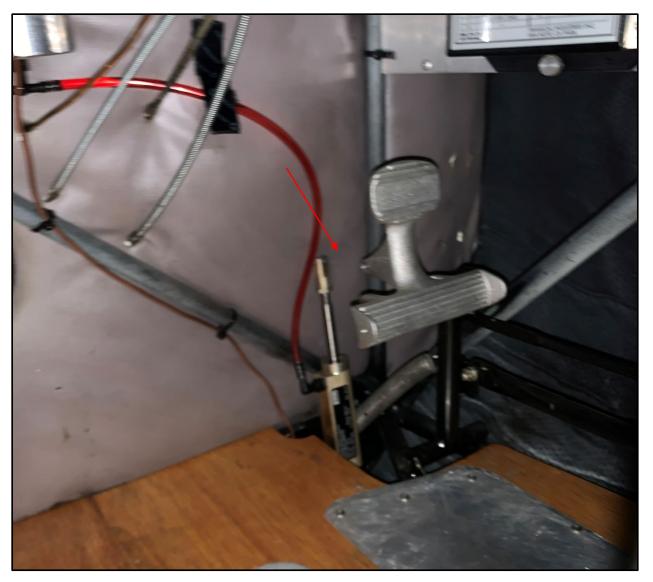
Figure 1: View of right pedal disconnected from the brake cylinder.

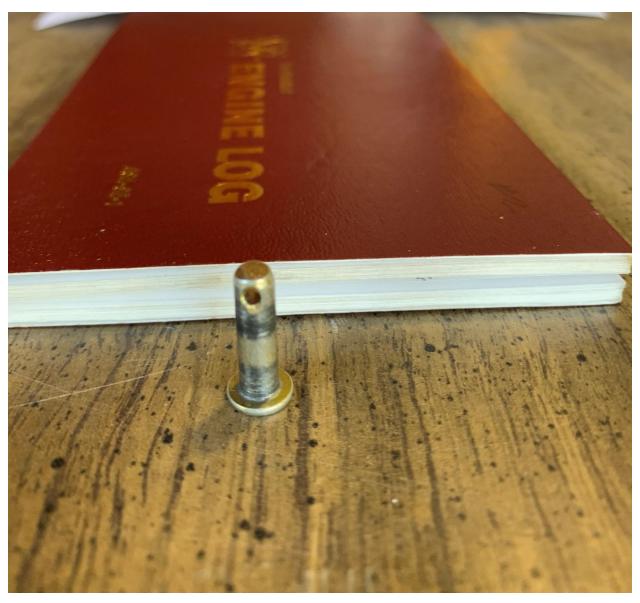
Figure 2: View of the clevis pin.
