N808NV

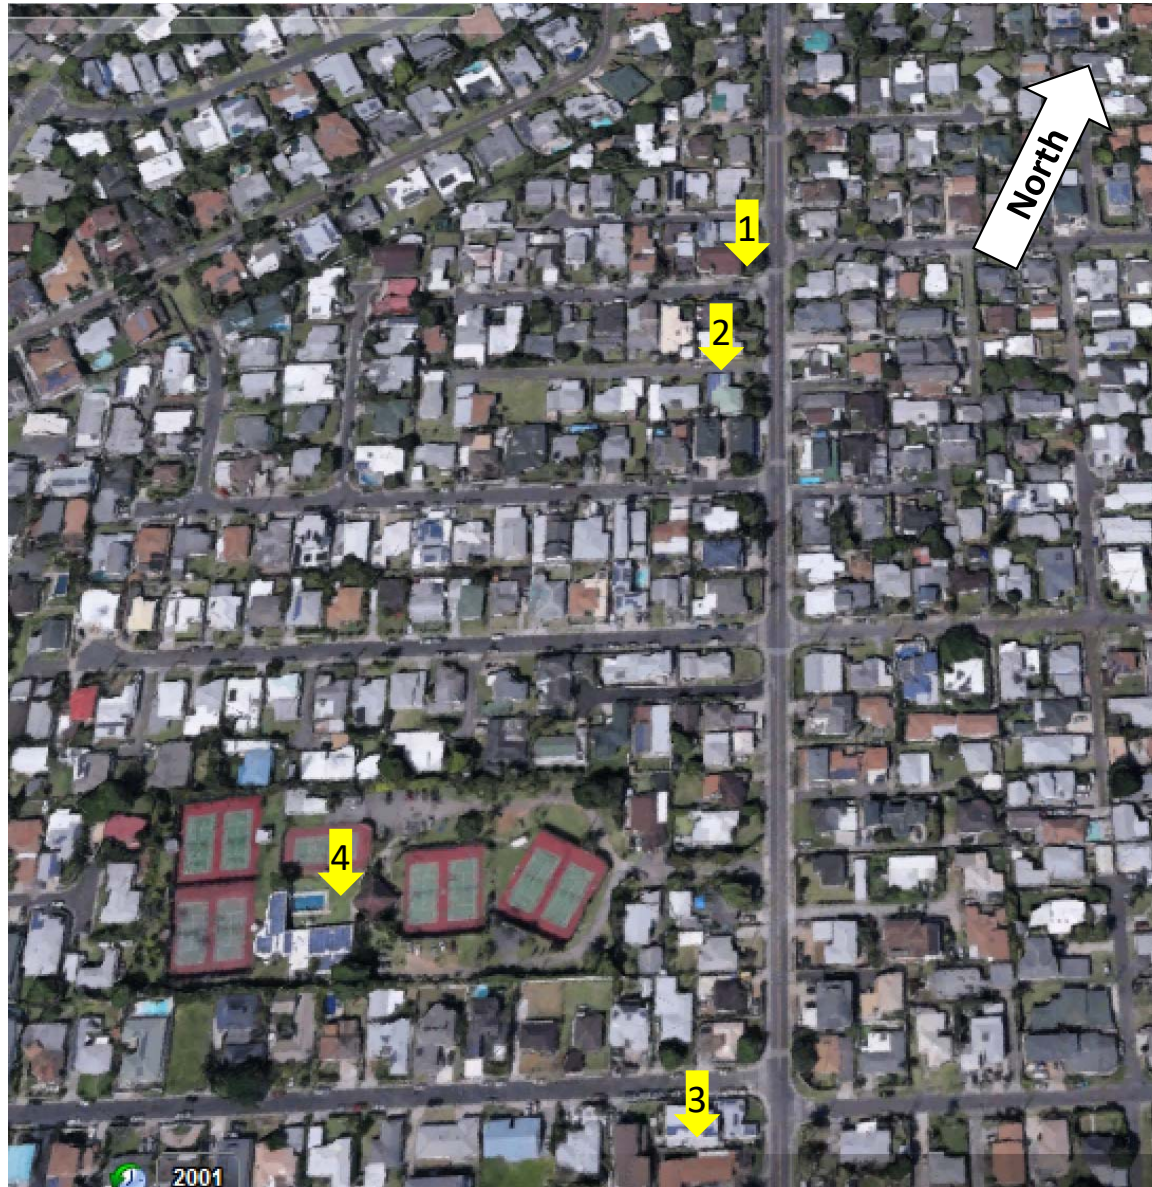
1. Main wreckage
2. Fuel tank
3. Main rotor blade fragment
4. The Racquet Club contained a large debris area of airframe and cockpit fragments

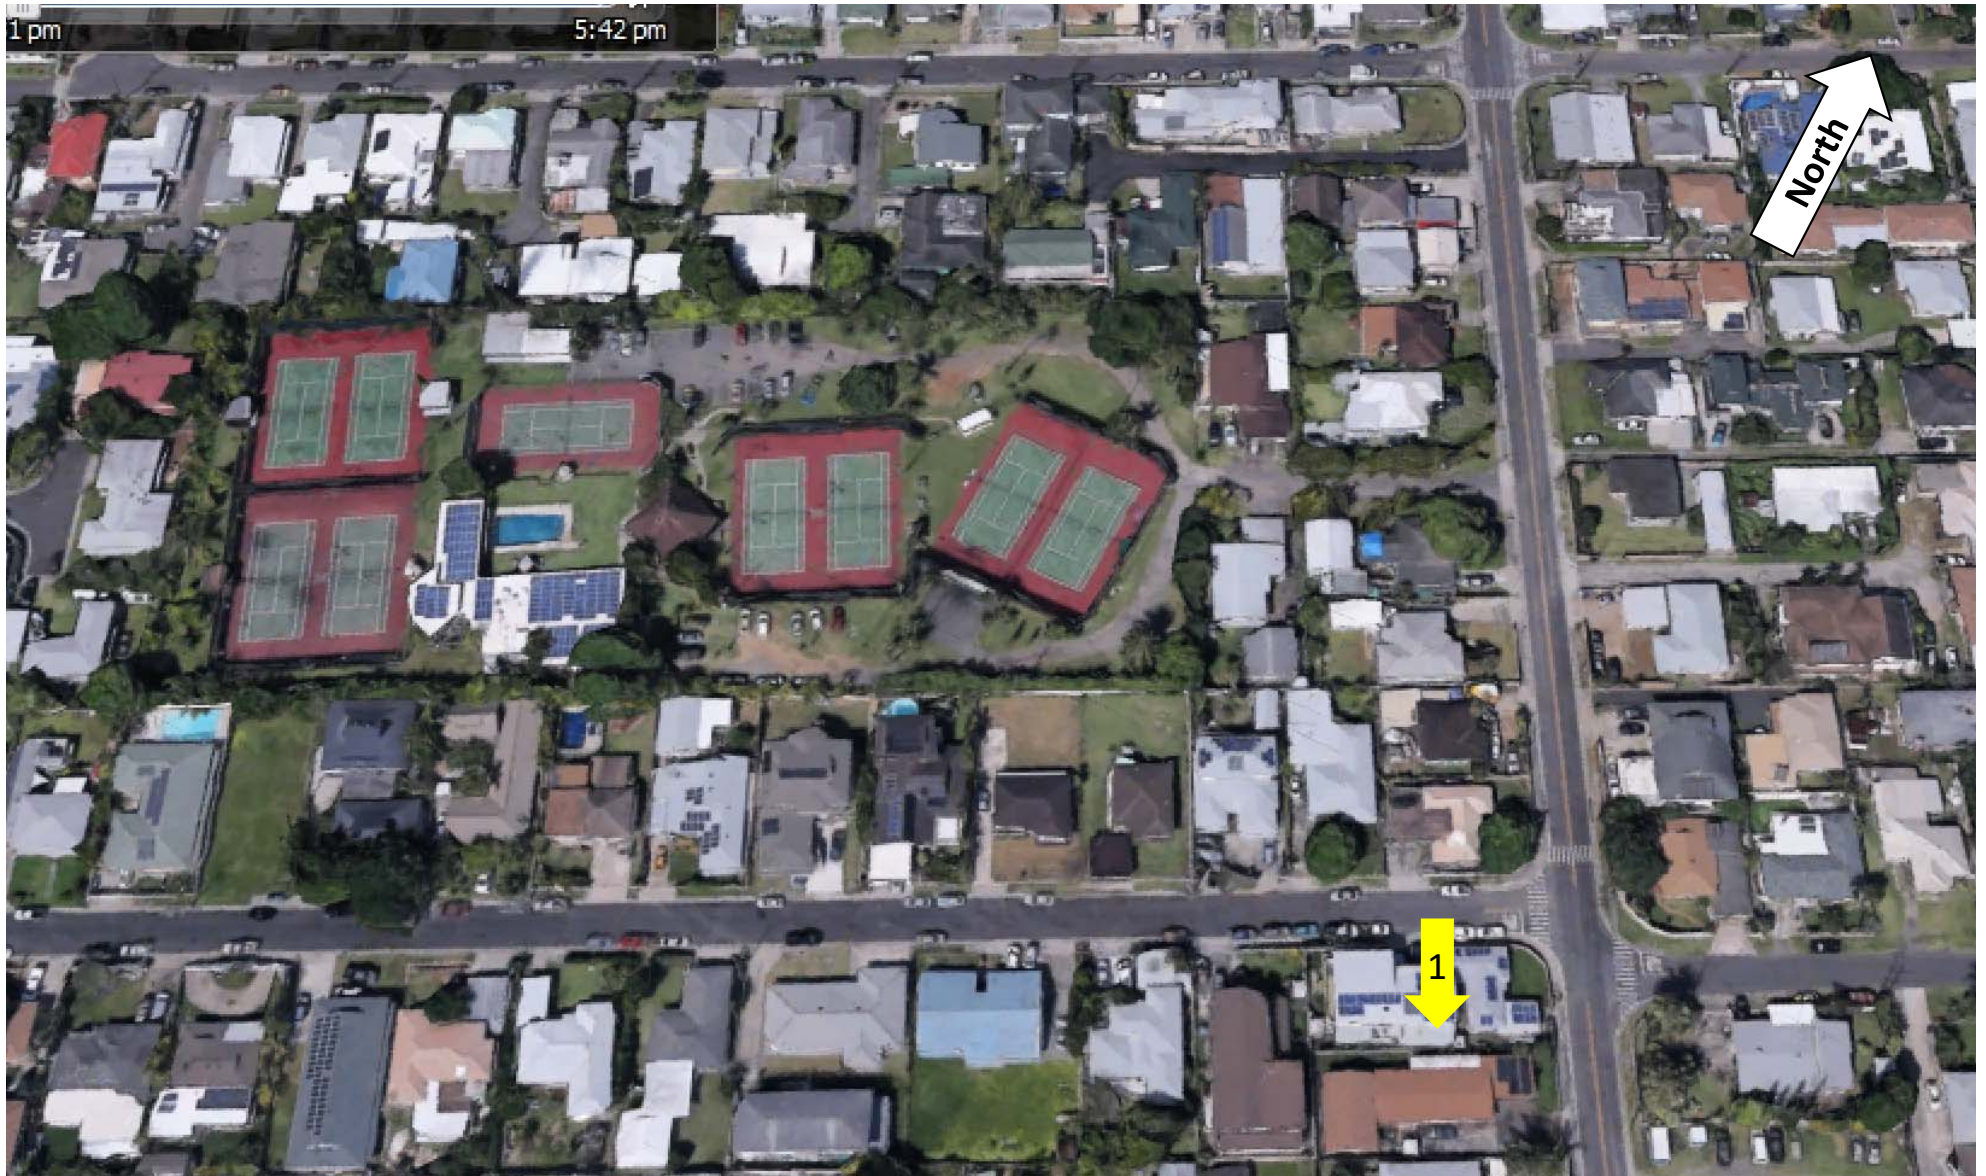
1. Main rotor blade fragment

| 1. Plexi-glass | 6. Tinted Plexi-glass | 11. Multiple Plexi-glass fragments (>20) | 16. Top of Fire Extinguisher |
| 2. Fiberglass | 7. Fiberglass | 12. Blade Fragment | 17. Black metal fragment |
| 3. Plexi-glass | 8. Battery Cover, multiple pieces of Plexi-glass, Fiberglass | 13. Metal Fragment | 18. Red painted metal |
| 4. Tinted Plexi-glass | 9. Tinted Plexi-glass, multiple pieces (7), Skid tip | 14. Ear Cup | 19. Red painted metal (part of door) |
| 5. Safety for Fire Extinguisher | 10. Not related to accident | 15. Headphone Chord | 20. Main Rotor blade fragment |

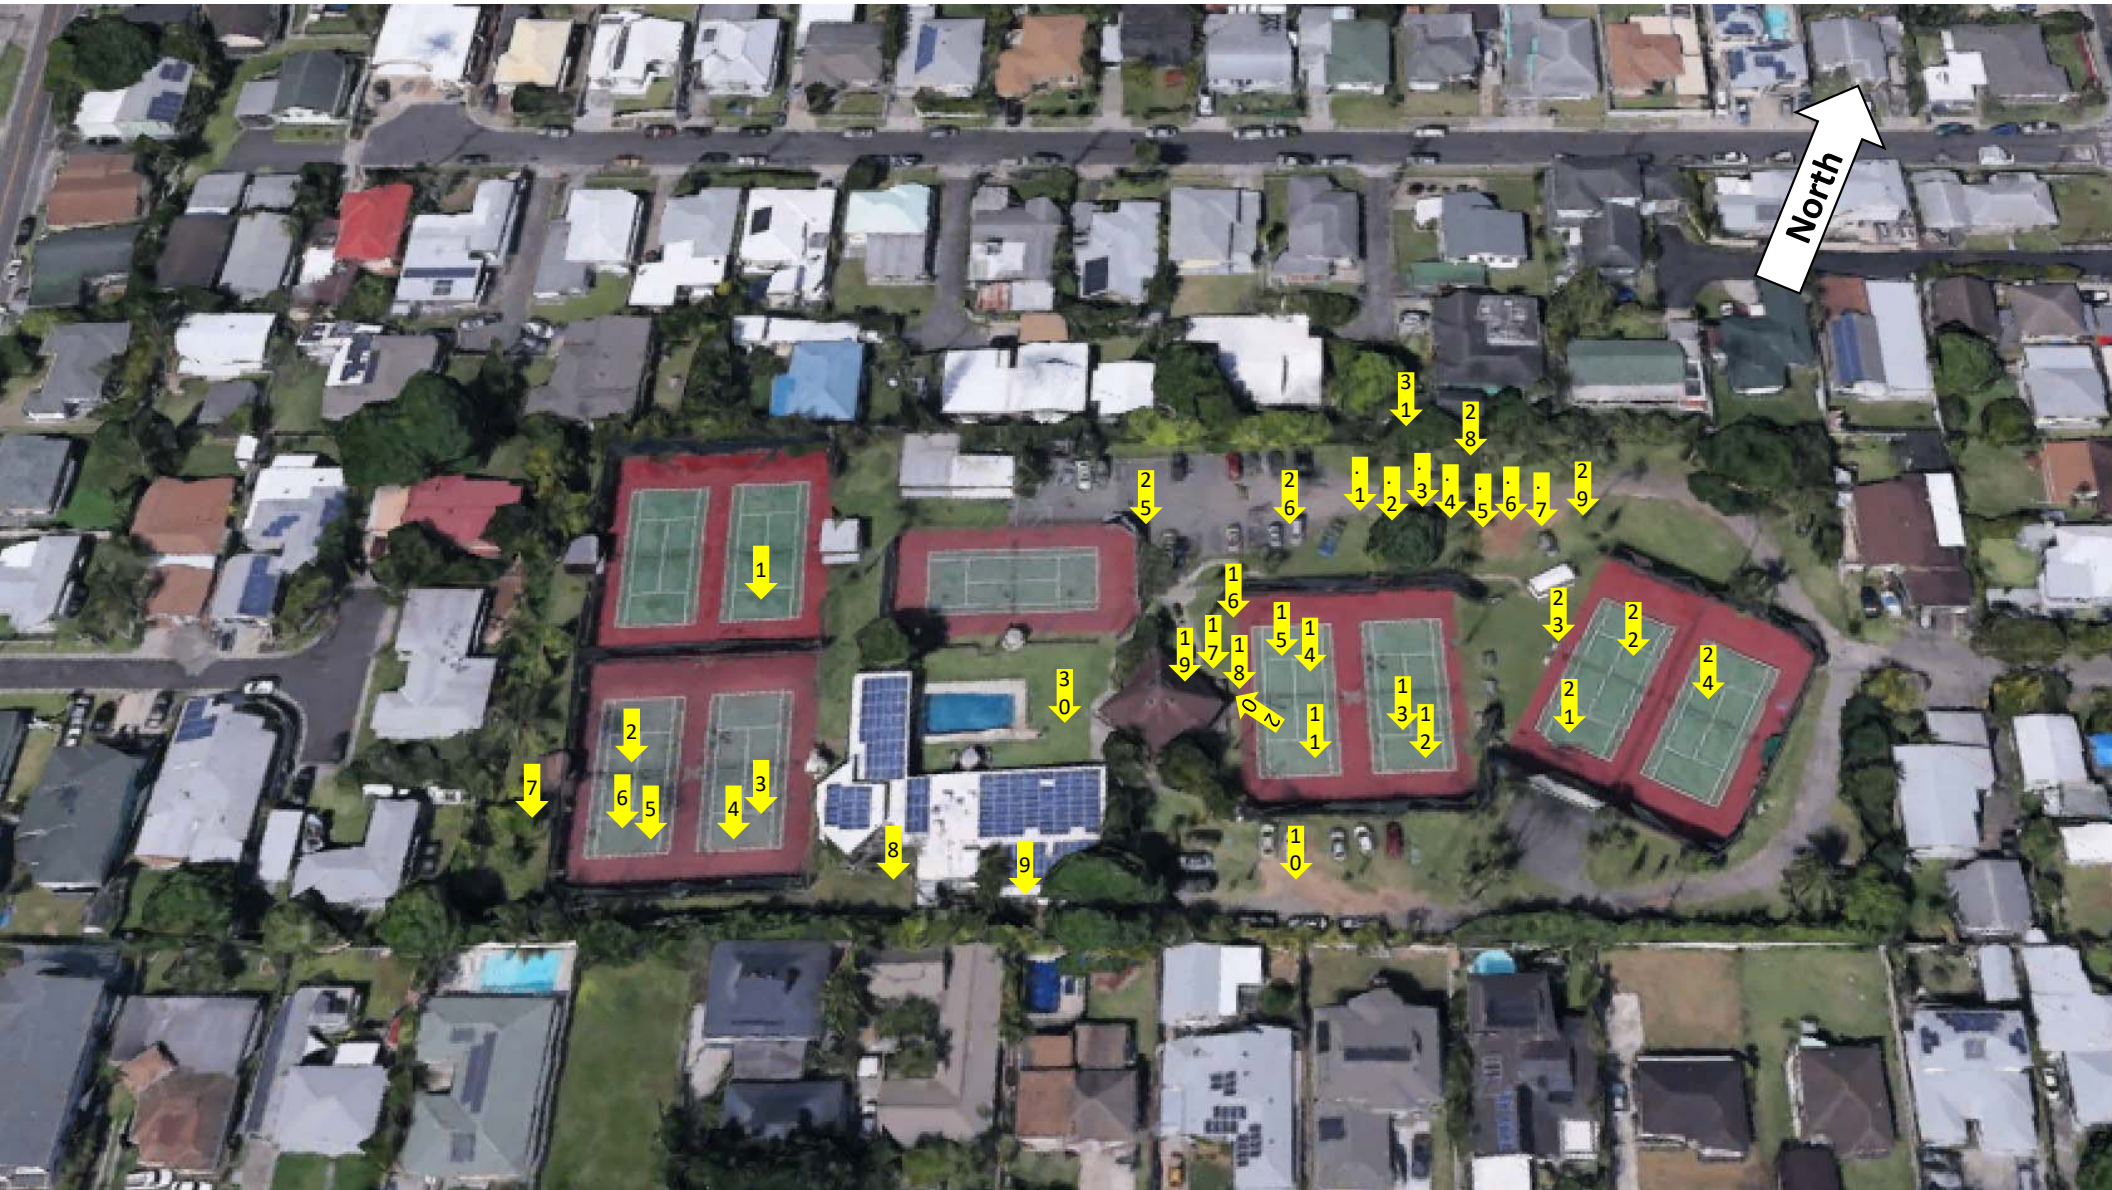
| 21. Door | 26. Instrument housing fragment | 27.5 Instrument housing fragment | 30. Plexi-glass fragments (>15) |
| 22. Sunglasses (frame and two liberated lenses) | 27.1 Sheet metal | 27.6 Pen | 31. Cell Phone |
| 23. Rubber piece | 27.2 instrument housing fragment | 27.7 Instrument housing fragment | |
| 24. Camera mount or latch | 27.3 Red sheet Metal | 27.8 Altimeter pieces | |
| 25. Shoe Sole | 27.4 Door Hinge | 29. Fire Extinguisher | |

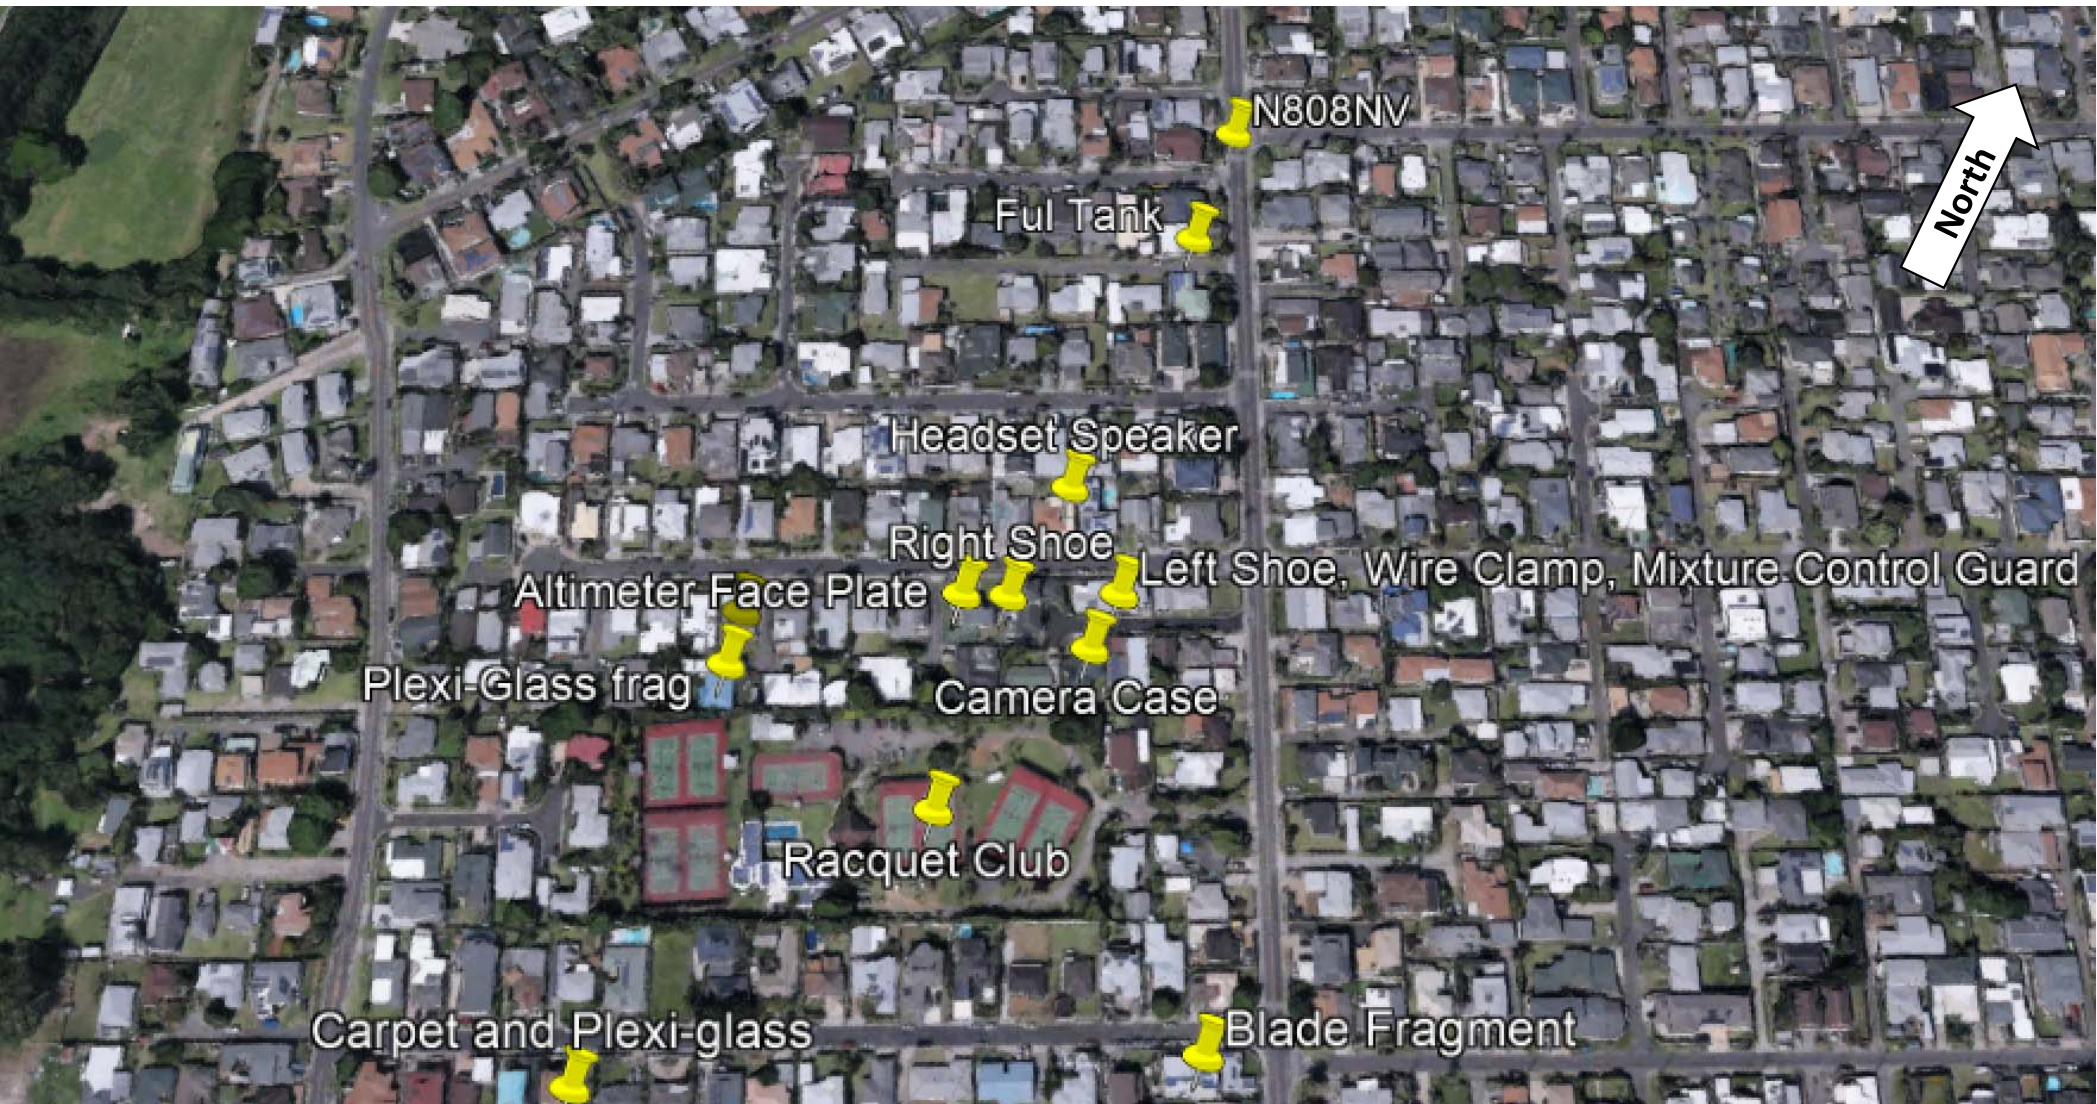
Ful Tank

Headset Speaker

Right Shoe

Left Shoe, Wire Clamp, Mixture Control Guard

Altimeter Face Plate

Plexi-Glass frag

Camera Case

Racquet Club

Carpet and Plexi-glass

Blade Fragment
