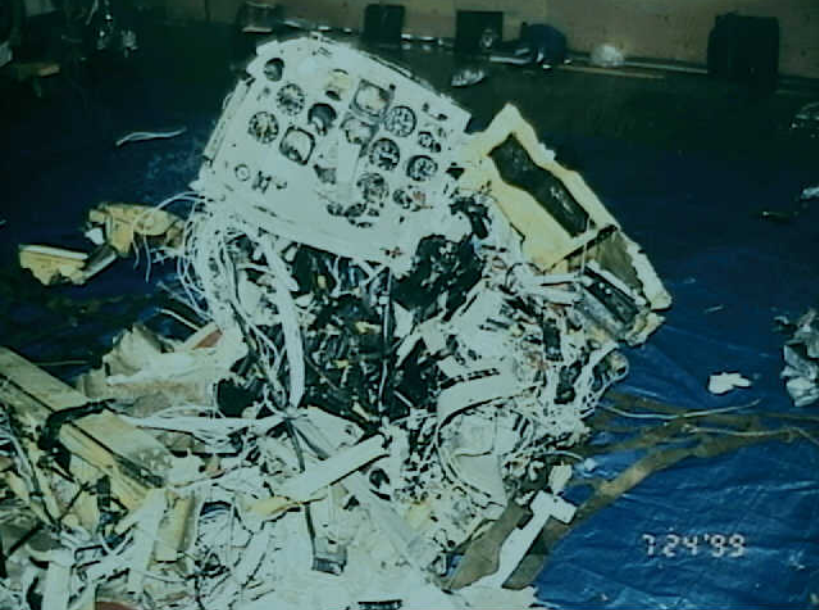
Airworthiness - Photo 2. Close-up view of the instrument panel. Note that the attitude indicator (denoted by arrow) is captured in nose-down, steep right bank attitude. (NTSB-E21)
